**Investigation of Fatality
Green Canyon Block 304, Well No. 1
OCS-G 28066
3 September 2009**

Gulf of Mexico
Off the Louisiana Coast

Glynn T. Breaux – Chair
Ben Coco
Josh Ladner
Jason Mathews

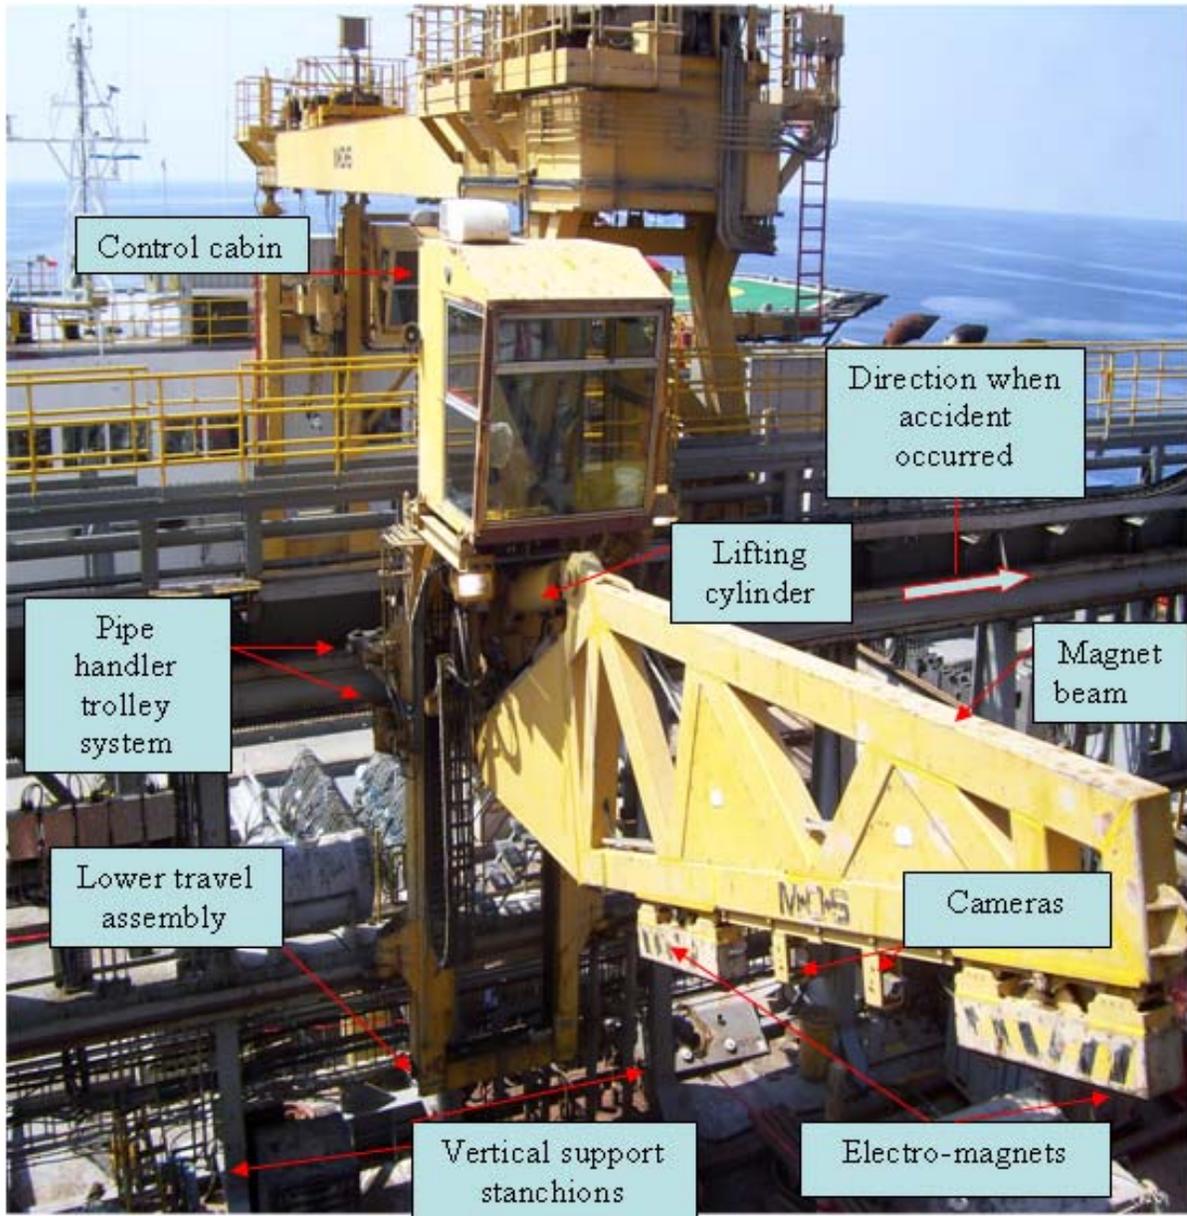
Figure 2 – Major components of the pipe handler

According to the Operator, the specific pipe handler (*see Figure 2*) operation consisted of retrieving the pipe from the catwalk and traversing the pipe to be stacked onto the pipe bay deck. The pipe handler incorporates the spinning and torquing functions of the automated roughneck with the automatic hoisting and racking of disconnected sections of pipe. These functions are integrated via computer controlled sequencing, with the Operator enclosed in an environmentally secure cabin.

Immediately prior to the incident, the Operator placed a joint of drill pipe onto the pipe bay deck. Once the pipe was released, the Operator raised the pipe handler arm up to its full height and proceeded to traverse starboard at a rate of approximately 1.4 miles per hour (118 feet per minute) in preparation to retrieve the next joint.

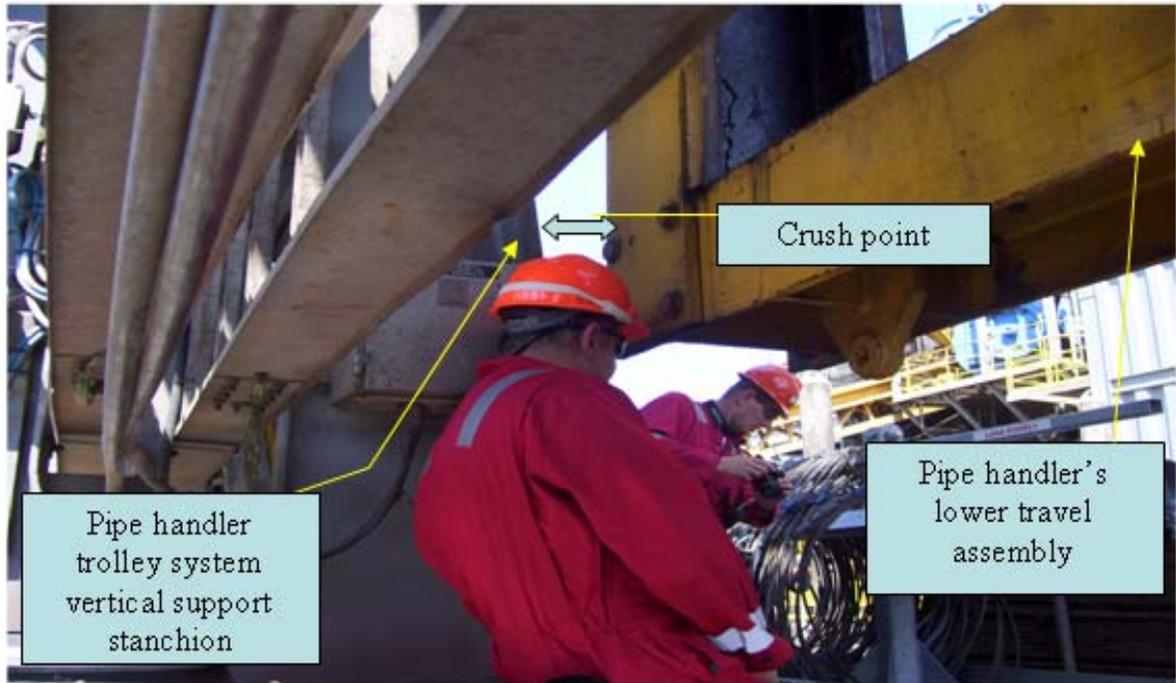
As the pipe handler traversed itself into position along its trolley to transfer the tubulars to the pipe bay deck, a crush point (*see Figure 3*) developed between the pipe handler's lower travel assembly and one of the pipe handler trolley system's vertical support stanchions. Another angle can be used to demonstrate the crush point area (*see Figure 4*), and the obstructed/unobstructed control cabin view of the Operator to the accident area is noted (*see Figures 5 and 6*).

Figure 3 - Crush point location resulting from the pipe handler's lower travel assembly and vertical support stanchion

- The trolley crane operations should be inspected with the intent to identify all potential hazards (including pinch/crush points) with their respective mitigations, and communicate these findings with all necessary personnel.

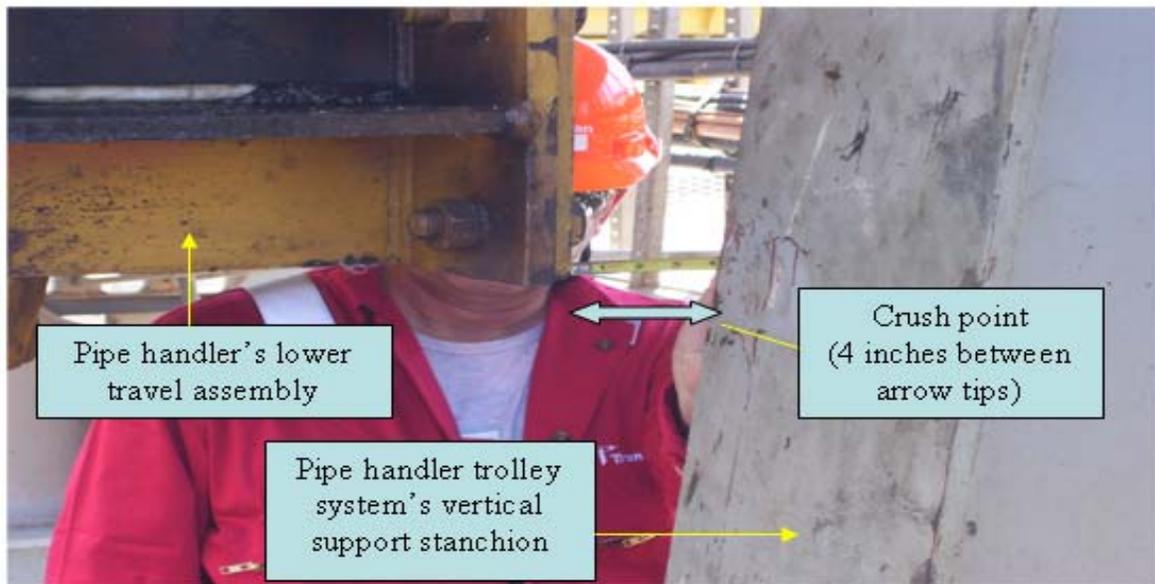
Figure 4 - Another view of the crush point location between the pipe handler's lower travel assembly and vertical support stanchion

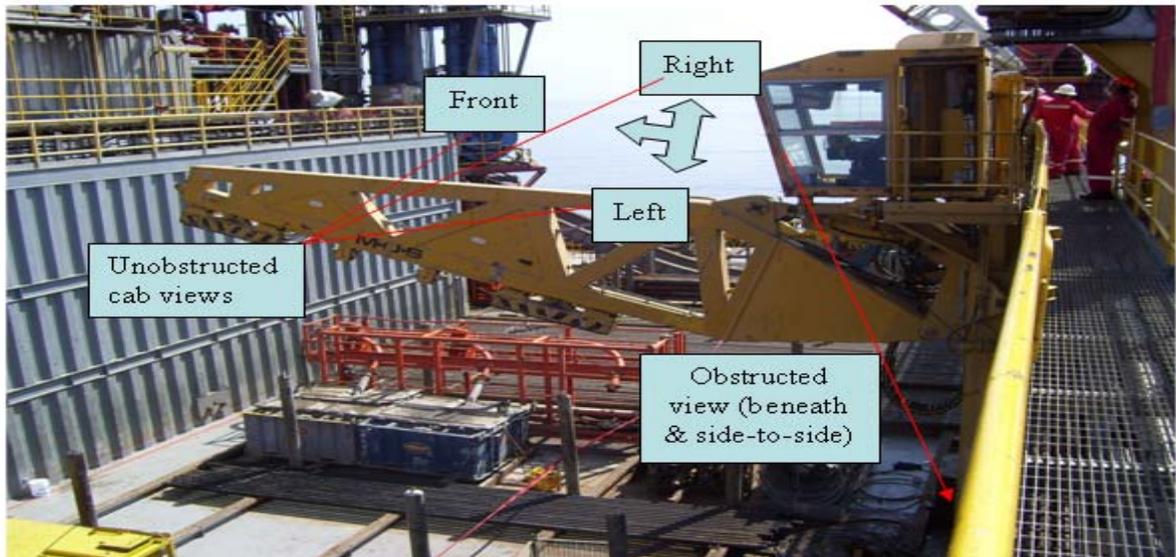
Figure 5 – Unobstructed /obstructed control cabin views of the Spotter and crush point

[Note: During the MMS interviews the Panel confirmed that the Operator and Spotter would keep periodic radio communication as well as visual confirmation, but the Operator only observed the Spotter 30-40% of the time the load was actually being moved from the catwalk to the pipe bay deck.]

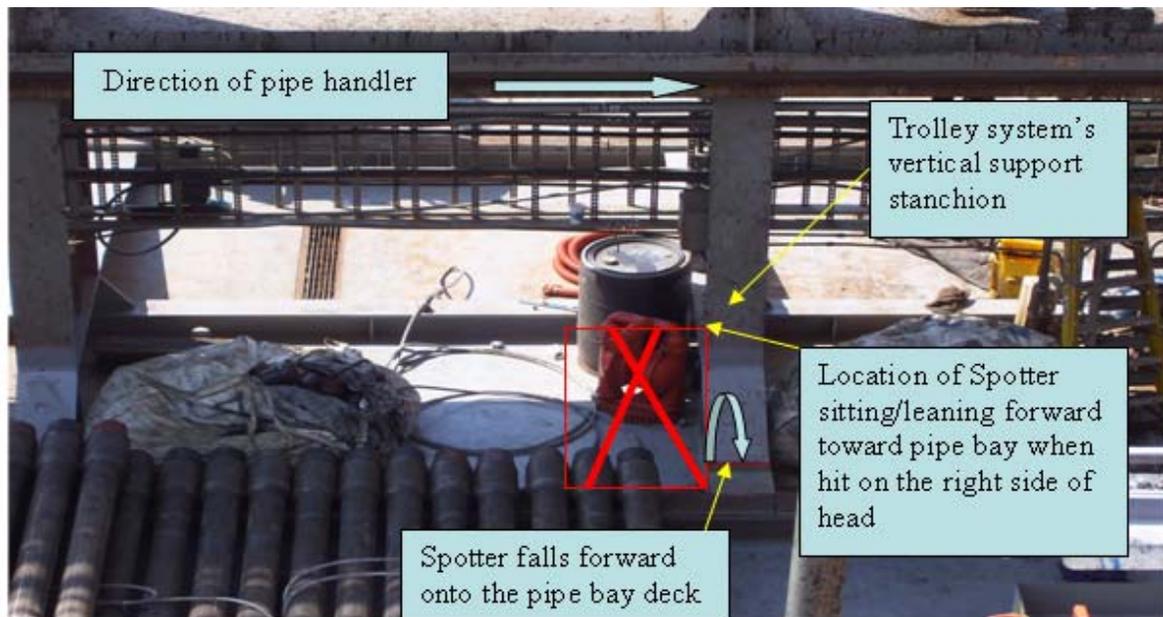
Figure 6 – Location of accident

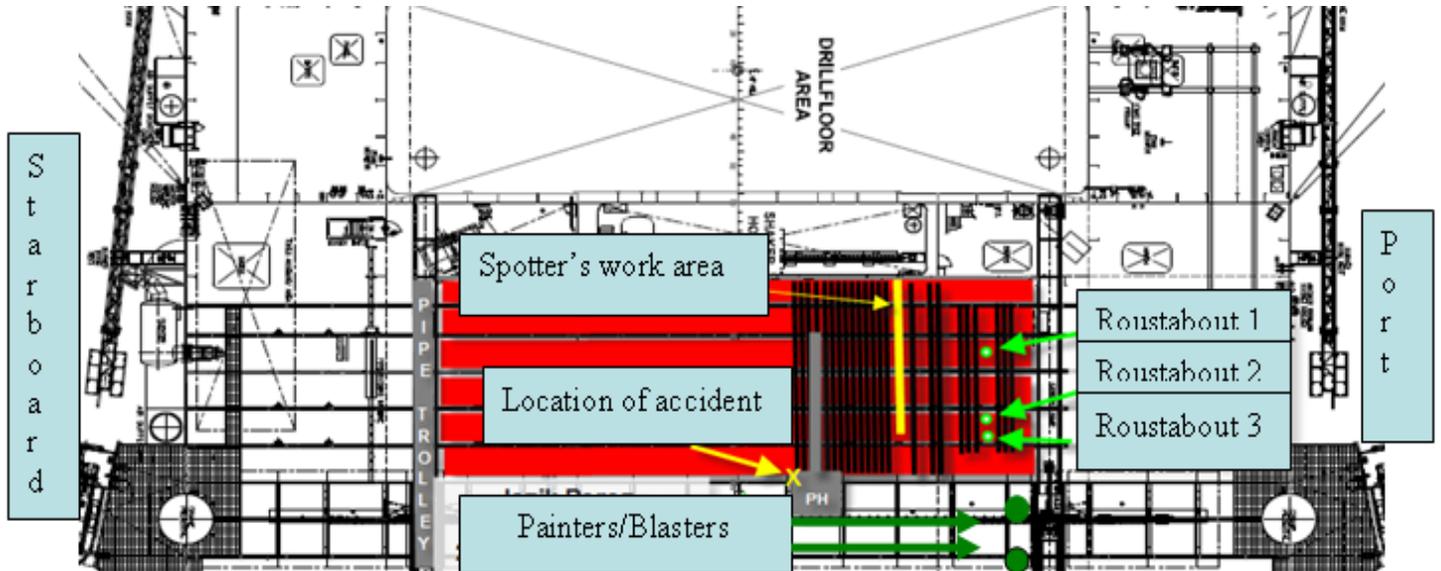
Figure 7 – Personnel positions at time of the accident (Plan)

At the time of the accident, there were two Painters removing equipment in the next bay from where the Spotter was severely injured and three Roustabouts working with the port pedestal crane back-lading drill collars near the Spotter's position (see Figures 7 and 8 for position of personnel in both Plan drawing and Photographed View, respectively).

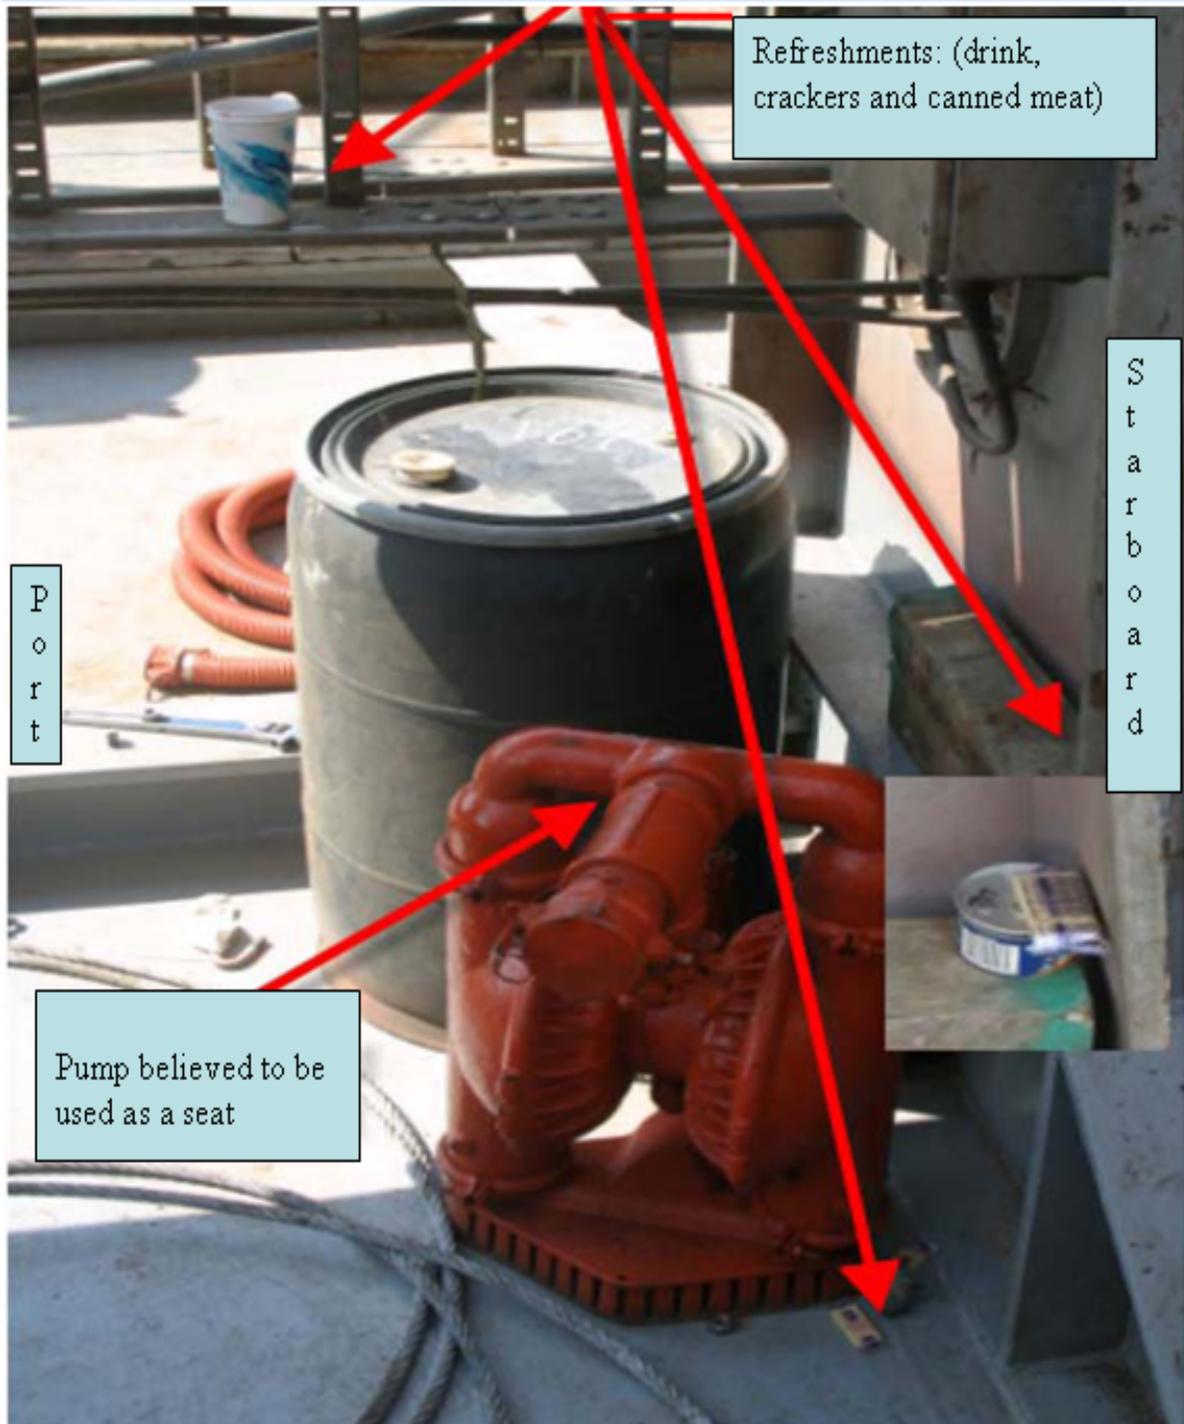
Figure 9 – Spotter’s suspected rest area with refreshments

The MMS interviews with the Operator indicated that he was not that concerned about the heat secondary to working in the pipe handler air-conditioned cab, and he believed the Spotter was getting regular drinks from the crane pedestal area while being shaded from the sun beneath the pipe handler trolley area. He stated that the Spotter was working in direct sunlight on a hot day and repeatedly moved in and out of the shaded trolley area after the sun came up. No breaks were taken during the 4-1/2 hour period from 0600 hours until the time of the accident at 1025 hours. The Acting Crane Operator had one person identified to relieve the Operator and/or Spotter but assigned this individual to another task. Lastly, it would appear from the Transocean photograph in Figure 9 that the Spotter utilized the Wilden pump as a shaded rest area with

The hot work environment is considered to be a possible contributing cause of the accident because the Spotter repeatedly moved into the shaded area of the trolley system across the pipe handler's traversing path when he was not assisting the Operator.
