**Investigation of Loss of Well Control  
South Timbalier Block 135, Well No. 6  
OCS 0462  
1 December 2005**

Gulf of Mexico  
Off the Louisiana Coast

U.S. Department of the Interior  
Minerals Management Service  
Gulf of Mexico OCS Regional Office

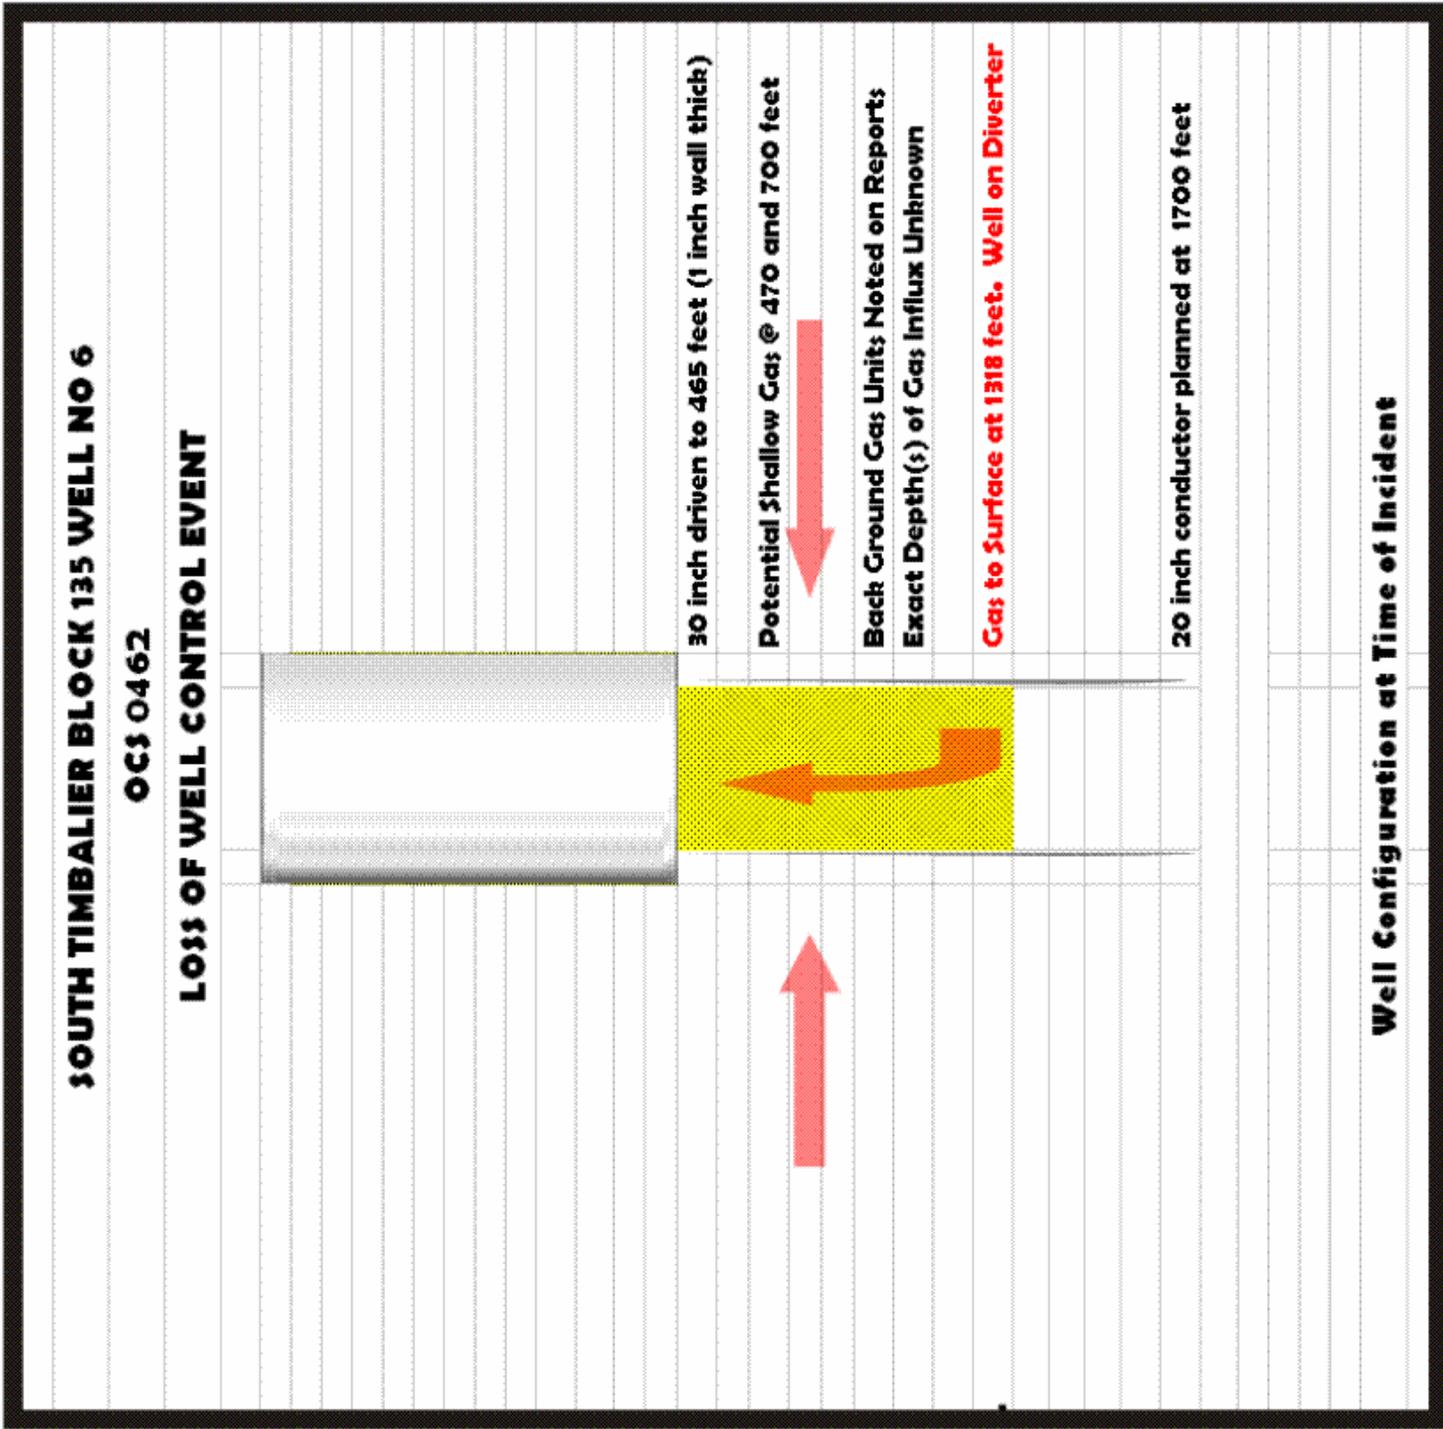
South Timbalier Block 135 Well No. 6 Well Bore Configuration at Time of Incident

While drilling ahead beneath drive pipe in open water on 01 December 2005 on Well No. 6, at a depth of 1,027 feet, the Contractor observed a background gas reading of 224 units with corresponding mud weight loss from 9.8 pounds per gallon to 9.6 pounds per gallon. Mud was weighted up to 10.2 pounds per gallon and drilling continued. At a depth of 1,318 feet in the conductor hole section of Well No. 6 (*See Attachment 3*), while the prescribed mud weight up schedule was being followed, the well became unstable and released a pocket of gas. Contractor

The loss of well control of the subject well was caused by drilling into a sand lens below 1,000 feet without sufficient mud weight to offset the higher pore pressure encountered. During the permitting stages for this well, the Operator had anticipated the maximum mud weight at the 20-inch conductor shoe to be about 8.9 pounds per gallon. The well was eventually controlled through persistent circulation of kill weight mud exceeding 11 pounds per gallon.

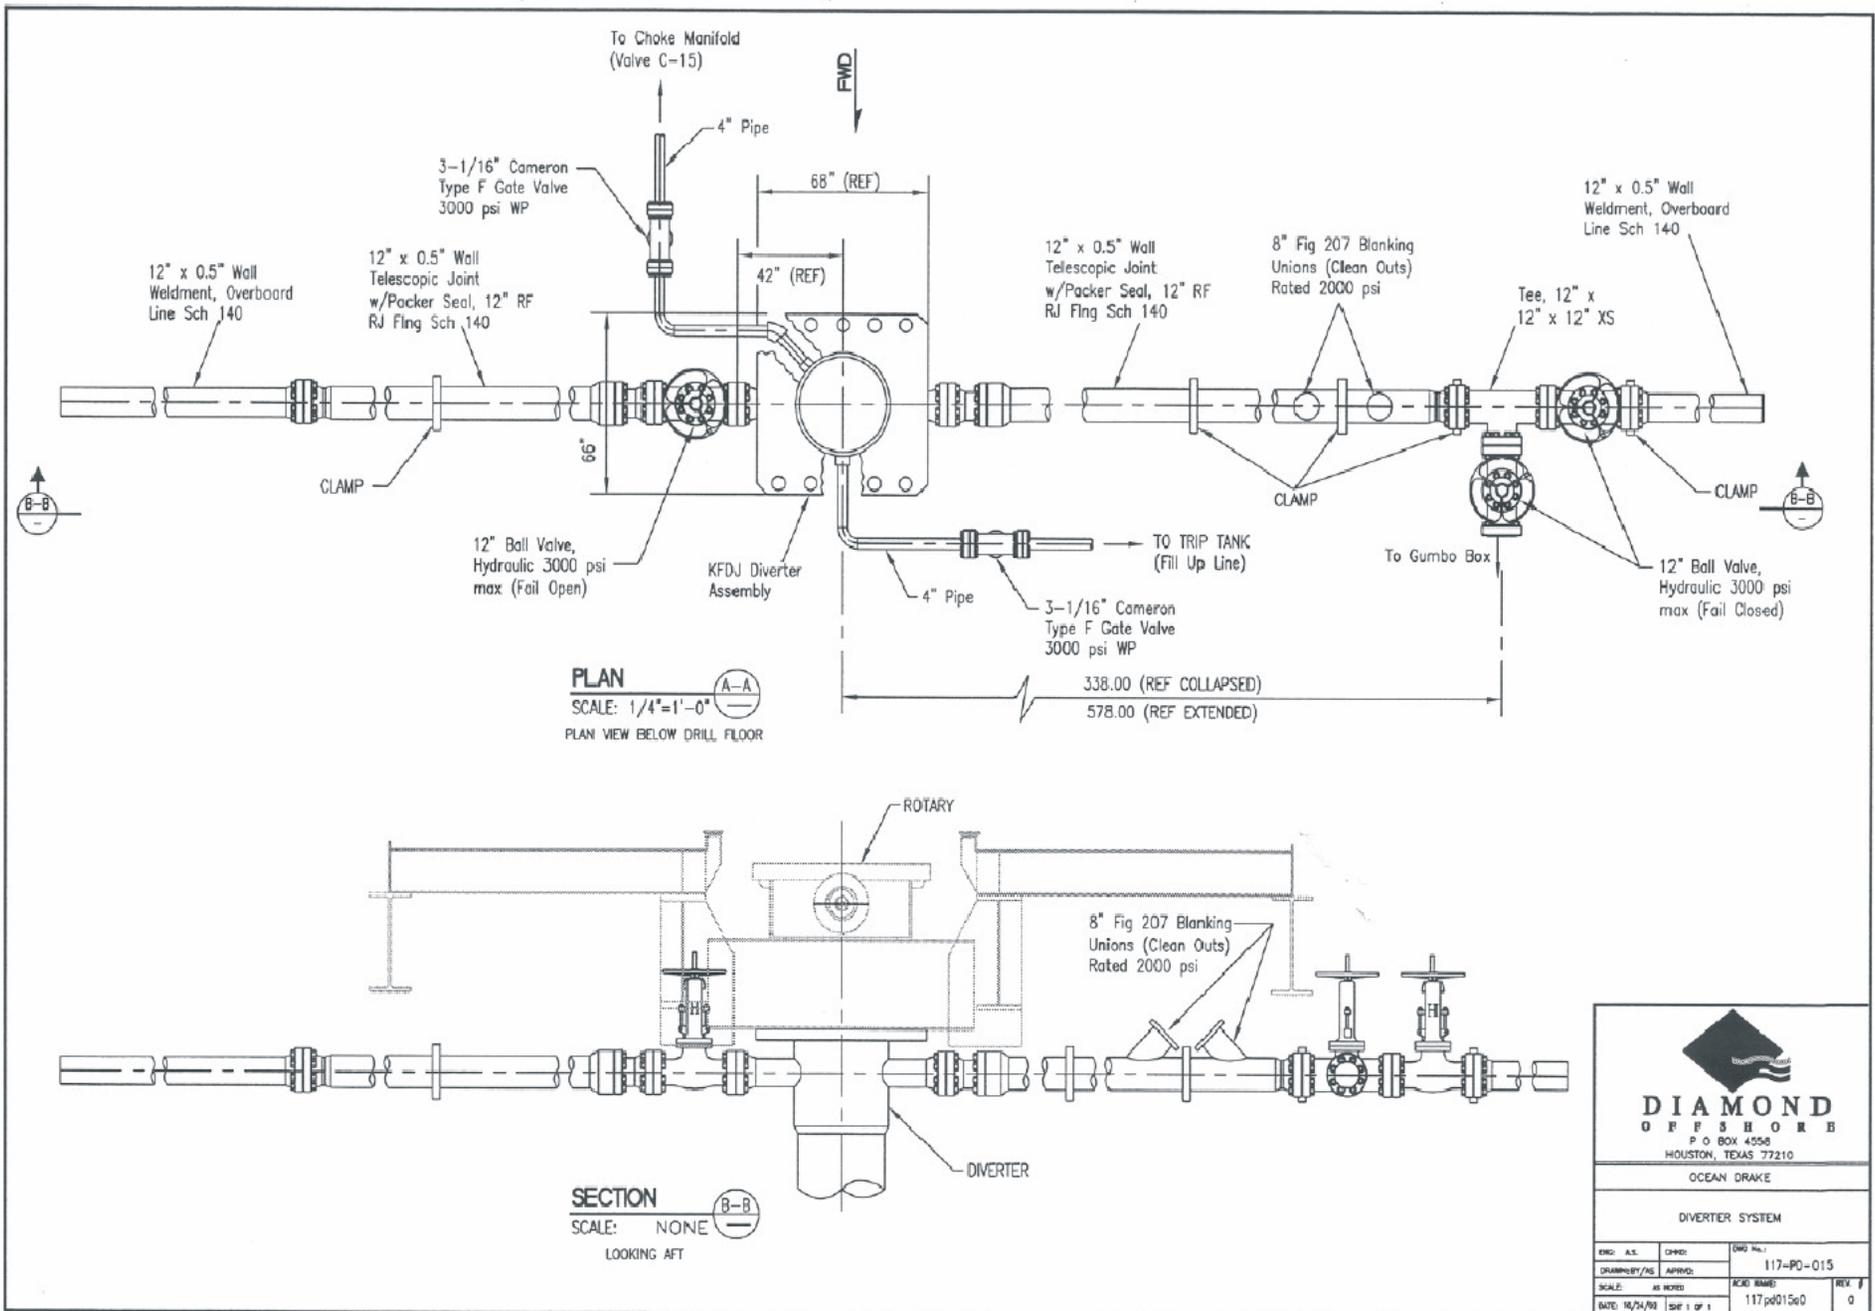
Diverter System Schematic on Ocean Drake

personnel noted gas emanating from the drive pipe by drill pipe annulus. The well was shut in at 1600 hours on 01 December 2005 and placed on the diverter system (See *Diverter System Schematic, Attachment 4*) at that point. Contractor personnel on the Rig continued to pump kill weight mud while monitoring the well. As a precaution, at 1645 hours, all non-essential personnel were evacuated to the *M/V Randall McCall*. Within two hours, the non-essential personnel were allowed to return to the rig. The well continued to “burp” gas over the next day, but remained under control while on diverter. Operations continued over the next five days, circulating heavy weighted mud approaching 11 pounds per gallon, while washing to bottom and back-reaming to prevent stuck pipe. With approval from MMS, on 07 December 2005, the Operator washed to total depth of 1,318 feet and mixed and spotted a barite plug. After tripping to bottom to circulate and clean up the hole, approval was obtained from MMS by the Operator to set the 20-inch conductor casing at 1,274 feet, significantly higher than had originally been programmed in view of the hole conditions. The original plan had been to drill down to 1,700 feet prior to setting the conductor pipe. The Operator received verbal approval from MMS at 1700 hours on 12 December 2005, to obtain a Formation Integrity Test (FIT) below 20-inch conductor casing in the 26-inch "rat-hole" after washing barite plug without drilling 10 feet of new formation. It was also agreed to drill ahead with a 12.8 pound-per-gallon FIT and reduce the safe drilling margin to 0.3 pound per gallon.

**29 Nov** – Offload diverter packer and installed same. Rigged up test assembly. Attempted four times to test diverter package, but unable to get test. Clean-out cap initially leaking as was 6-foot extension on port side. Next starboard diverter valve leaking. Pulled diverter packers, and performed pressure wash. Not able to get test.
