**Investigation of Fatality and Loss of Well Control
High Island Block A466, Well No. B-11
OCS G-03242
20 February 2006**

Gulf of Mexico
Off the Texas Coast

J. David Dykes – Chair
Richard Clingan
Jim Hail
Frank Patton

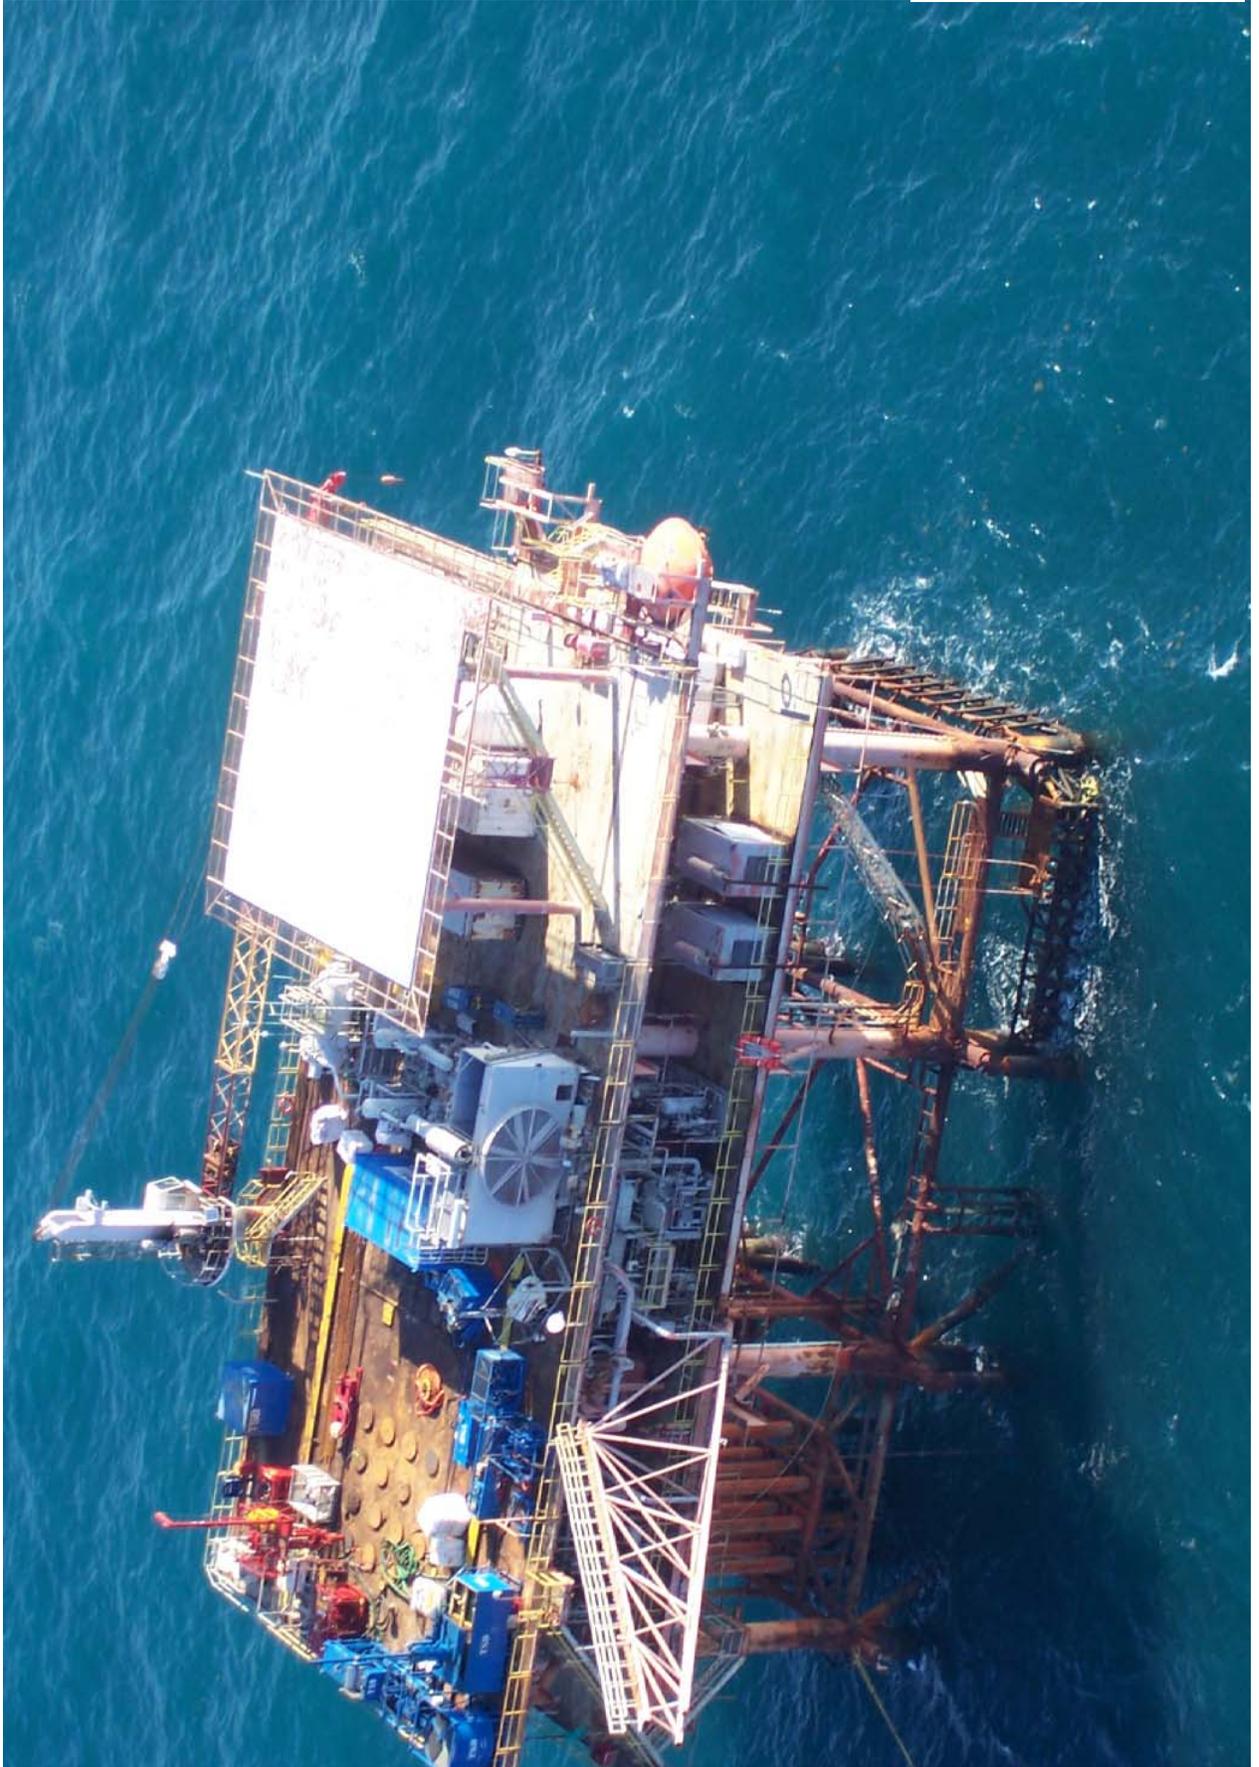
Photograph of High Island Block A466 Platform "B"

This job was taking place on platform “B” in High Island Block A466. “B” platform is an eight-pile structure with a top deck and a cellar deck. The top and cellar decks have an approximate dimension of 130 ft by 60 ft. (*See Attachment 2 for Photograph of Platform.*)

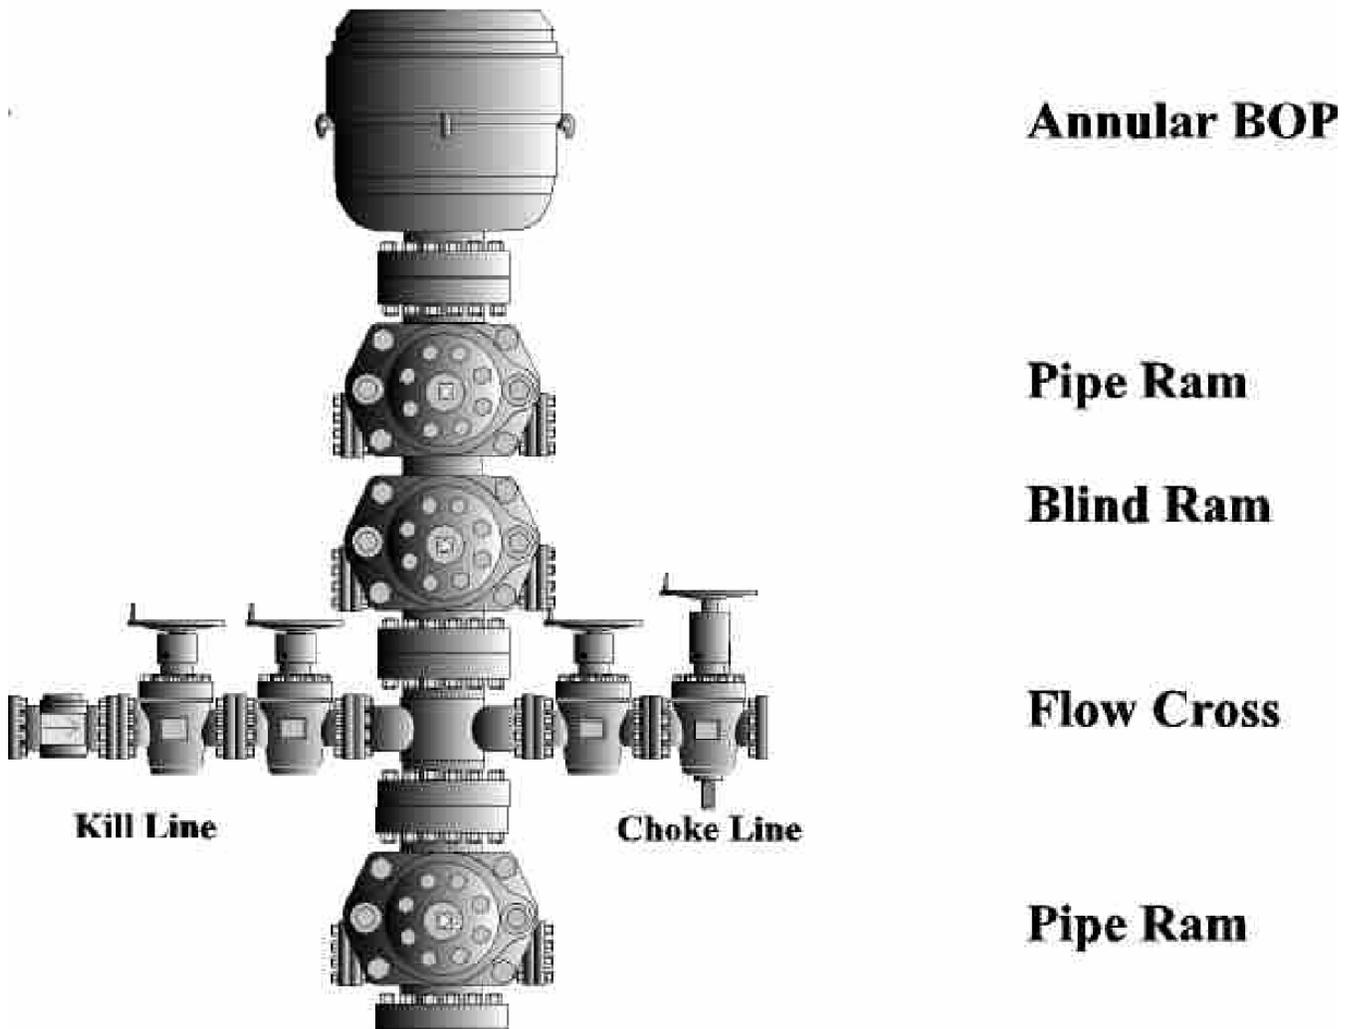
Diagram of Approved BOP Configuration

The approved permit displayed a drawing of the blowout preventer (BOP) stack to be used. The diagram shows a 7 1/16 inch, 5000-pound BOP with 1 annular, 2 pipe rams, 1 blind ram, and a spool with a proper choke kill valve configuration. *(See Attachment 3 for diagram of approved BOP configuration.)*

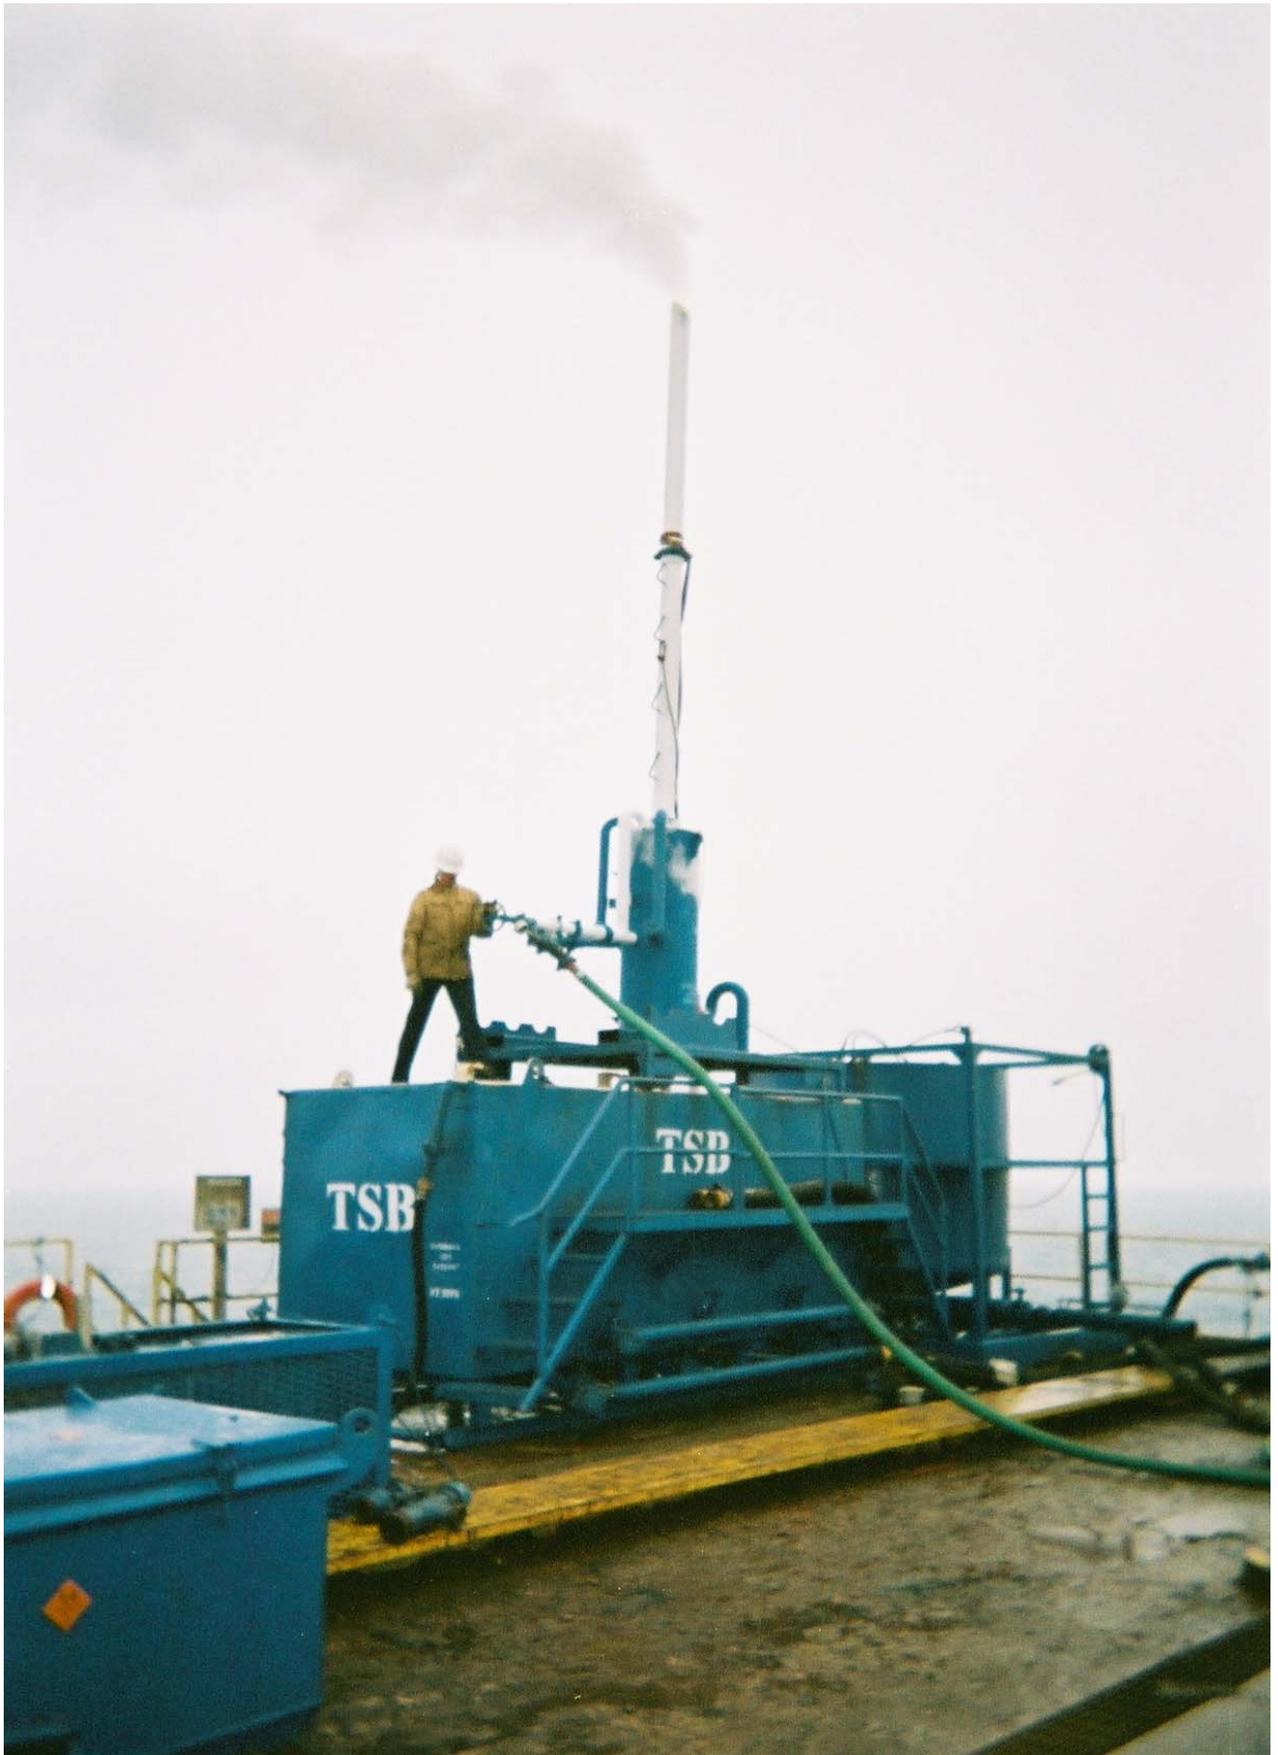
Photograph of TSB Crewmember Working Without Fall Protection

During a review of pictures taken by a TSB crewmember, another TSB crewmember was observed operating the choke on the gas buster. The choke is located on top of the trip tank at an elevation greater than six feet off the deck and near the outside edge of the platform (*See Attachment 5 of photograph of TSB crewmember working without fall protection*). TSB’s *Supervisor’s Health/Safety/Environmental Manual and Training Guide* (Safety Manual) states in the section titled “Personal Protective Equipment Programs,” subsection “Fall Protection,” the following:

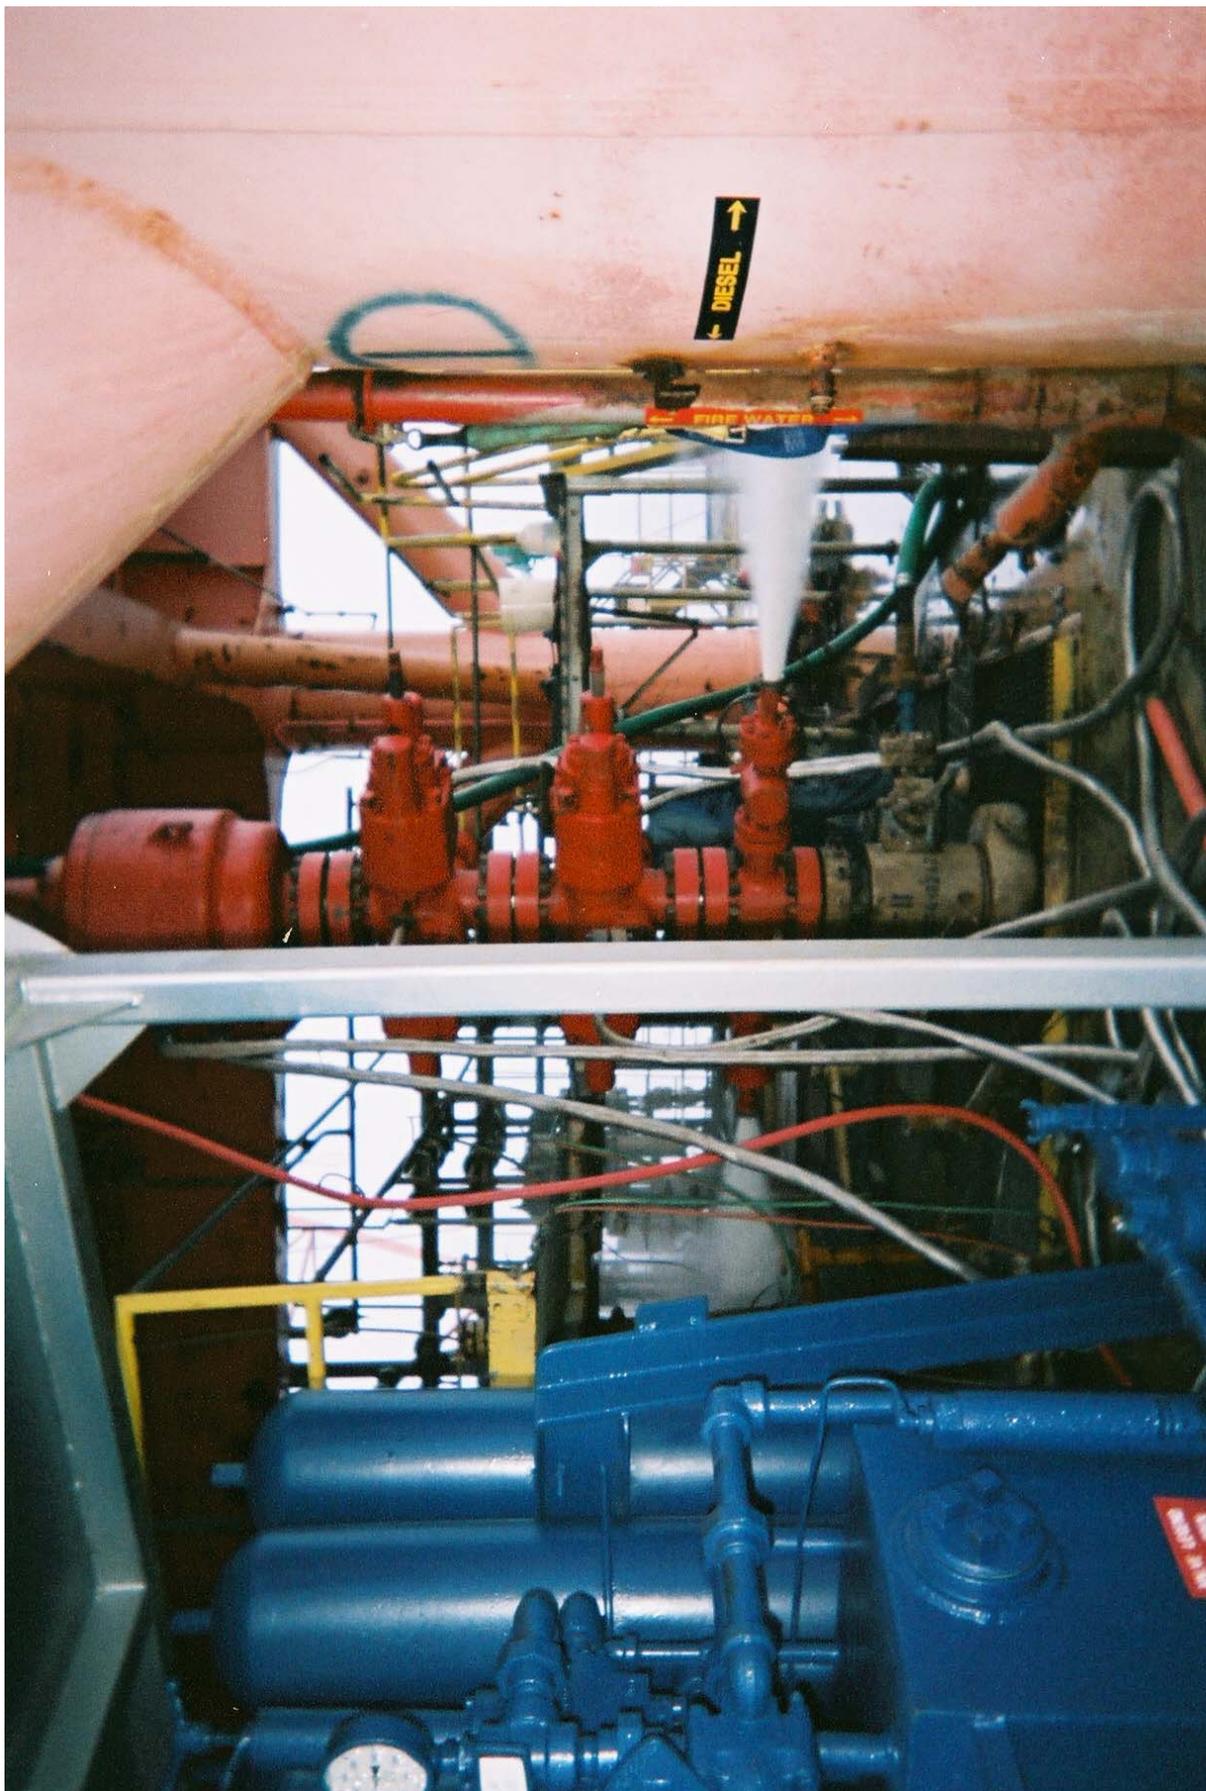
Photograph of Bleeding Gas at BOP Stack

Another crewmember stated that he observed the TSB day crew supervisor bleeding the gas off the casing at the wellhead instead of bleeding it off through the gas buster (*see Attachment 6 for photograph of bleeding gas at BOP stack*). The result of the action led to pollution of the Gulf waters (*see Attachment 7 for photograph of pollution*).

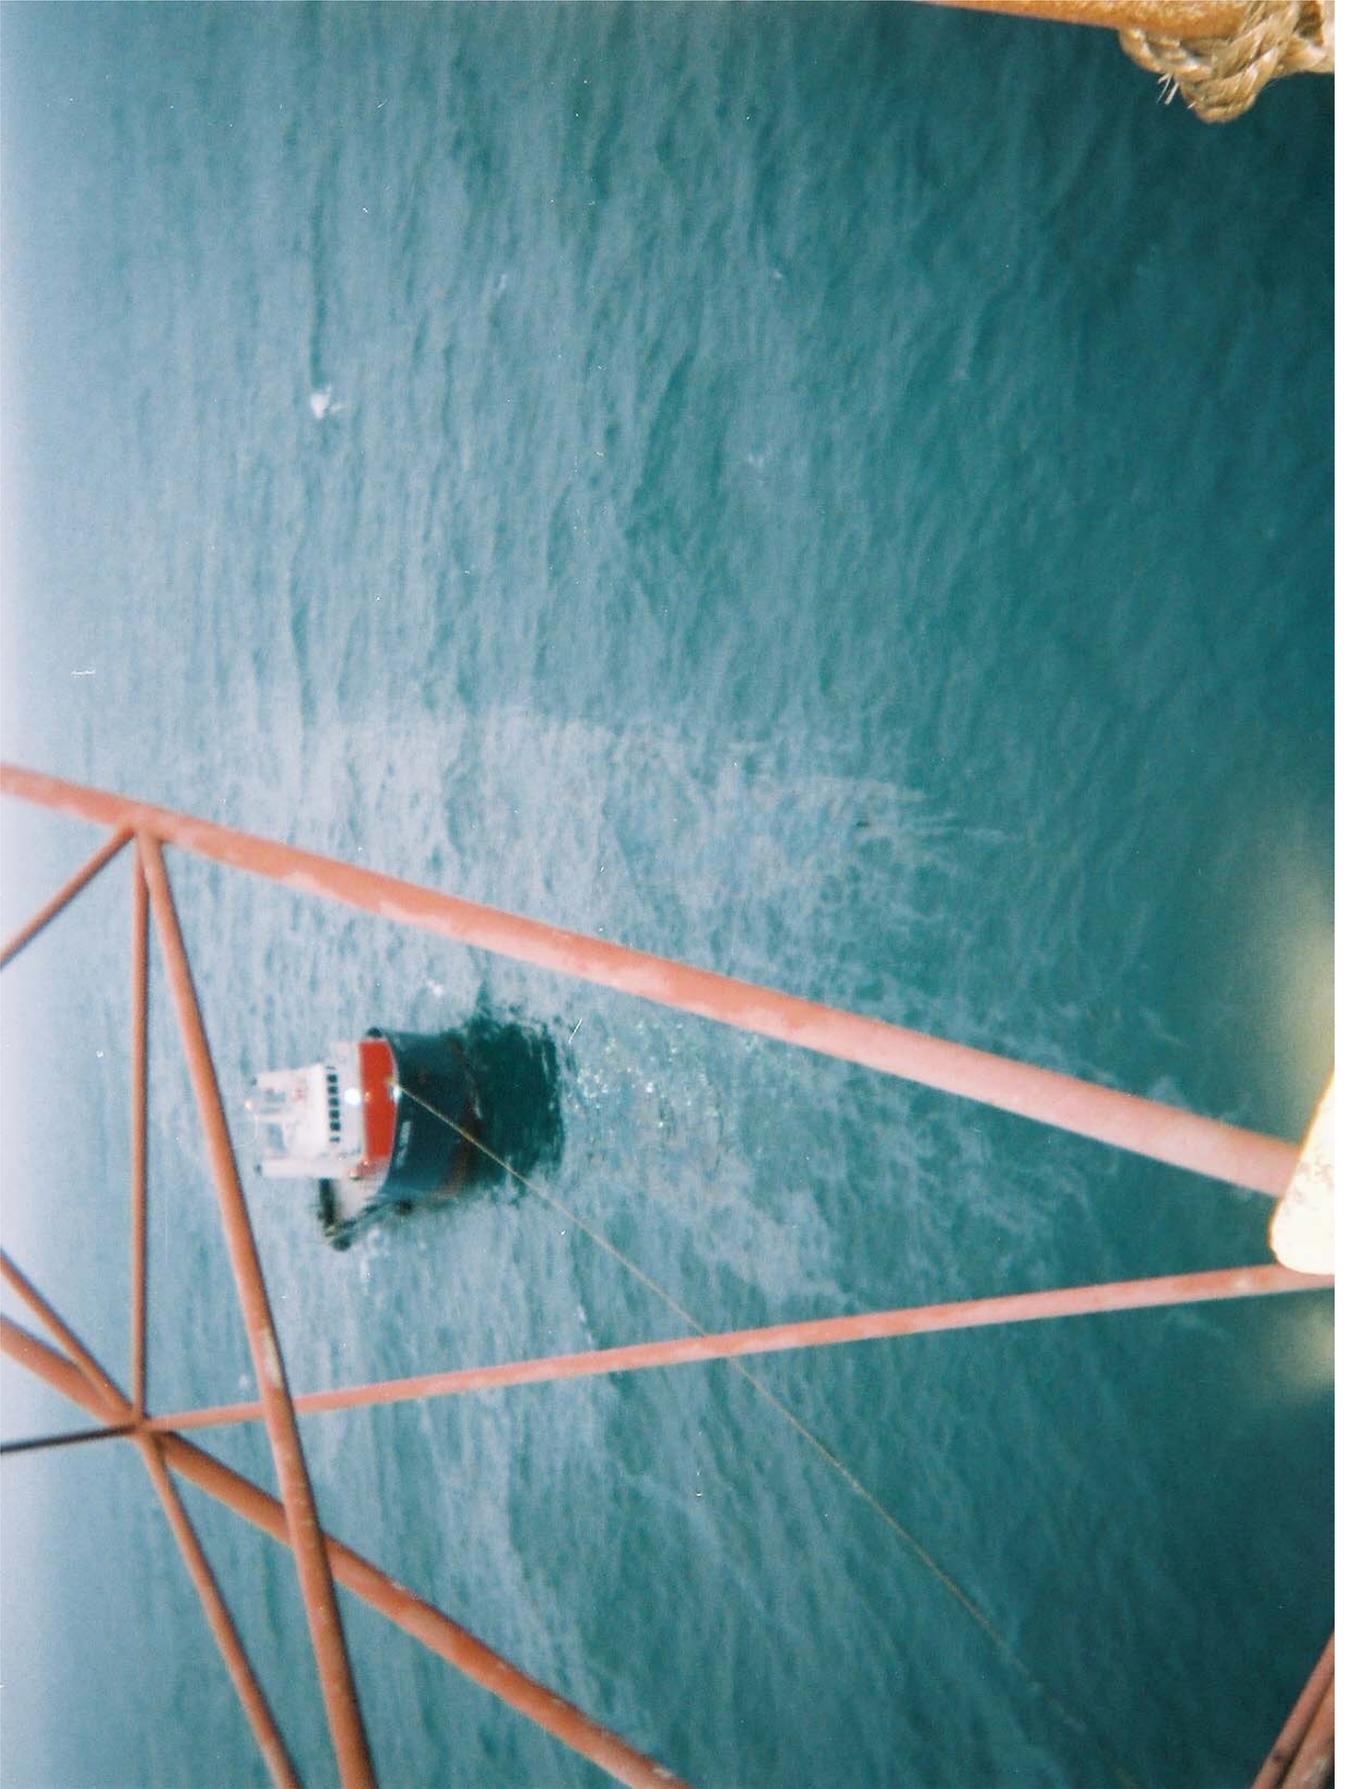
Photograph of Pollution

The regulations at 30 CFR 250.300 state that during the exploration, development, production, and transportation of oil and gas or sulphur, the lessee shall take measures to prevent unauthorized discharge of pollutants into the offshore waters. The lessee shall not create conditions that will pose unreasonable risk to public health, life, property, aquatic life, wildlife, recreation, navigation, commercial fishing, or other uses of the ocean.
