**Investigation of Fatal Accident  
Lift Boat-Coil Tubing P&A  
Main Pass Block 98, Well No. 3  
OCS-G 5694  
12 August 2005**

Gulf of Mexico  
Off the Louisiana Coast

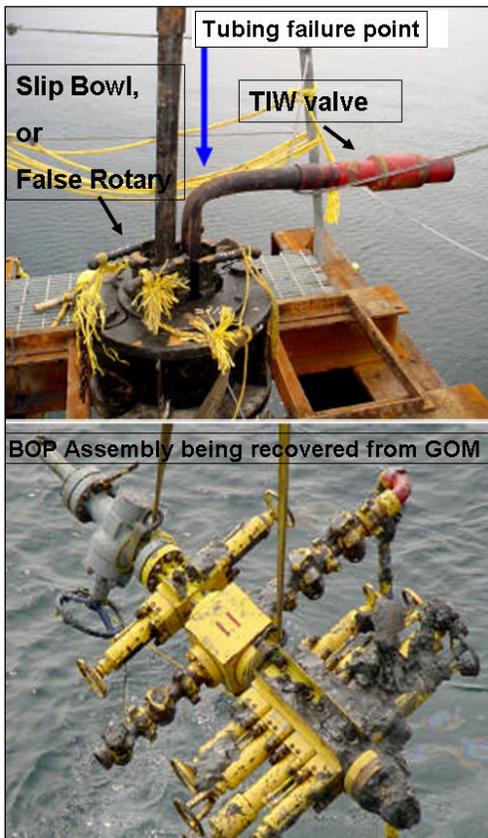
*Figure 3: False rotary or slip bowl and BOP assembly*

The CTU supervisors observed working conditions on the Extension Platform to be unsatisfactory for coil tubing operations. The ends of the tie-back strings topped by the Texas Iron Works (TIW) valves were over 30 ft above the False Rotary. No hand rails were installed on the Extension Platform and large openings were present around the False Rotary.

After meeting with the Company Man and discussing the work conditions, the Slip Bowls were shimmed and H-beams and angle iron were installed to support the False Rotary and prevent its movement independent of the motion of the Lift Boat. Some grating was installed to reduce the size of open holes around the False Rotary. A wire rope hand rail was installed. A joint of tubing was removed from each tie-back string and the Lift Boat was re-positioned so that the end connections of the tie-back string assemblies were approximately 3.5 ft above the slips. The TIW valves were re-installed atop both tie-back tubing strings.

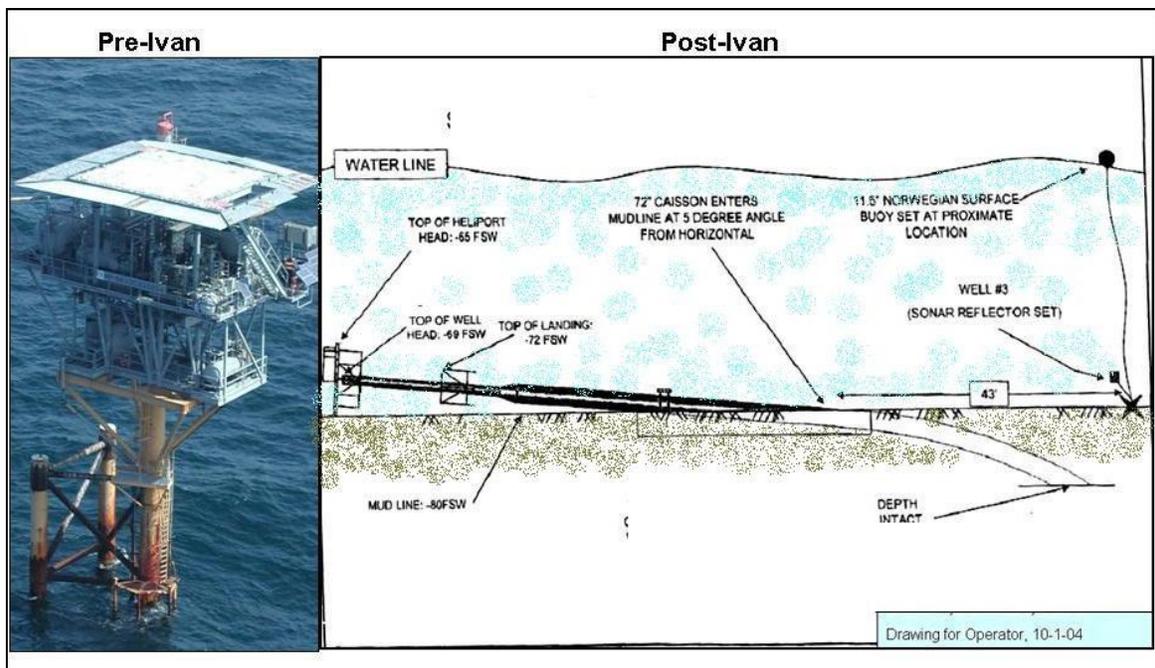
**Figure 5: Main Pass 98, Well # 3 caisson, pre-Ivan, post-Ivan**

The MMS estimated that 150 platforms were in the direct path of Hurricane Ivan. Industry reported to MMS that seven platforms were destroyed and six platforms had major damage. One of the destroyed platforms was the Main Pass Block 98 Well No. 3 Caisson. Hurricane Ivan toppled and bent the Caisson and casing almost flat onto the ocean floor (*see figure 5*).

An Operator survey of the damage sustained to the Well found the Caisson bent but intact as it entered the mud line at a 5-degree angle from horizontal. By jetting down to 9 ft below the mudline (BML), it was determined that the Caisson was probably intact with no buckles or tears. No gas bubbles were observed, which was interpreted as indicating that the downhole safety valves were containing well pressure.

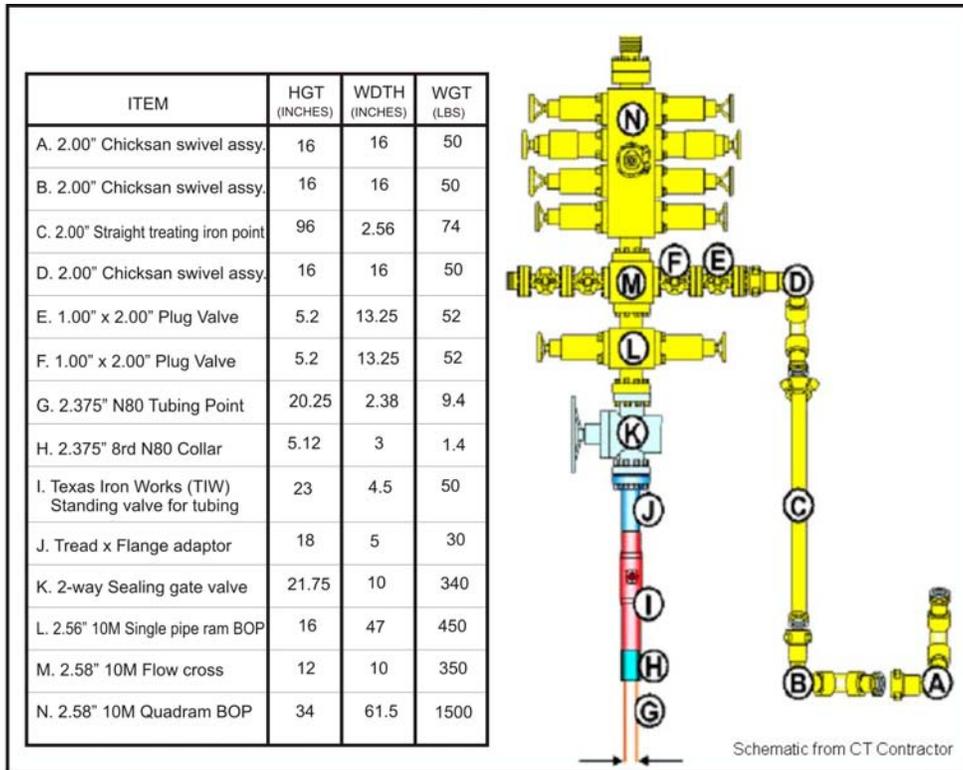
**Figure 8: Coil tubing BOP assembly**

Using the data available (*see figure 8*), the calculated axial load on the tubing was between 3,000 and 3,500 lbs with the center of gravity estimated to be approximately 11 ft above the point where the 2 $\frac{3}{8}$ -in tie-back string was held in the slips. In this case, a static displacement of the center of gravity of the BOP Assembly of less than 1 ft could have resulted in plastic deformation and failure of the 2 $\frac{3}{8}$ -in tie-back. Any addition of a momentum force caused by movement of the load could have effectively added to the static load torque, or changed the torque effect to a dynamic modulus.
