**Investigation of Fatality from Falling Load
Main Pass Block 30, Well No. A-14 ST01
OCS-G 4903
7 March 2009**

Gulf of Mexico
Off the Louisiana Coast

Glynn T. Breaux – Chair
Randy Josey
David Emilien

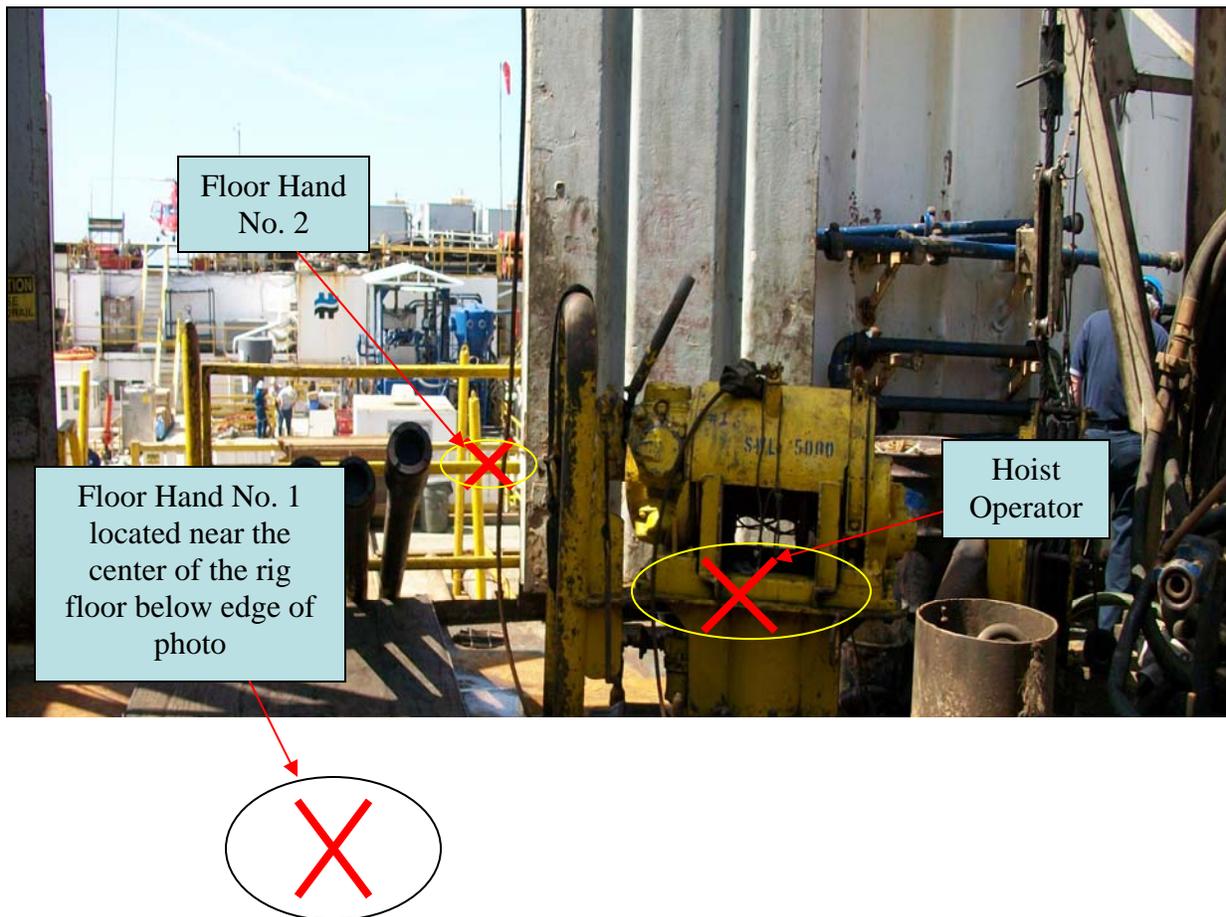
Figure 2: Location of Hercules Rig Floor Hands and Hoist Operator during accident

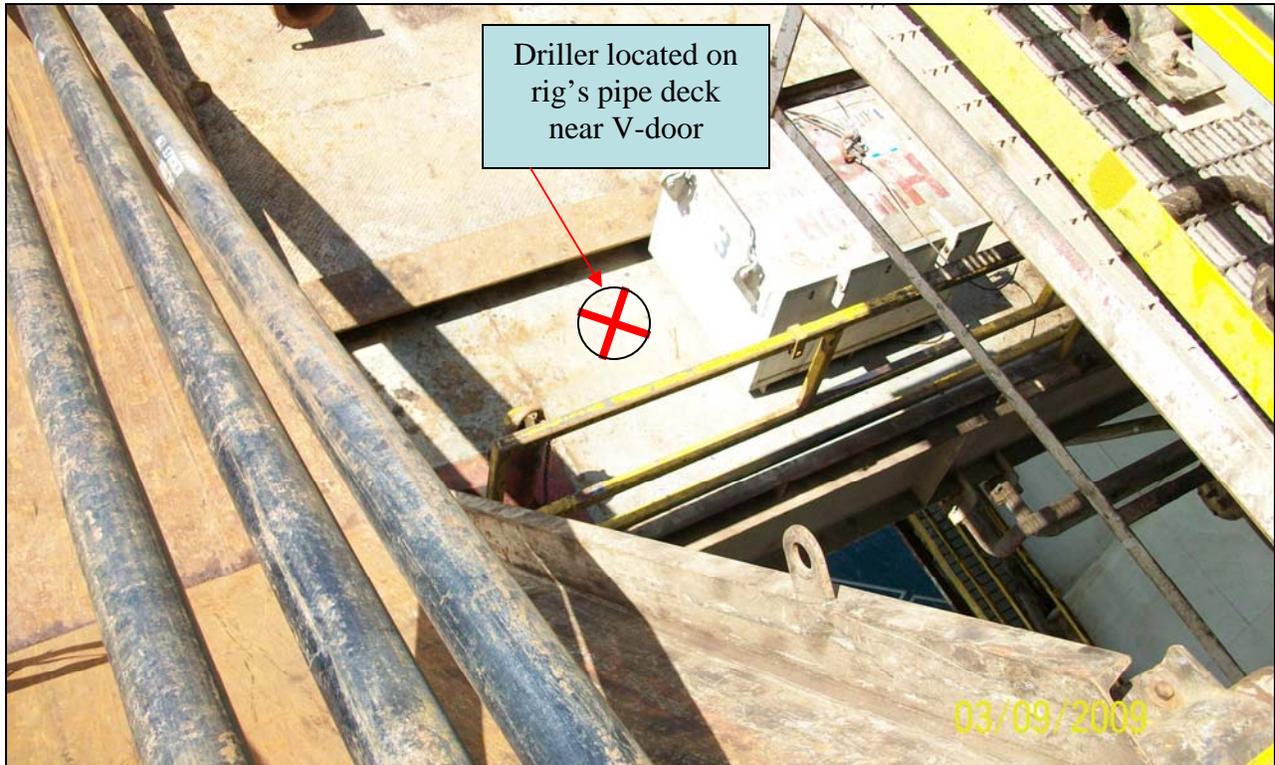
Figure 3: Location of Driller on rig deck beneath edge of rig floor and above wellhead deck

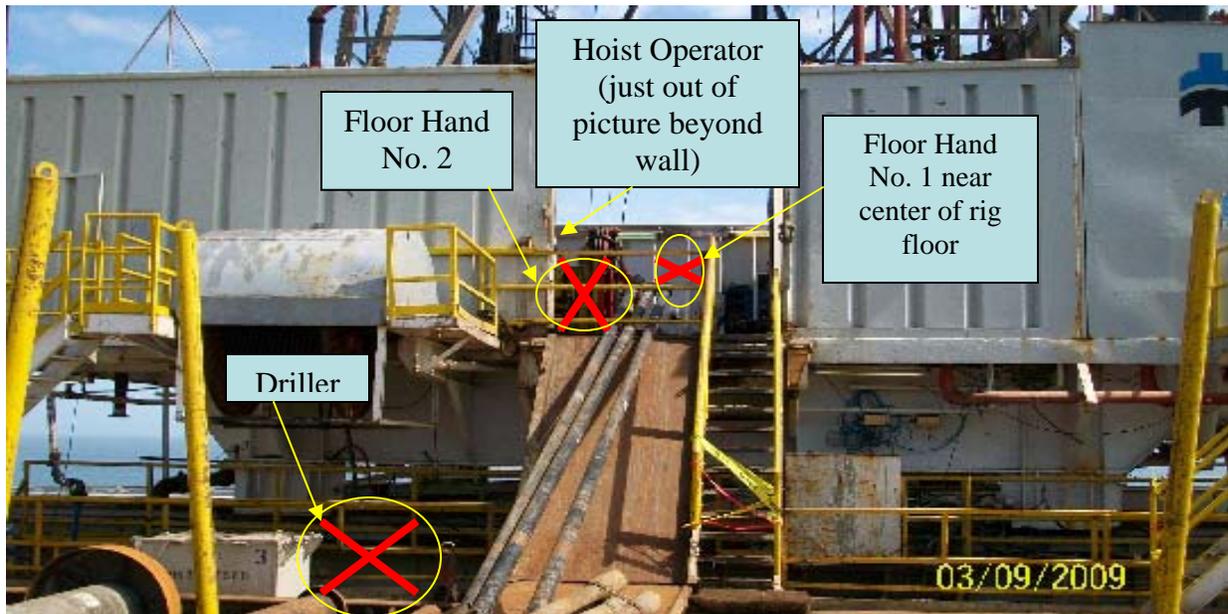
Figure 4: Another view of Driller's location in relation to rig floor

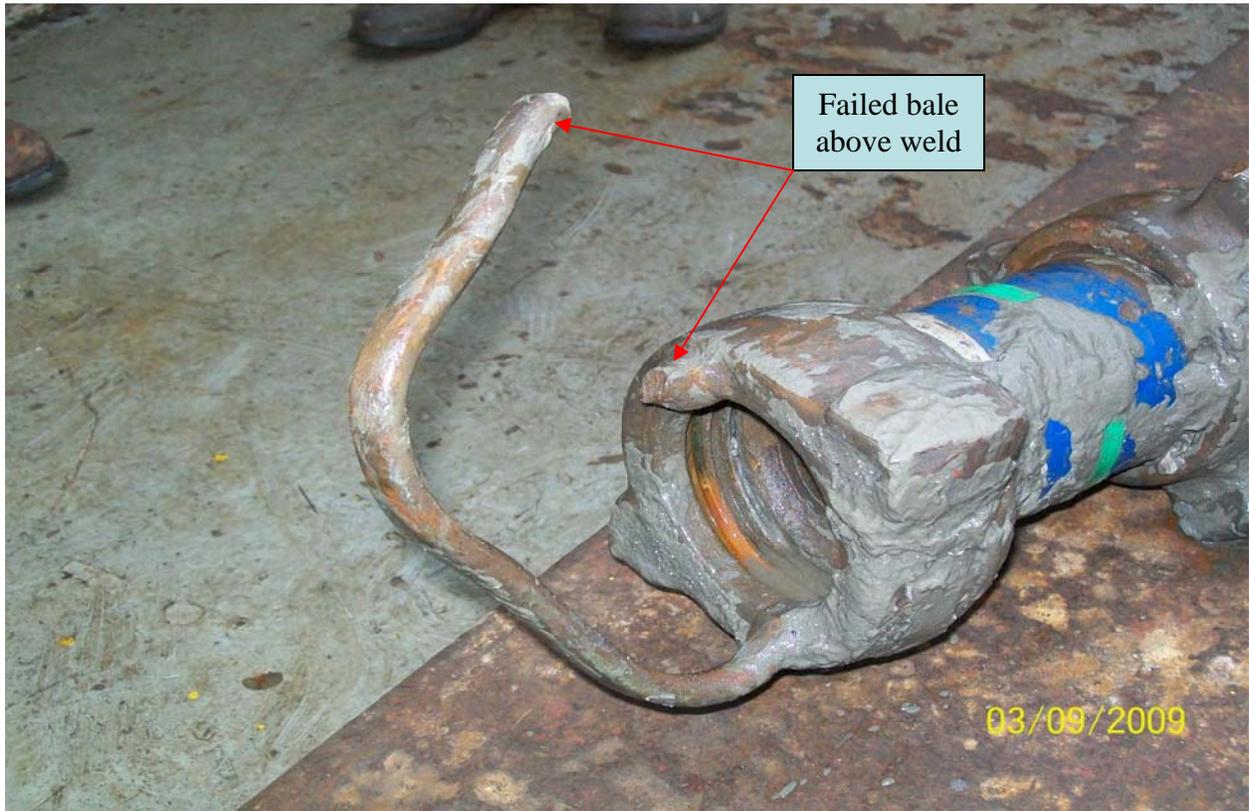
Figure 5: Recovered modified WECO Figure 1502 hammer union with failed welded bale

1. It is the conclusion of the Panel that, as the hose assembly was being lifted, the use of a modified WECO Figure 1502 hammer union resulted in failure just above the weld on one end of the welded bale.

The Panel was unable to ascertain when or by whom the hammer union had been modified, but from interview testimony learned that the modified union was located on the rig at least five (5) years. Hercules Offshore Policy Number HSE 100.20 Section 4.1 states that homemade or modified lifting equipment shall never be used. **Therefore, utilization of the modified WECO Figure 1502 hammer union as a lift connection is concluded to be the cause of the accident.**

Prior to utilization of the modified hammer union as a lift connection, no load capacity testing or other certification could be confirmed. In addition, there was no way to determine how many times the hammer union bale may have been fatigued by poor handling practices; e.g., striking the bale with a hammer during make-up, dropping/bending the bale during previous lifts, etc. **Therefore, the improper implementation and monitoring of the Hercules Offshore equipment inspection program is concluded to be a contributing cause of the incident.**

- *Non-approved/non-certified (homemade/field manufactured) lifting equipment should be immediately removed from service (discarded) and immediately brought to management's attention.*
- *In order for lift equipment inspection/maintenance programs to be effective, Operators and their Contractors should:*
 - *Include visual inspections prior to use.*
 - *Properly clean, grease and/or oil equipment after each use.*
 - *Ensure that the lifting component is used only in accordance with the manufacturer's specifications and instructions for use.*
 - *Replace the equipment when it exceeds the manufacturer's recommended use.*

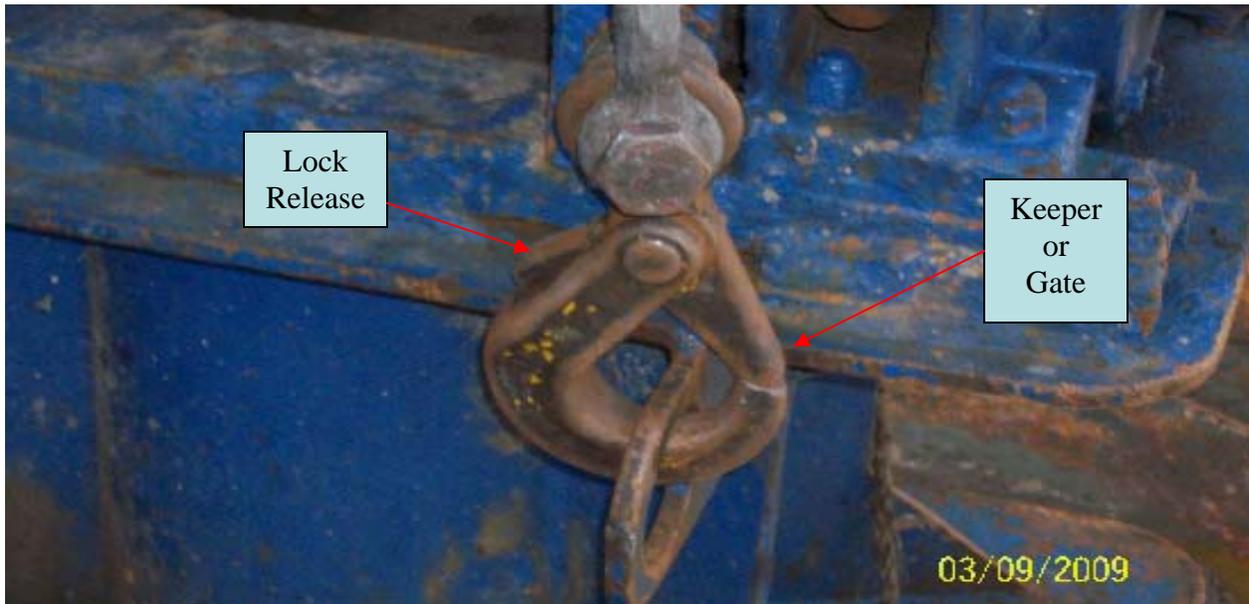
Figure 6: Safety Hook

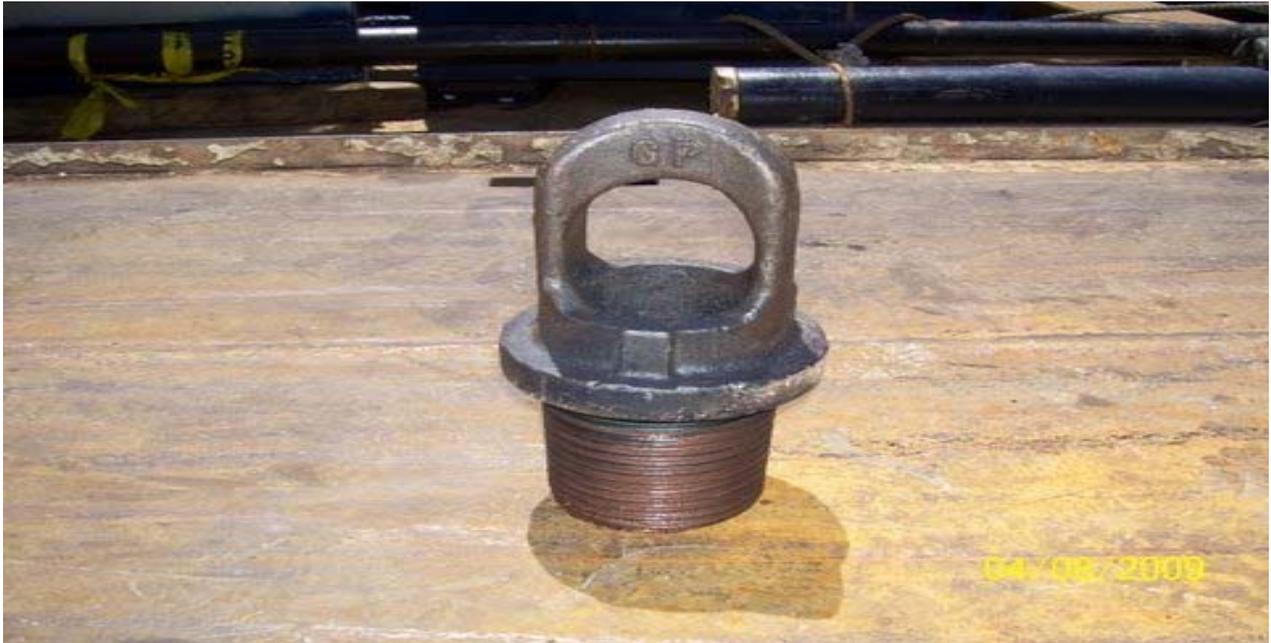
Figure 7: Manufactured drill collar lift sub taken from the rig floor

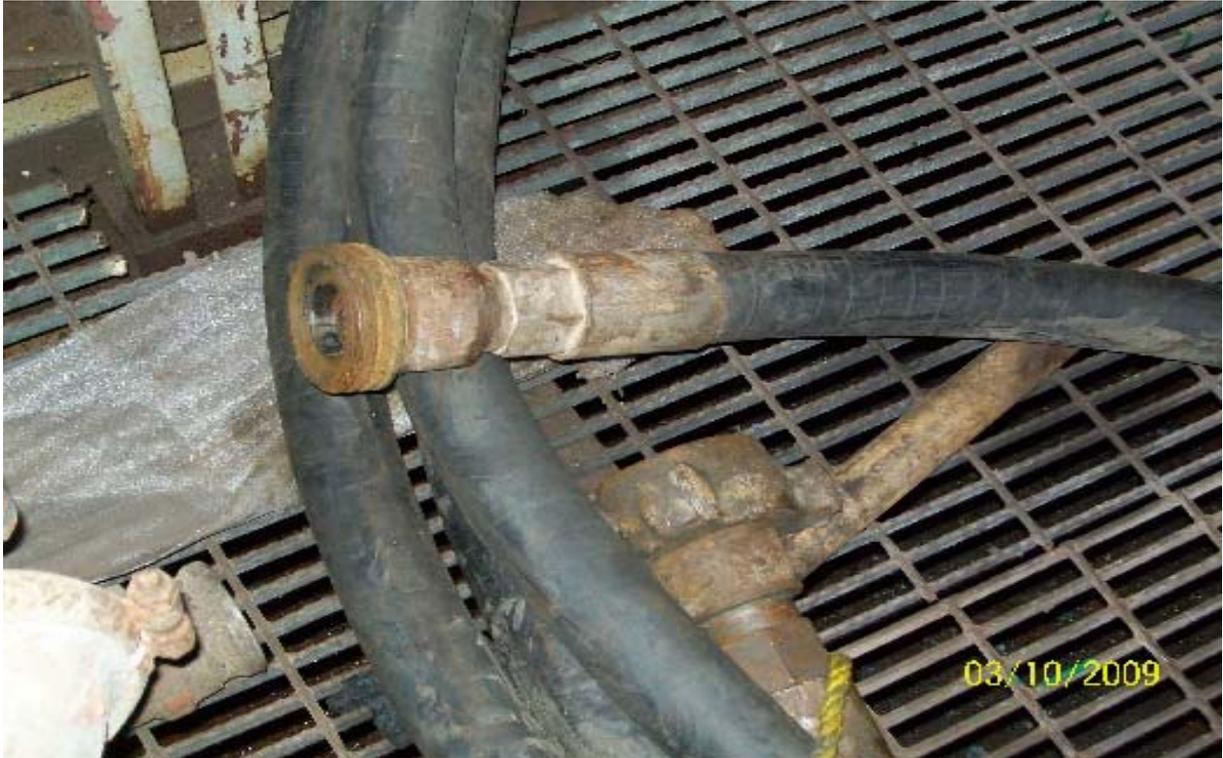
Figure 8: Recovered lower end of hose assembly to be connected to 13-3/8 inch x 9-7/8 inch casing annulus valve

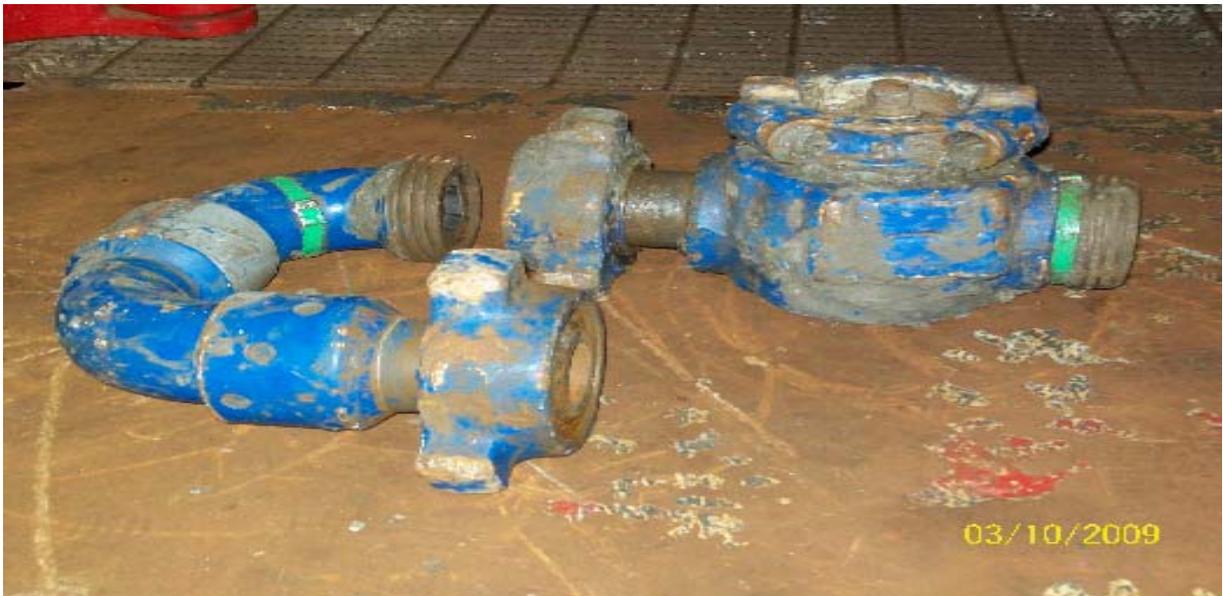
Figure 9: Manifold piping to be connected from the top of hose assembly to the rig floor manifold for pressure testing the 13-3/8 inch x 9-7/8 inch casing annulus

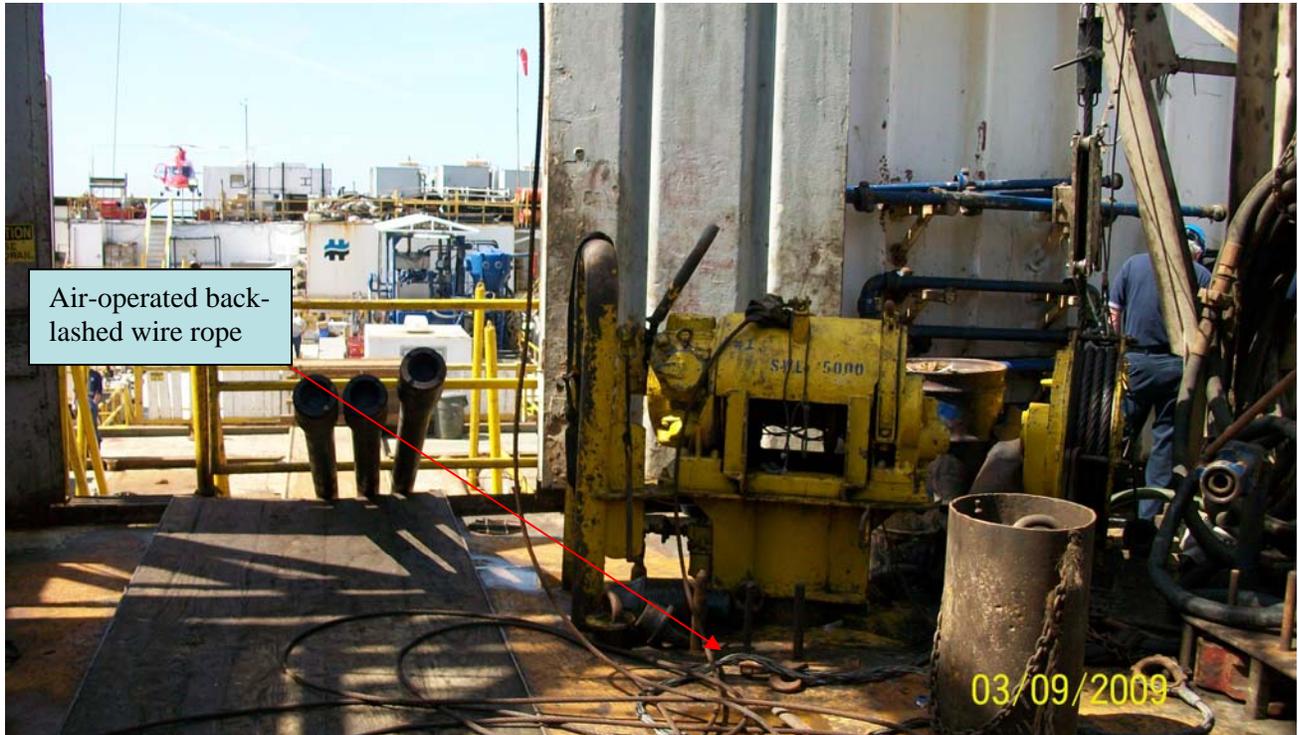
Subsequent to FH-1 being struck by the modified WECO Figure 1502 hammer connection, FH-2 was knocked down by the hose, arises to be knocked down again by the hoist wire rope that backlashes subsequent to the load being dropped (*see Figure 10*).

*Figure 10: Air-operated hoist back-lashed wire rope
(Subsequent to the dropped hose assembly)*
