**Investigation of Equipment Failure
Green Canyon Block 242, Well No. 1
OCS-G 21788
September 5, 2004**

**Gulf of Mexico
Off the Louisiana Coast**

**U.S. Department of the Interior
Minerals Management Service
Gulf of Mexico OCS Regional Office**

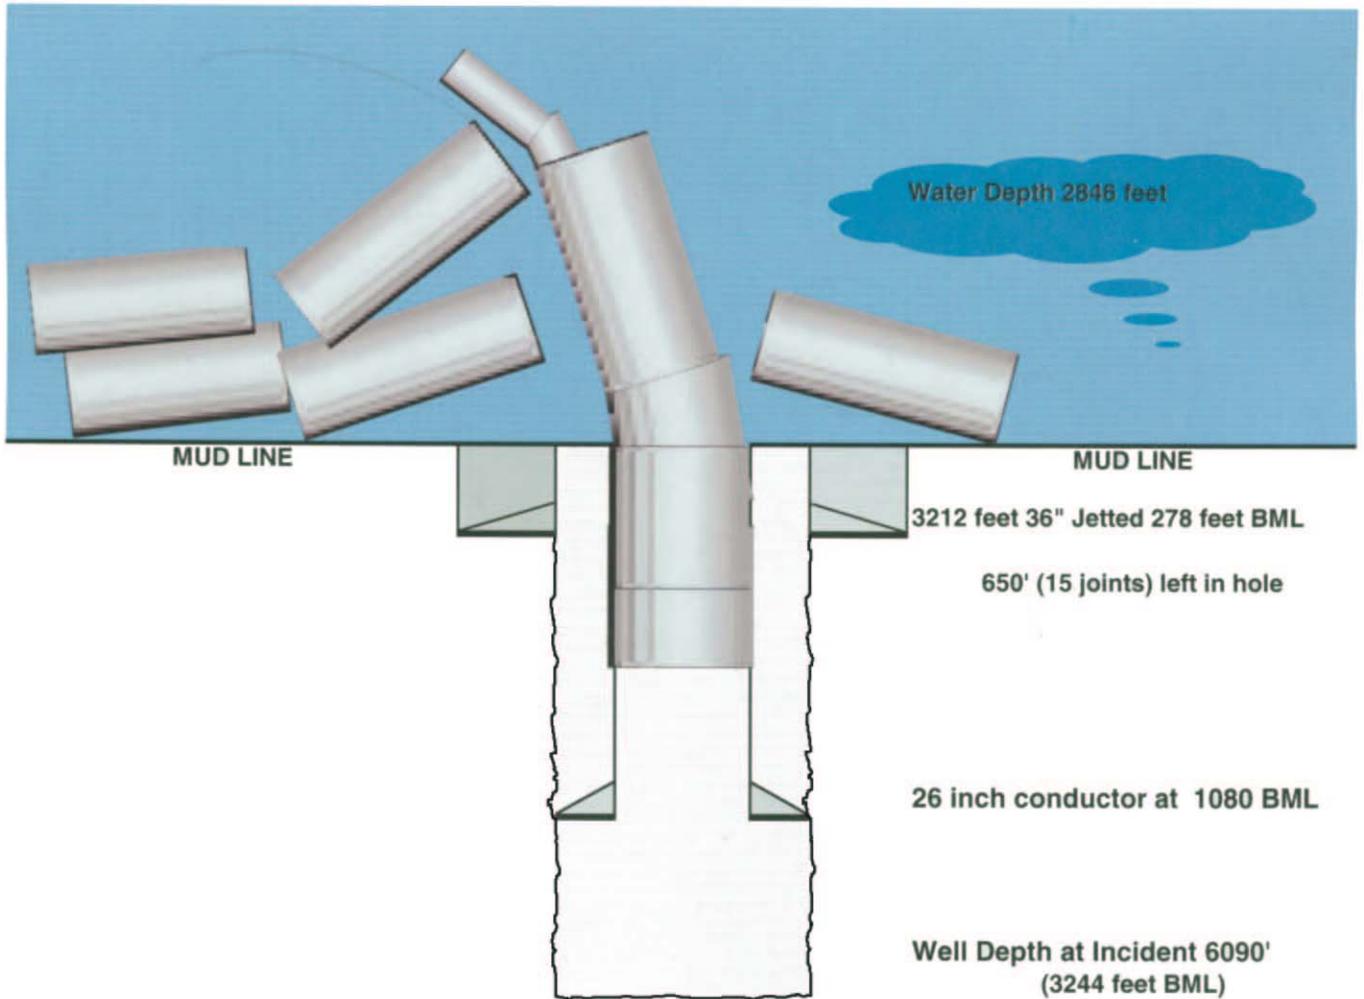
Well configuration, Post-Incident

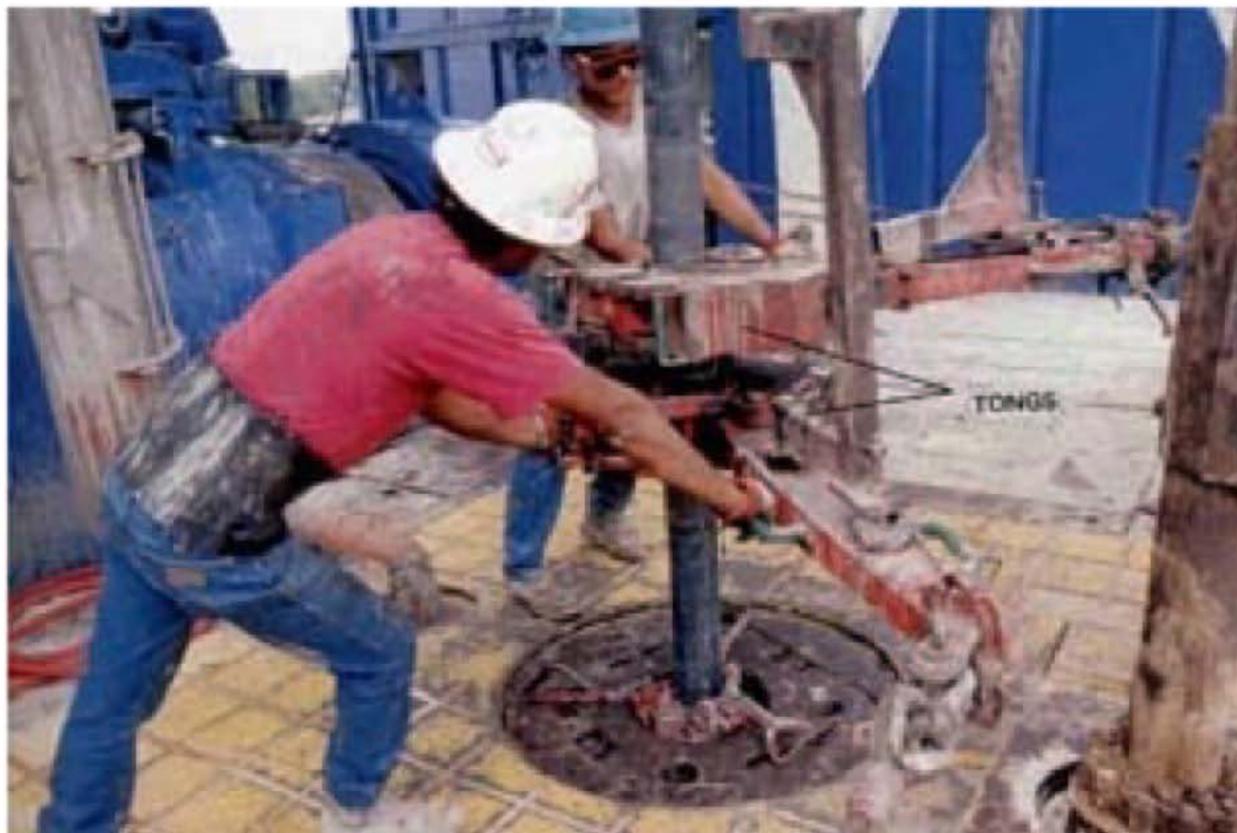
View of drill pipe in rotary slips.

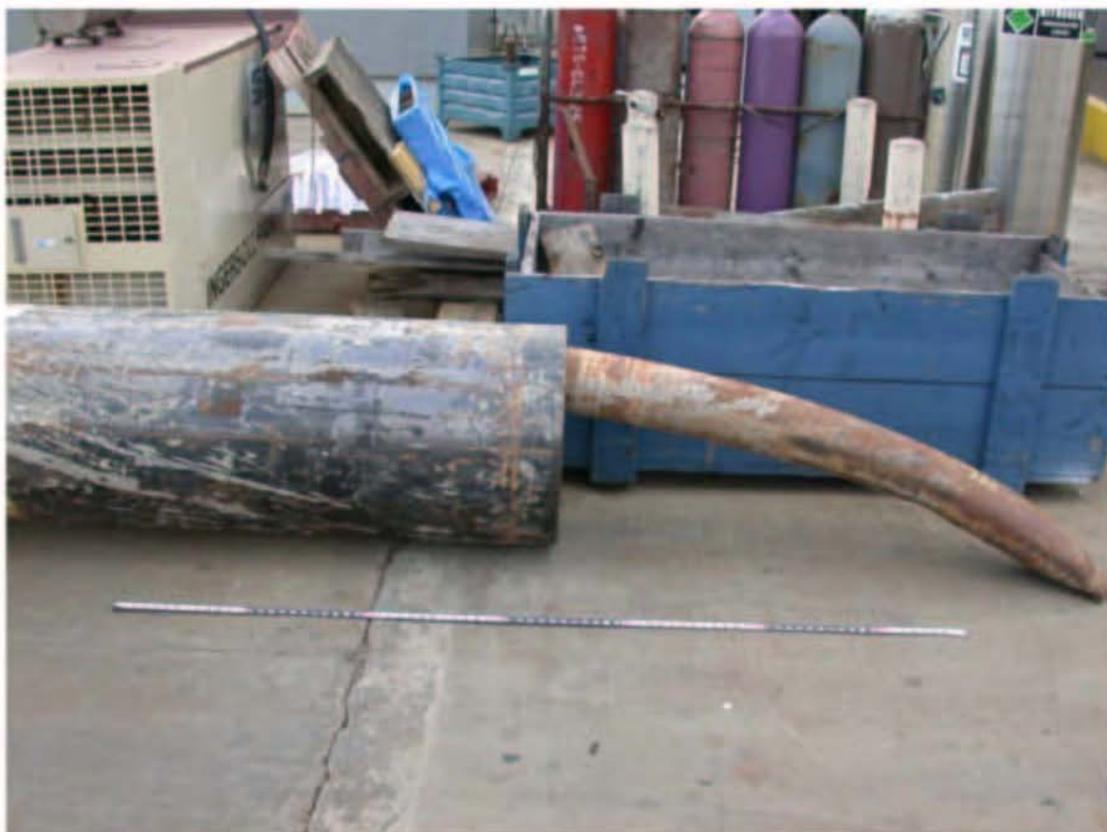
DAMAGED CASING AND DRILL PIPE

- Visual inspection of the top joint of drill pipe from the first stand (*Attachment 4*) contained an area of “*severe crushing damage, obviously caused by the action of the slips on the pipe.*” The crushing damage, with deep, slip teeth marks, was approximately 16 inches long and extended outward from 41-1/2 inches to 57-1/2 inches from the outer end of the box. Another area of deformation (about 9-1/2 inches in length) extended from 32 inches to 41-1/2 inches from the end of the box, apparently caused by the slips sliding along the pipe. A second set of slip teeth marks on the crushed pipe was found at a location approximately 10.9 feet below the heavily damaged area of pipe. SES personnel concluded that the pipe had been plastically deformed at the level of the second set of slip marks.

Upper damaged end of the 22-inch casing, showing the upper end of the drill pipe as delivered to lab.

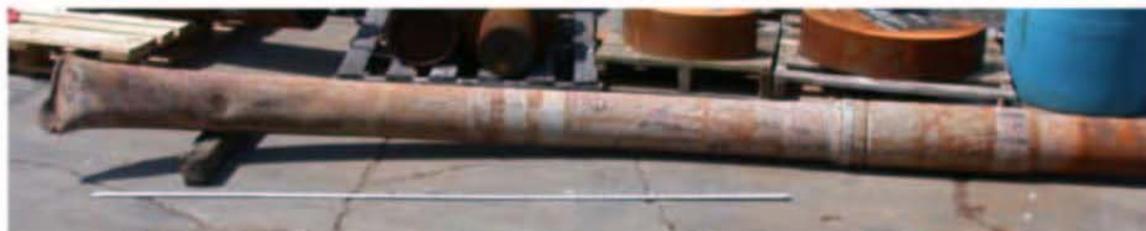
Upper end of the section of the drill pipe, after removal from the 22-inch casing.

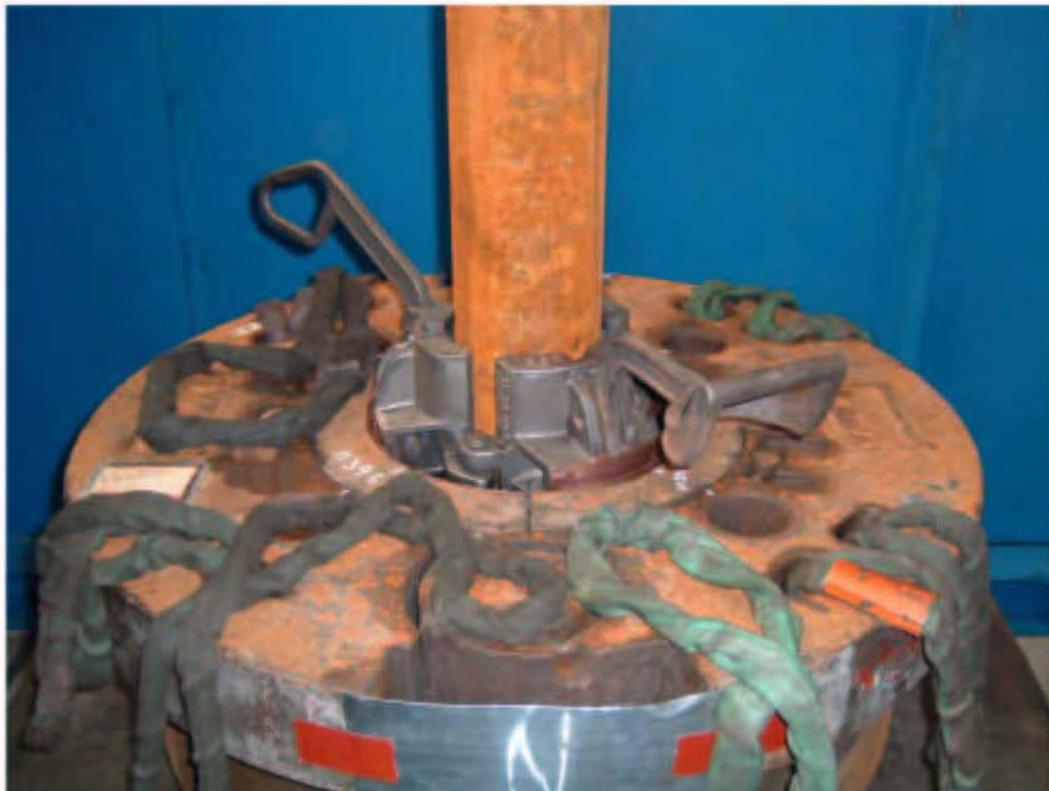
SLIPS AND PIPE BEFORE AND AFTER LAB TEST

View of the slips and pipe before test at lab.

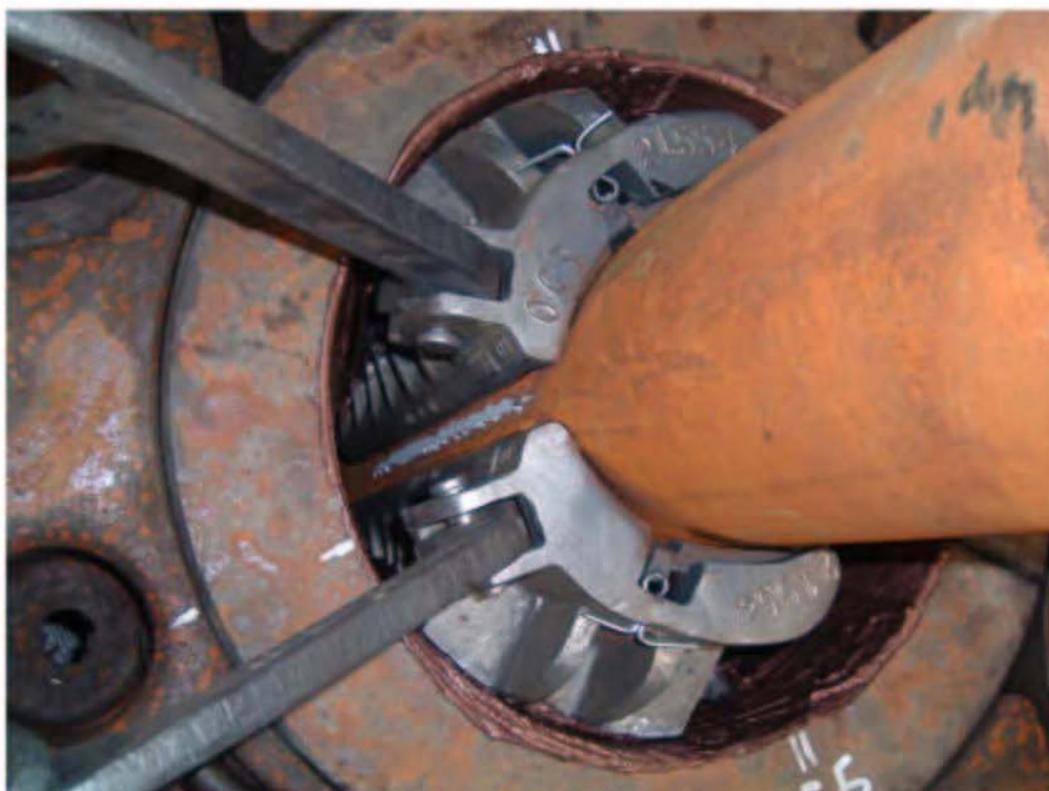
Pipe in slips after test at lab.

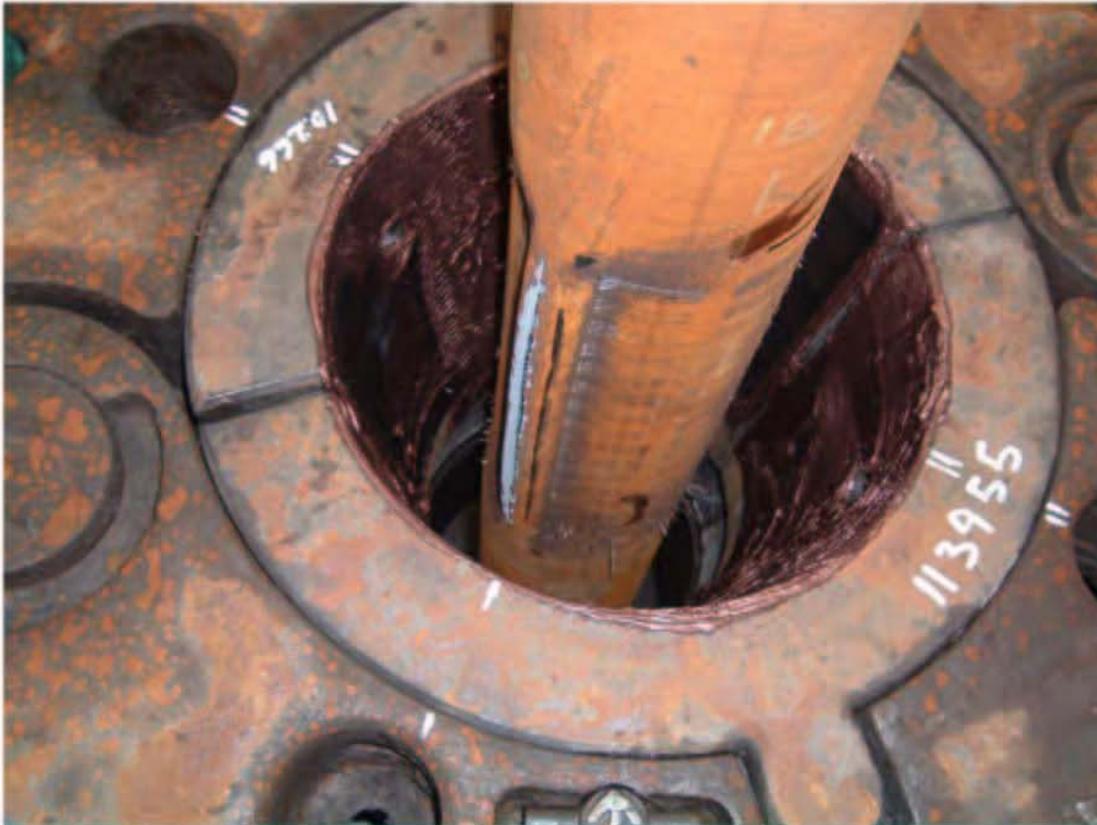
**COMPARISON OF CRUSHED TEST PIPE
TO DAMAGED DRILL PIPE FROM FIELD**

View of the crushed test pipe, following removal of the slips at lab.

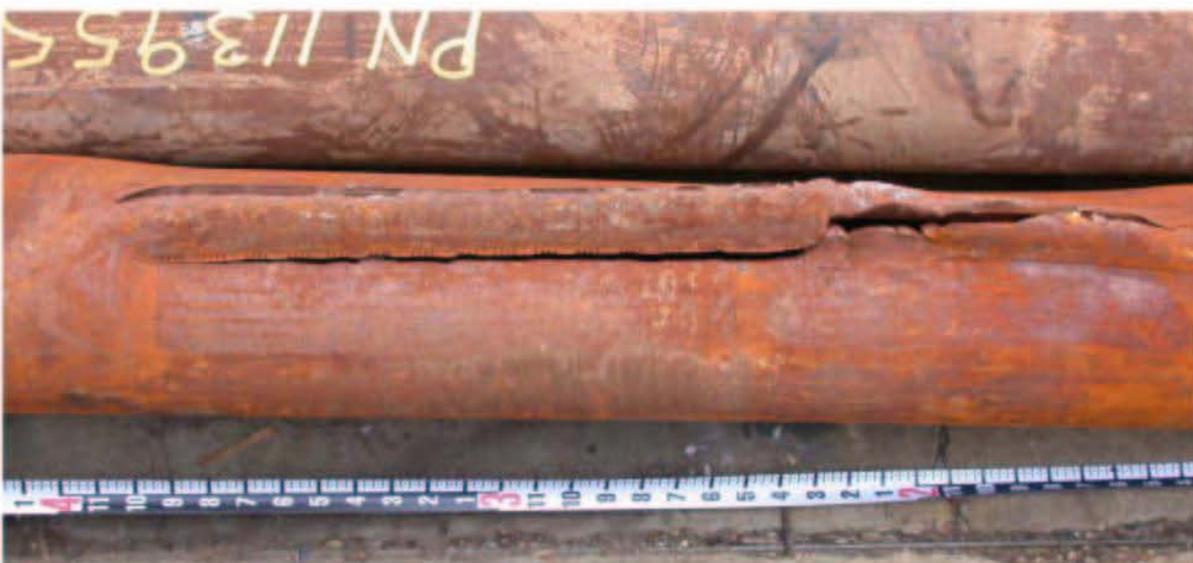
Damage in the drill pipe as received from the field.

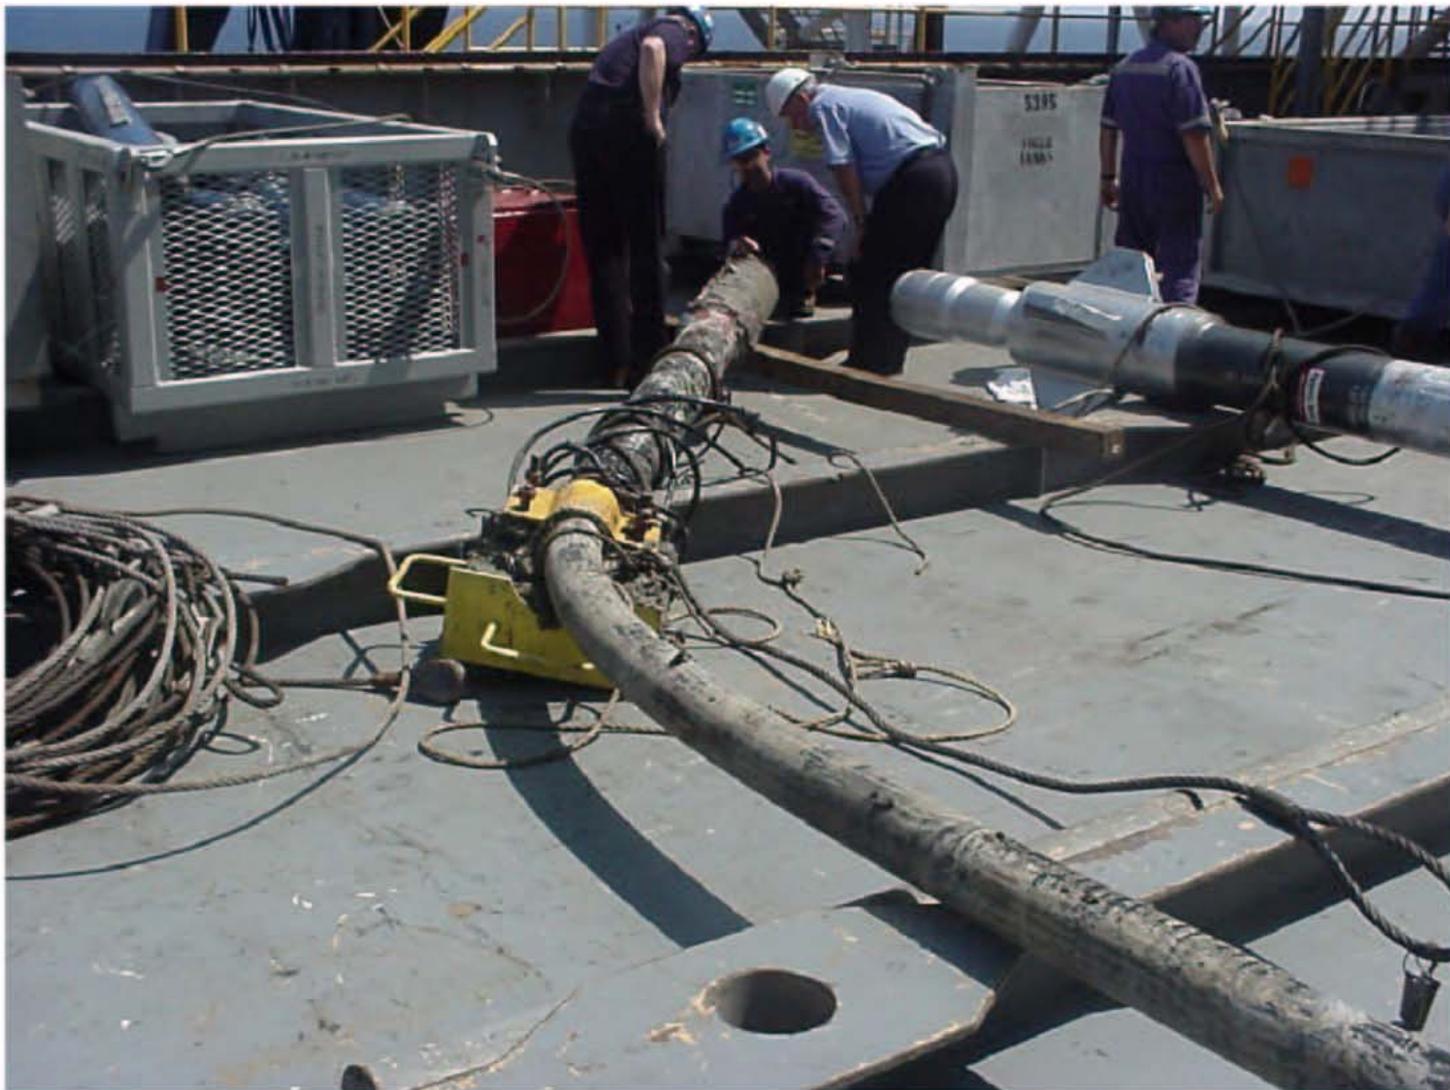
- Observations of field samples appeared to show that the casing and drill pipe failures likely took place primarily by bending as the casing assembly was falling downward (*Attachment 7*) after being released by the slips. Visual evidence showed that a joint of 22-inch by 0.75-inch casing had suffered significant deformation by bending (*Attachment 8*). Three joints of drill pipe that were found inside one field sample had clearly failed by bending at both their upper and lower ends. Further, the box connection at the upper end of the field sample was found to contain the pin end of the next higher casing joint. With the estimated total buoyed weight only 53 percent of the measured axial yield load of the drill pipe body, and only 17 percent of the yield load of the XLF connection in the 1-inch thick casing, and only 34 percent of the

Drill pipe bending below running tool.

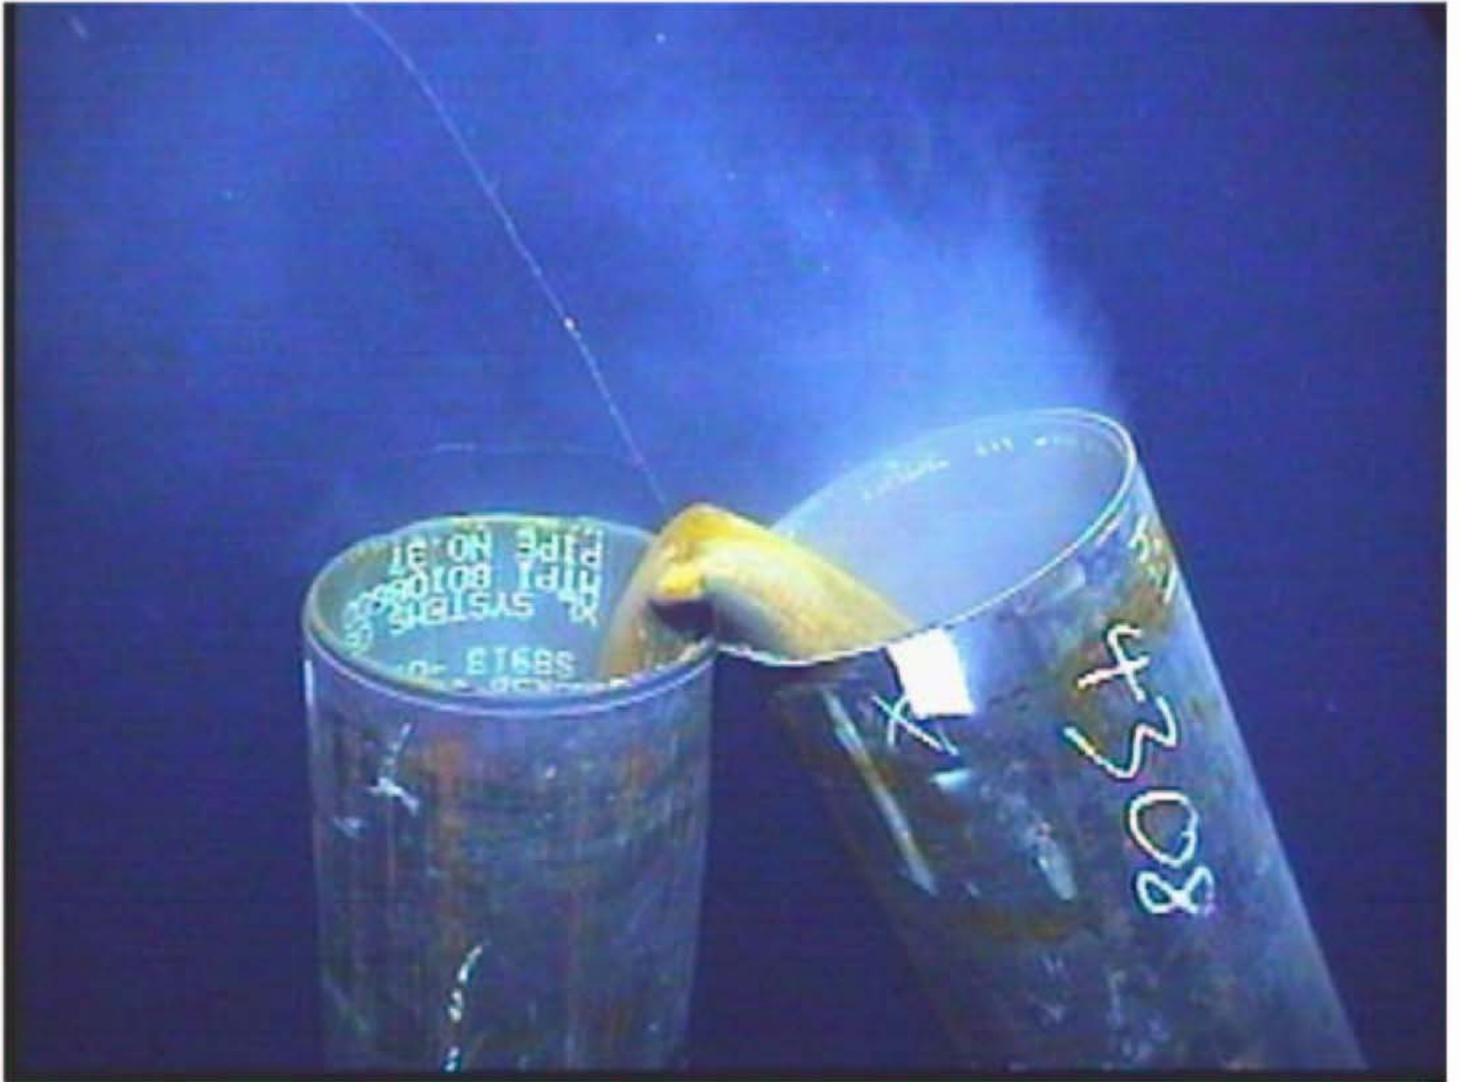
Pipe failure by bending.

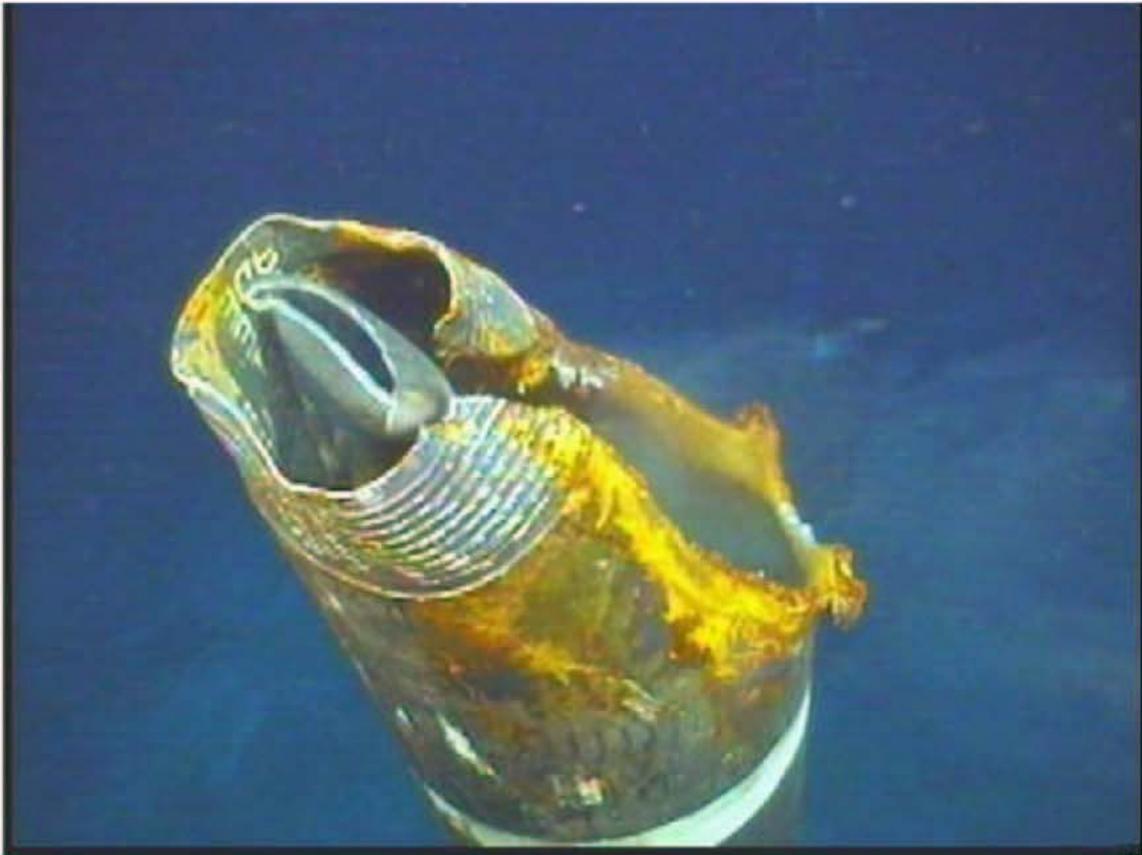
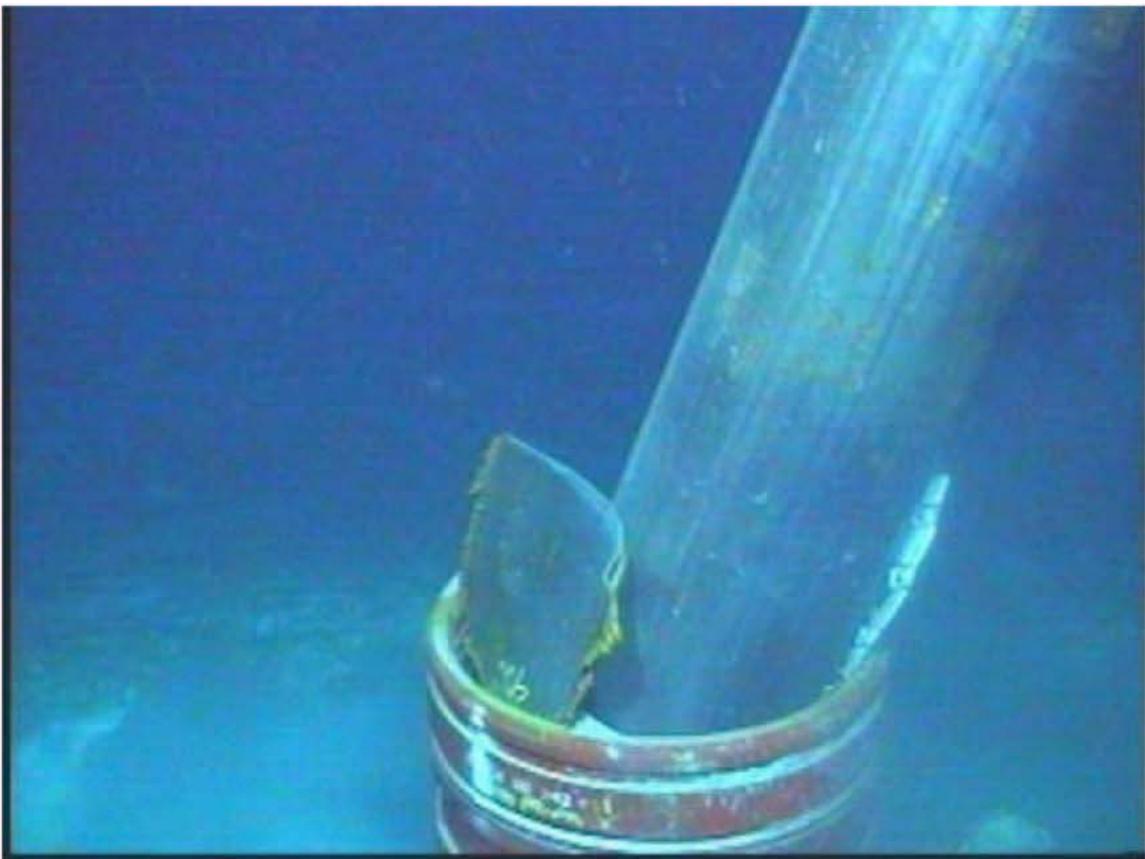
Parted and pinned casing on seafloor.
