OCS Report
MMS 2004-046

**Investigation of Fatality
South Marsh Island Block 130
OCS-G 02280
December 6, 2003**

Gulf of Mexico
Off the Louisiana Coast

U.S. Department of the Interior
Minerals Management Service
Gulf of Mexico OCS Regional Office

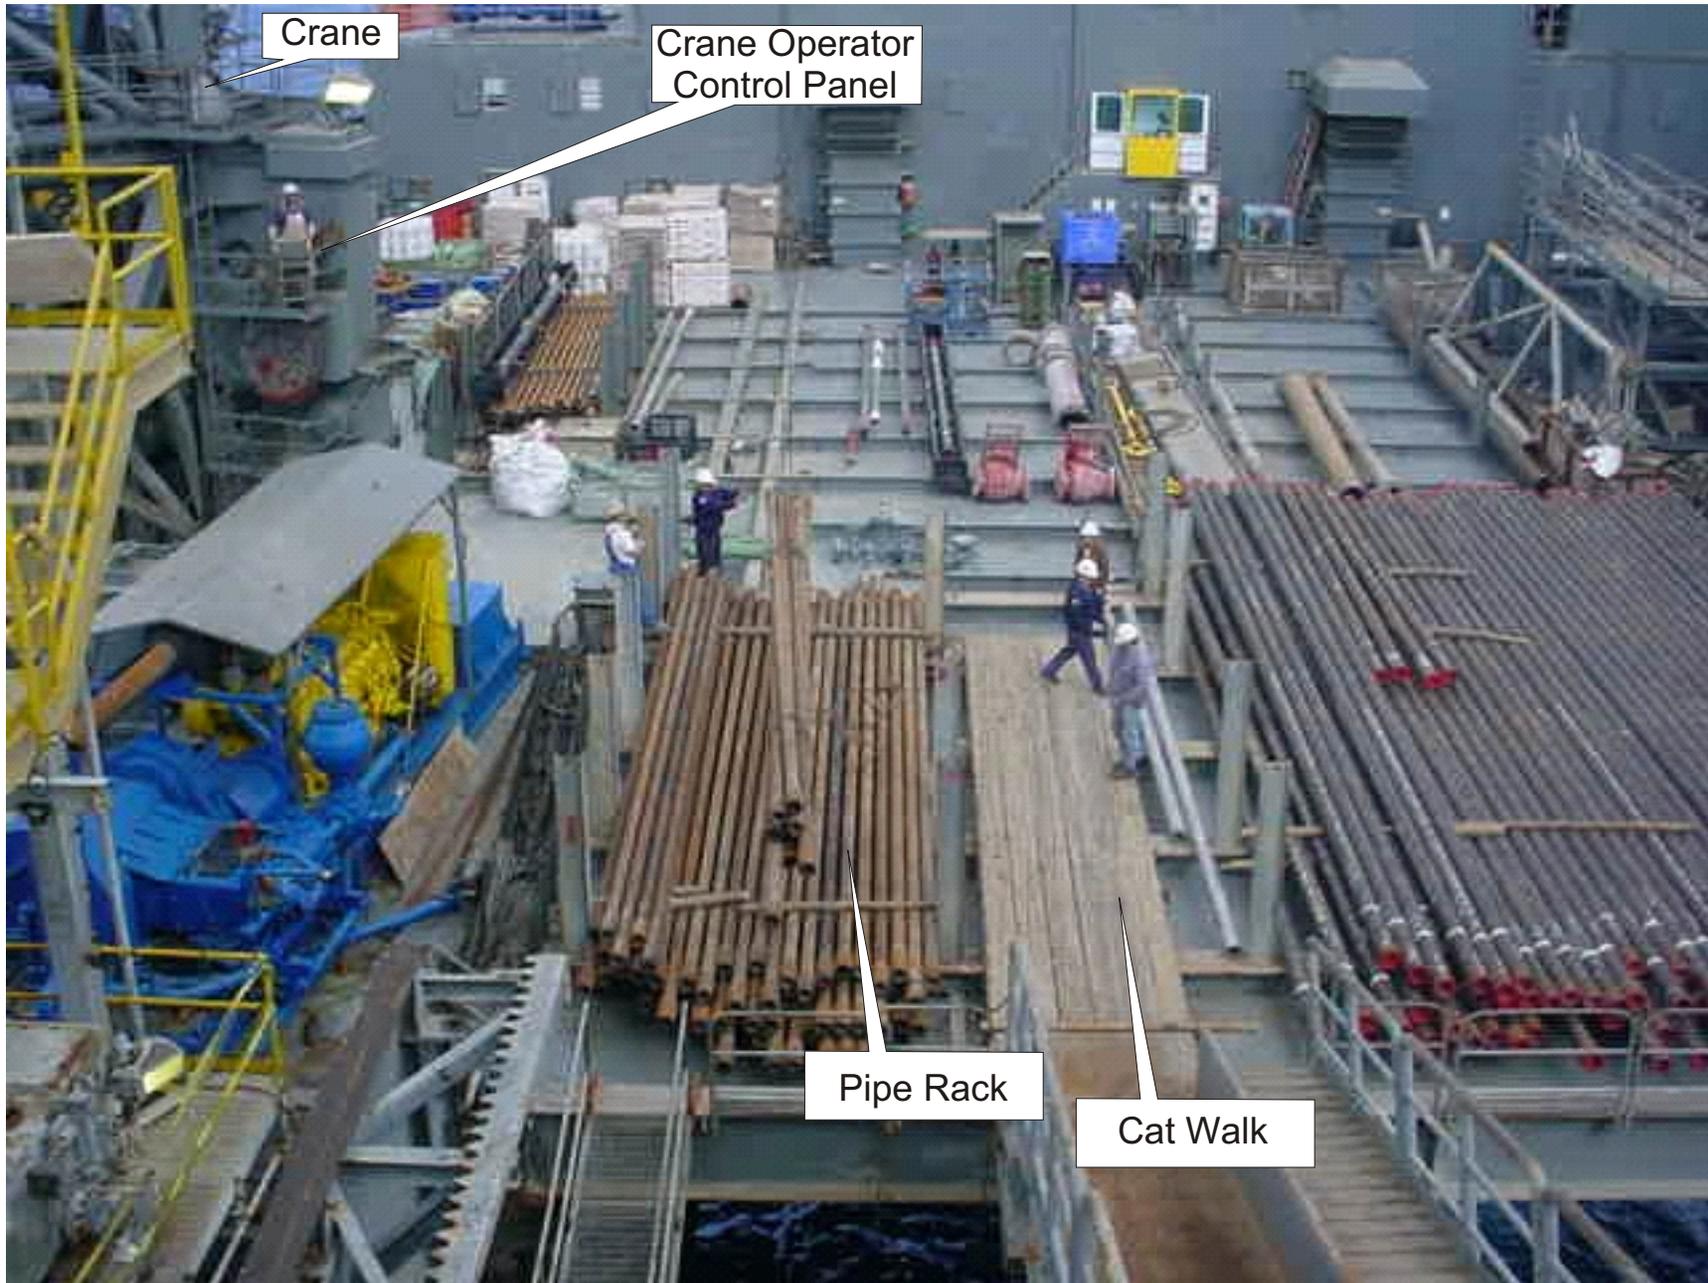
On the evening of December 6, 2003, the Rowan crane operator and three Rowan roustabouts began the task of lifting bundles of 5-inch drill pipe by crane from the pipe rack to the adjacent cat walk for eventual placement on the rig floor. *For a photograph of the pipe rack taken from the derrick, see Attachment 2. For a photograph of the pipe rack taken from the opposite direction (from the living quarters), see Attachment 3.*

Photograph of pipe rack as seen from derrick.

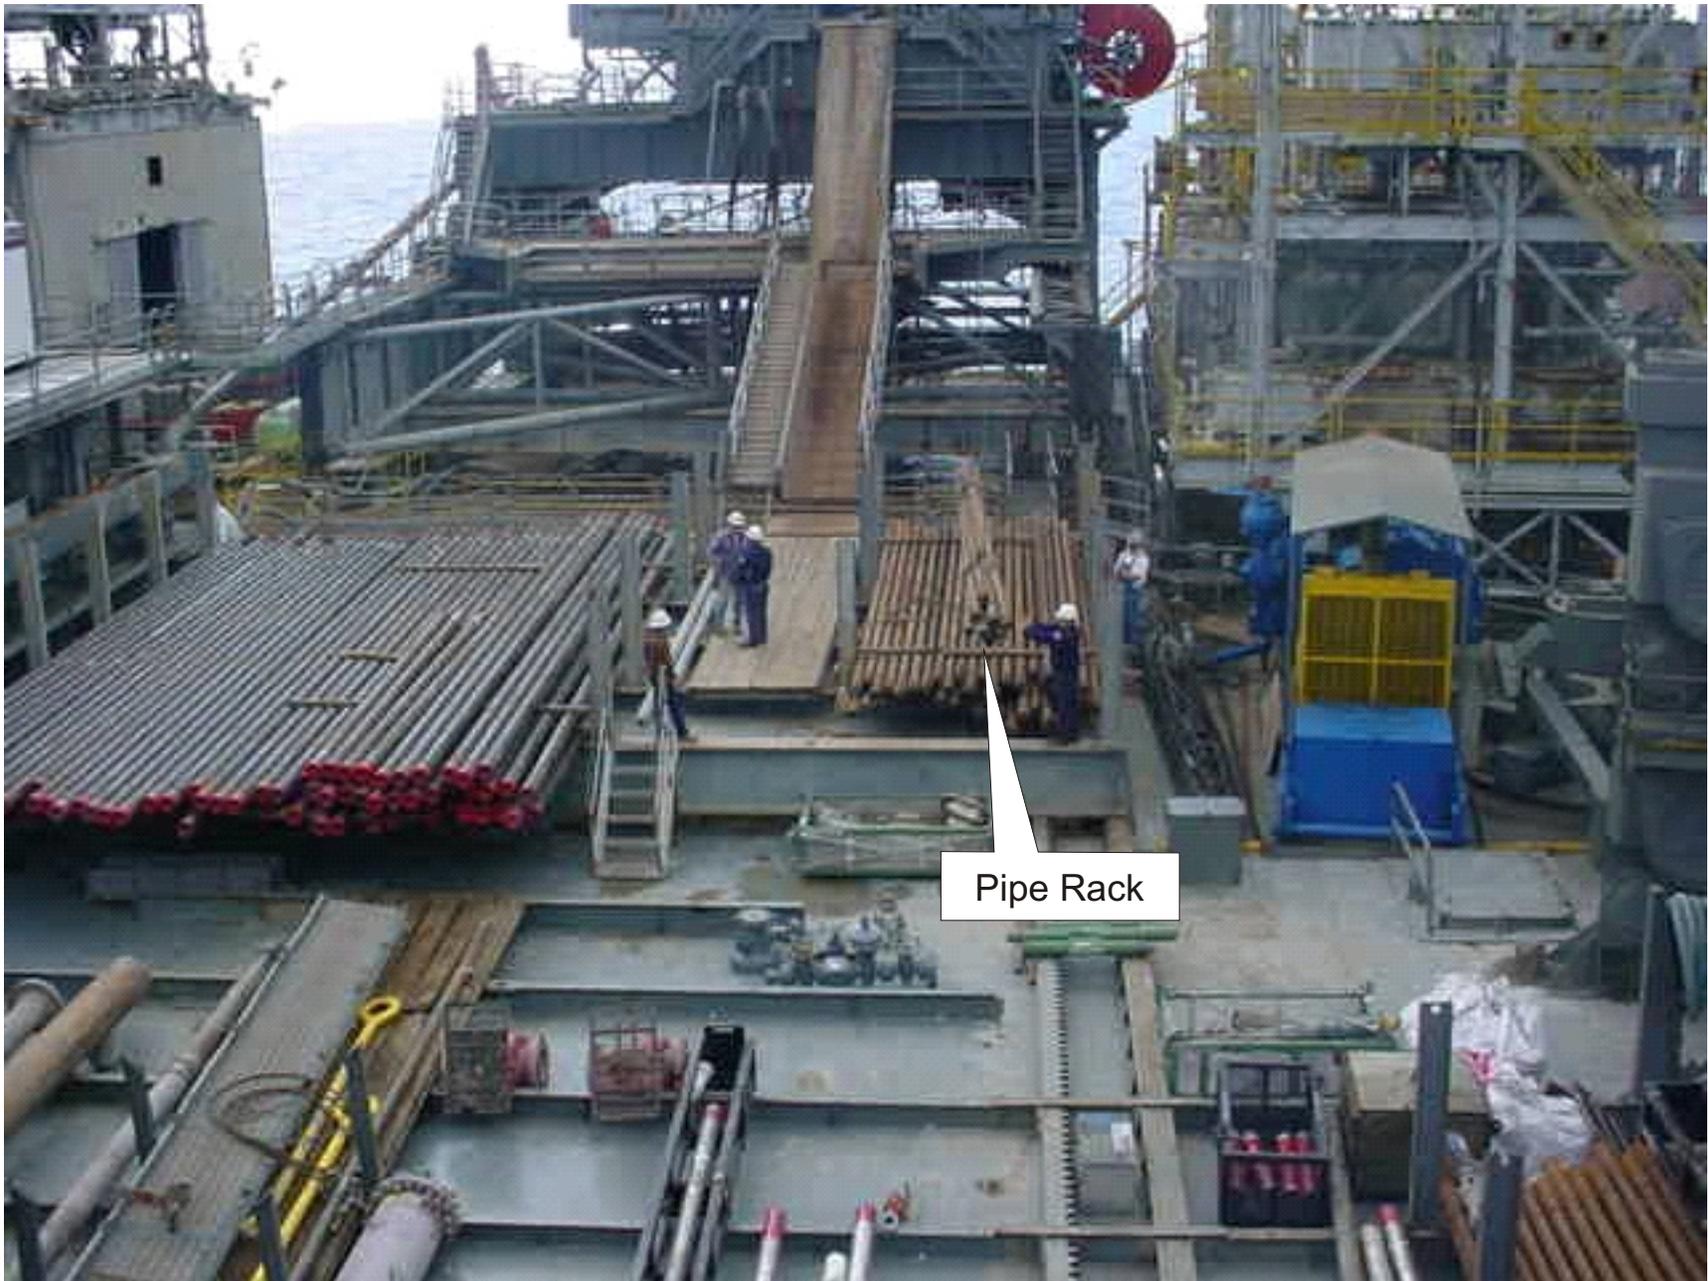
Photograph of pipe rack as seen from living quarters.

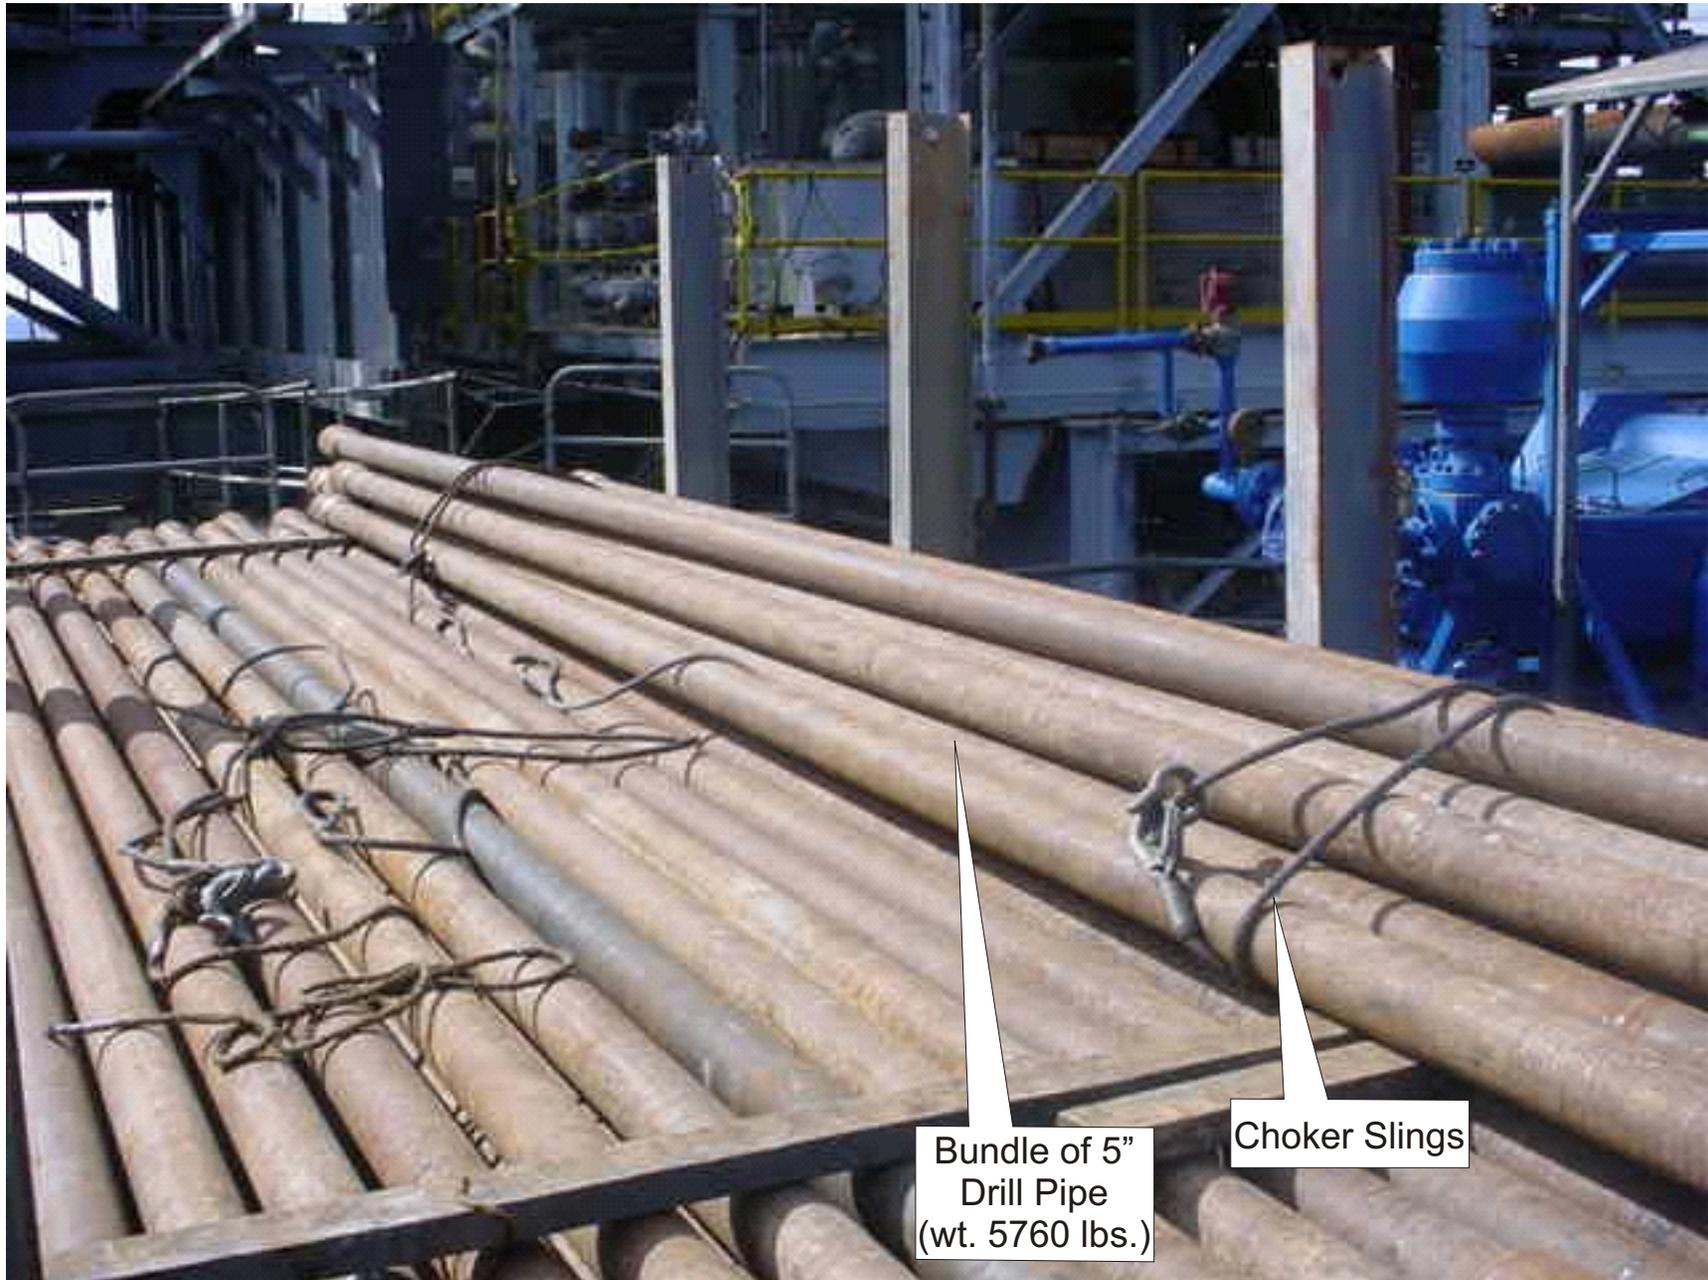
The crane sling assembly consisted of two choker slings, each of which was attached to the crane hook and to opposite ends of a pipe bundle. *For a photograph of the choker slings, see Attachment 4.*

According to rig personnel, the crane lowered the bundle of pipe immediately after the accident and was touched for the first time since the accident two days later when it lifted the bundle in the presence of MMS personnel, including a panel member. The MMS personnel witnessed that the slings were evenly spaced and that the crane performed with no irregularities.

It is concluded that neither sling placement, the crane's performance, nor the crane's operation are causes of the accident.

Bundle of 5"
Drill Pipe
(wt. 5760 lbs.)

Choker Slings

Photograph of choker slings.

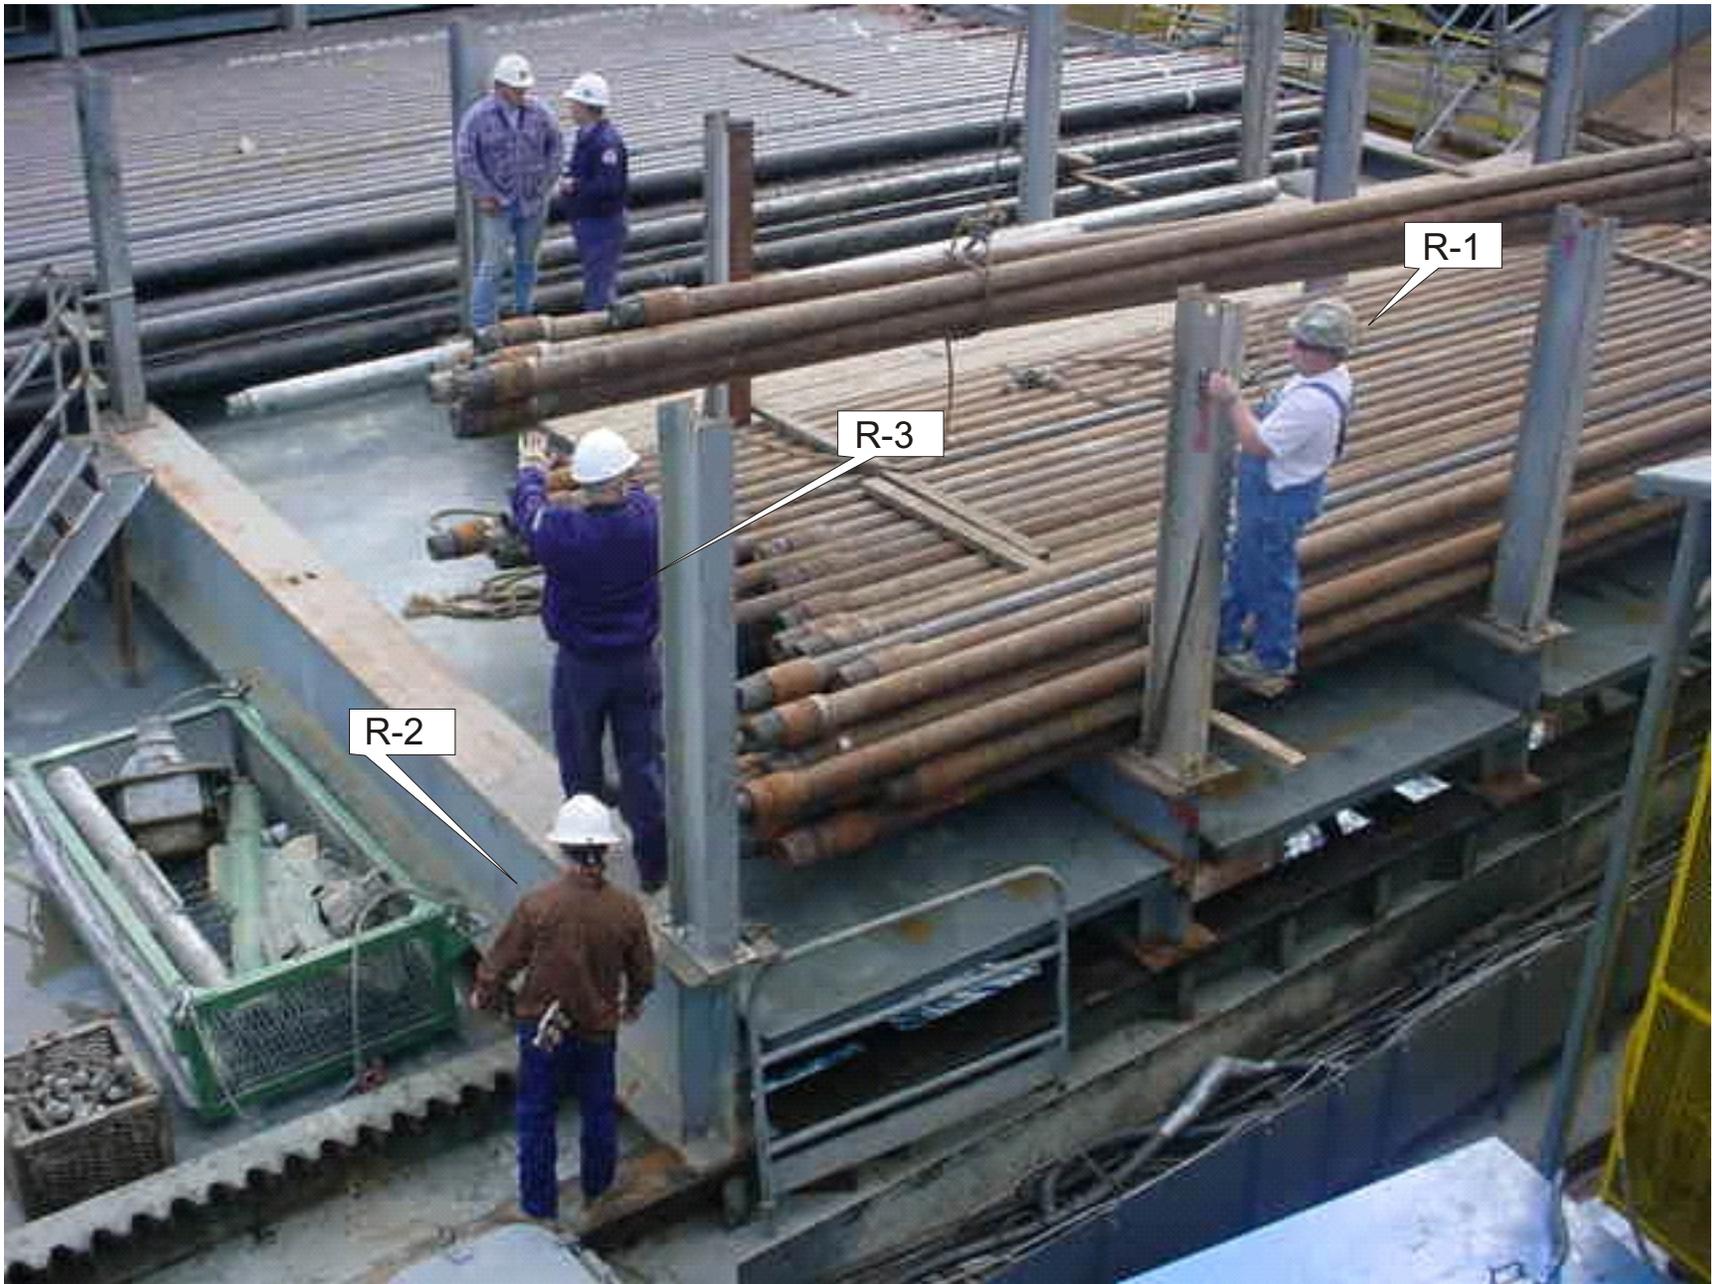
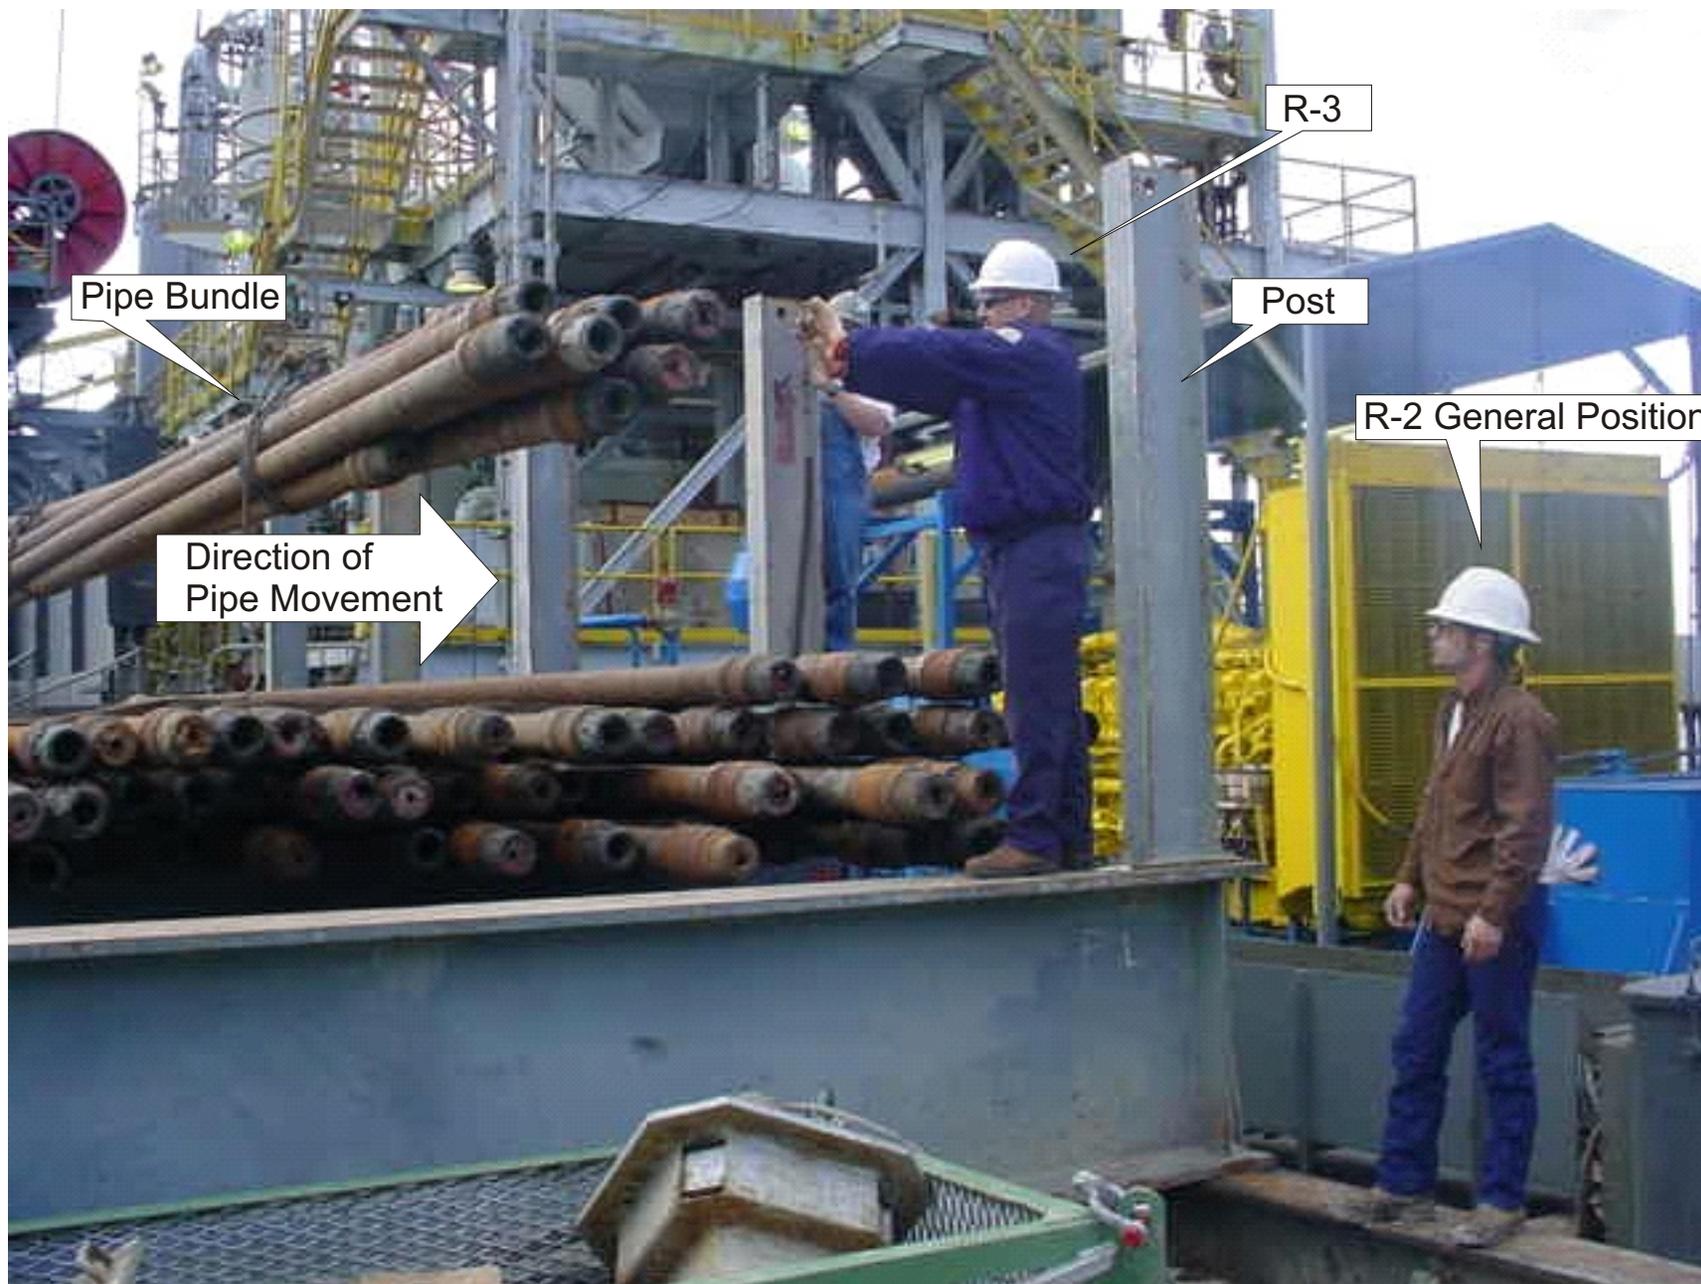
As the lift was being made, after R-1 signaled for the lift to commence, both R-1 and the CO stated that they next saw R-3 on the crane side of the pipe rack attempting with extended hands to stop the bundle from swinging. They next saw the bundle strike R-3 in the chest as his back was pressed against the pipe rack post. No one saw R-3 walk from the catwalk side to the crane side of the pipe rack. They then saw R-3 fall approximately four feet from the I-beam of the pipe rack to the skid deck. This occurred at approximately 2115 hours. *For a photograph taken from the crane operator's console panel of the pipe rack and the position simulation of the roustabouts at the time of the accident, see Attachment 5. For a photograph taken from the deck of the pipe rack and the position simulation of the roustabouts at the time of the accident, see Attachment 6.*

R-3 abandoned the tag line and walked unobserved to the crane (port) side of the pipe rack. Whether he went to the crane side of the rack to intervene manually in an effort to stop the swinging of the suspended load or walked to that side of the rack to move away from the intended placement area (cat walk) of the load is not known. However, once on the crane side of the rack, he attempted stop the load from swinging and was fatally pinned between the load and the pipe rack post. The reason the bundle swung is not known.

The employee's decision to intervene manually in attempting to stop the load from swinging is a cause of the accident. Whether the intervention was more reflexive or more thoughtful is not known. In either case, the intervention was fatal.

Photograph of position simulation of roustabouts at time of accident.
