Seafloor Disturbance and Recovery Monitoring at the Block Island Wind Farm, Rhode Island – Summary Report

March 2020

Prepared under BOEM Award
Contract No. M15PC00002
Task Order No. M17PD00015
By
HDR
9781 S Meridian Boulevard, Suite 400
Englewood, CO 80112

**US Department of the Interior
Bureau of Ocean Energy Management
Office of Renewable Energy Programs**

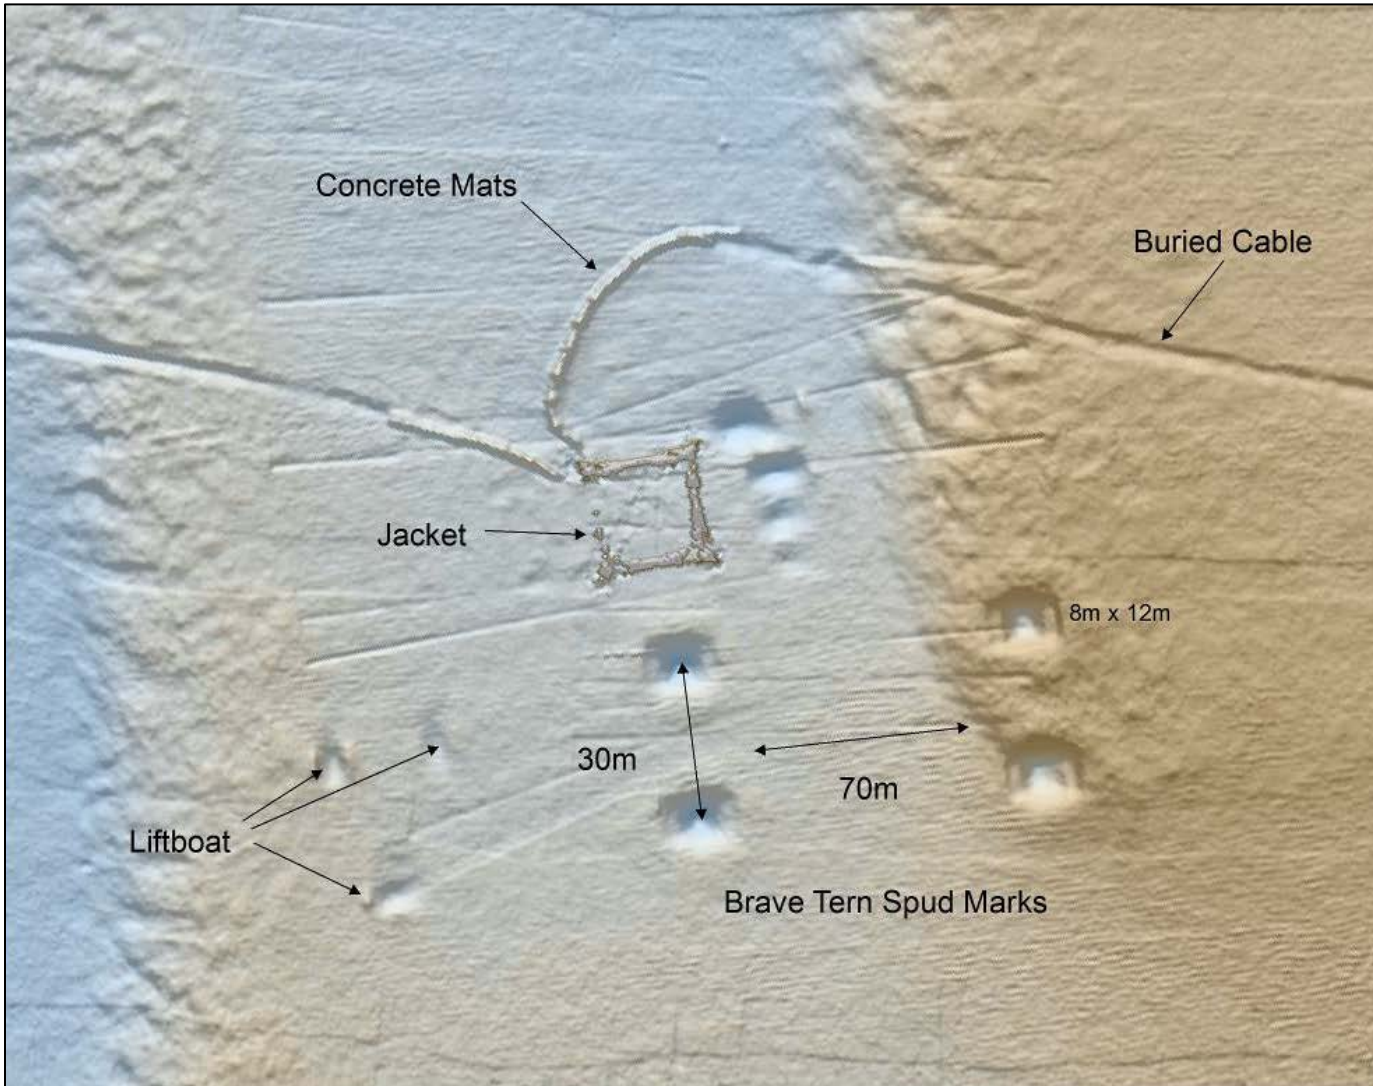
Figure 3. Examples of seabed disturbance features.

Note: Features shown in Figure 3 were observed near Turbine 4 during Survey 2.

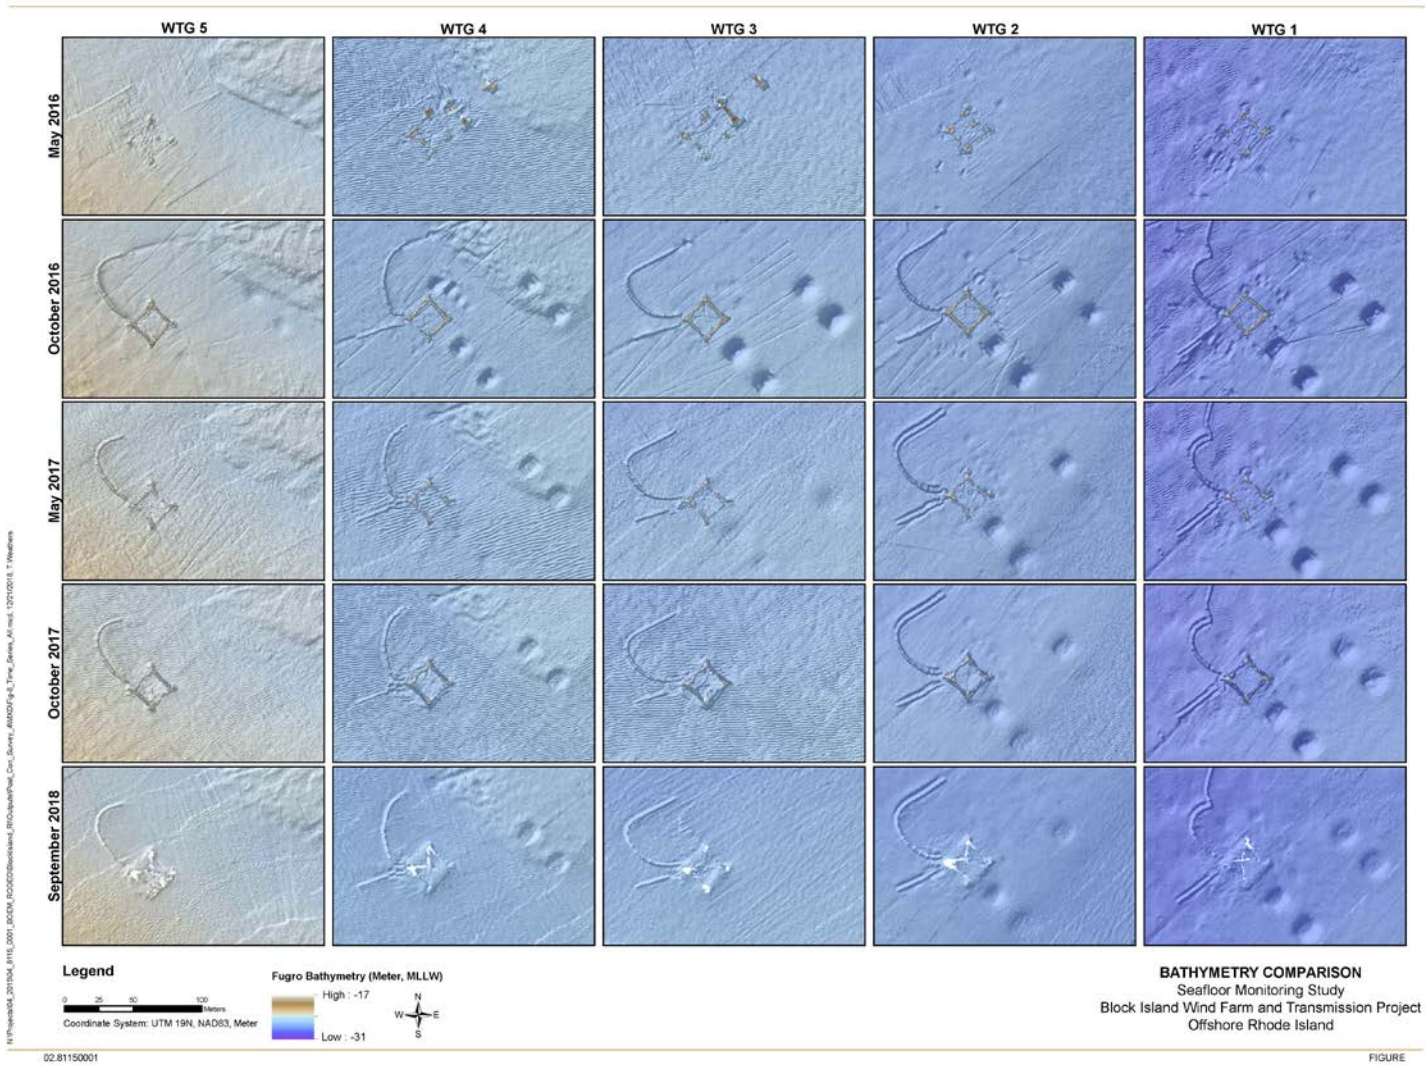
Figure 4. Time series from Survey 1 (May 2016) to Survey 5 (September 2018) for each Turbine, depicting seafloor disturbance and recovery.

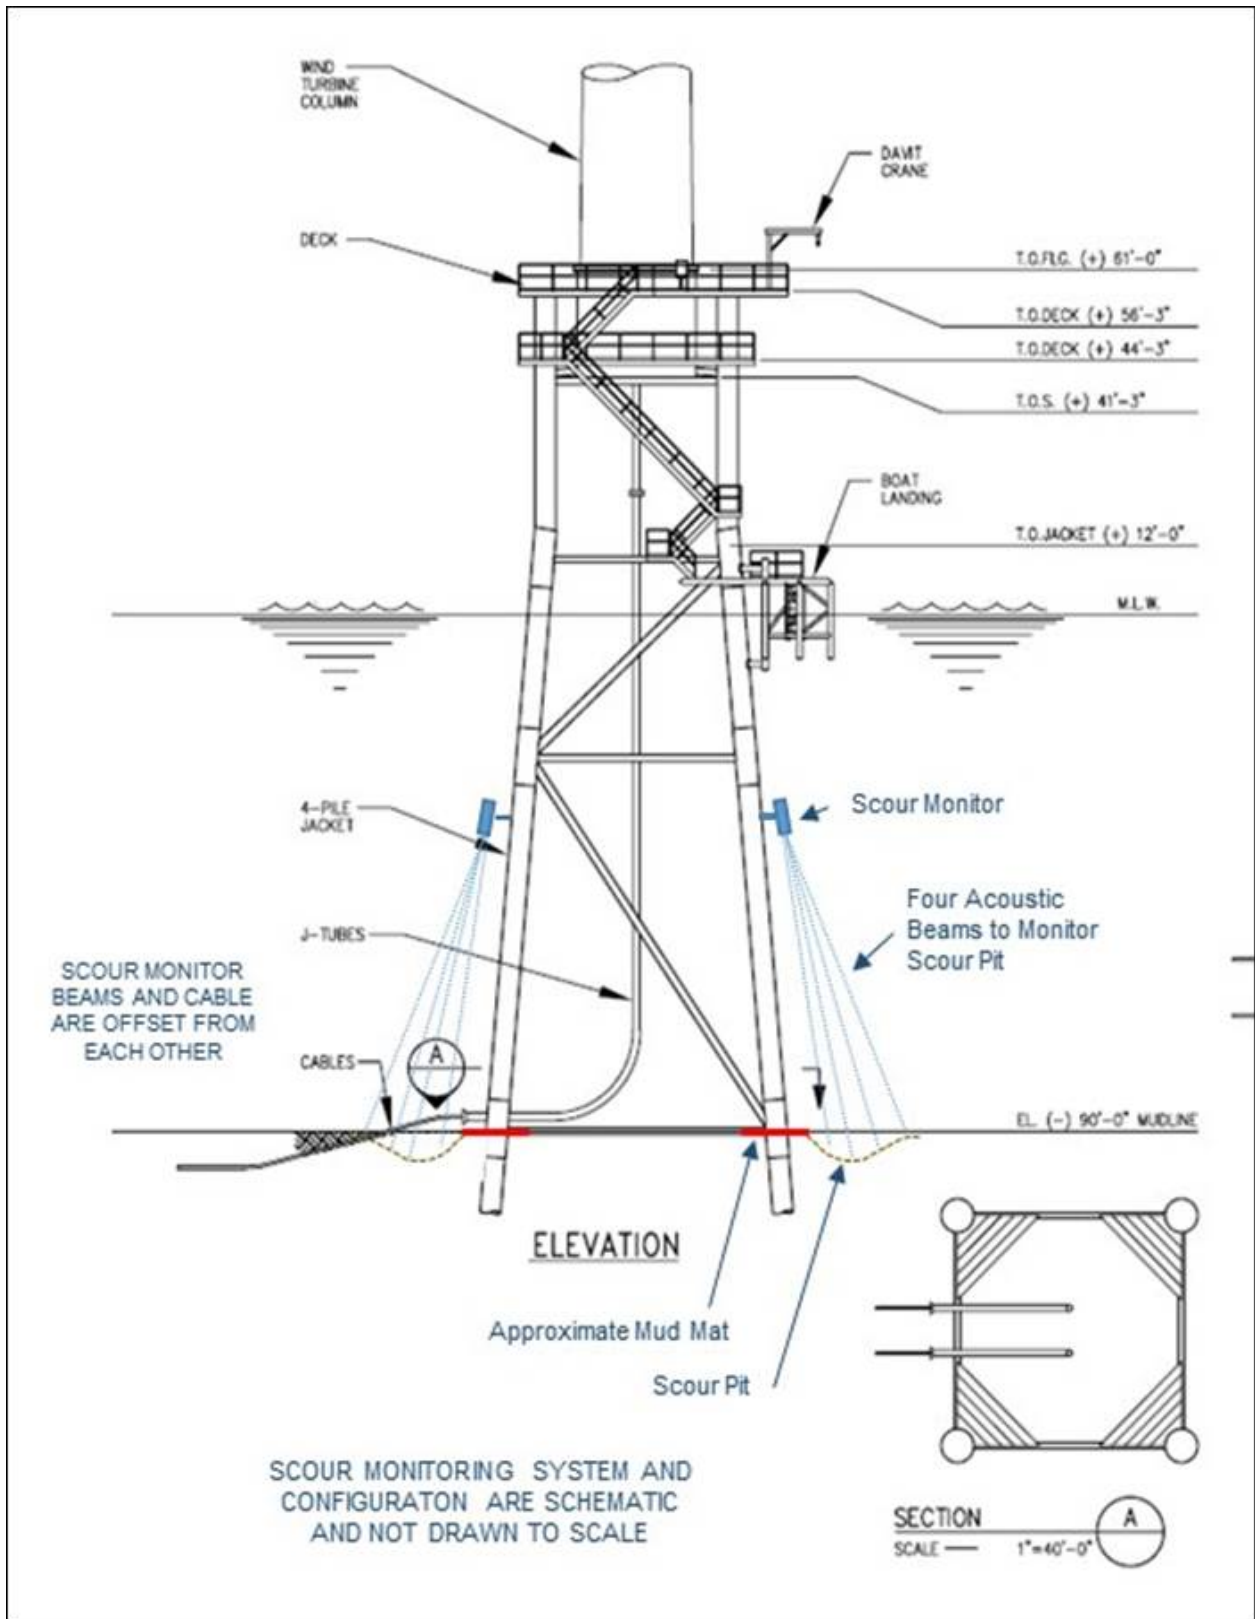
Figure 10. Positioning of the scour monitors on the turbine foundation.

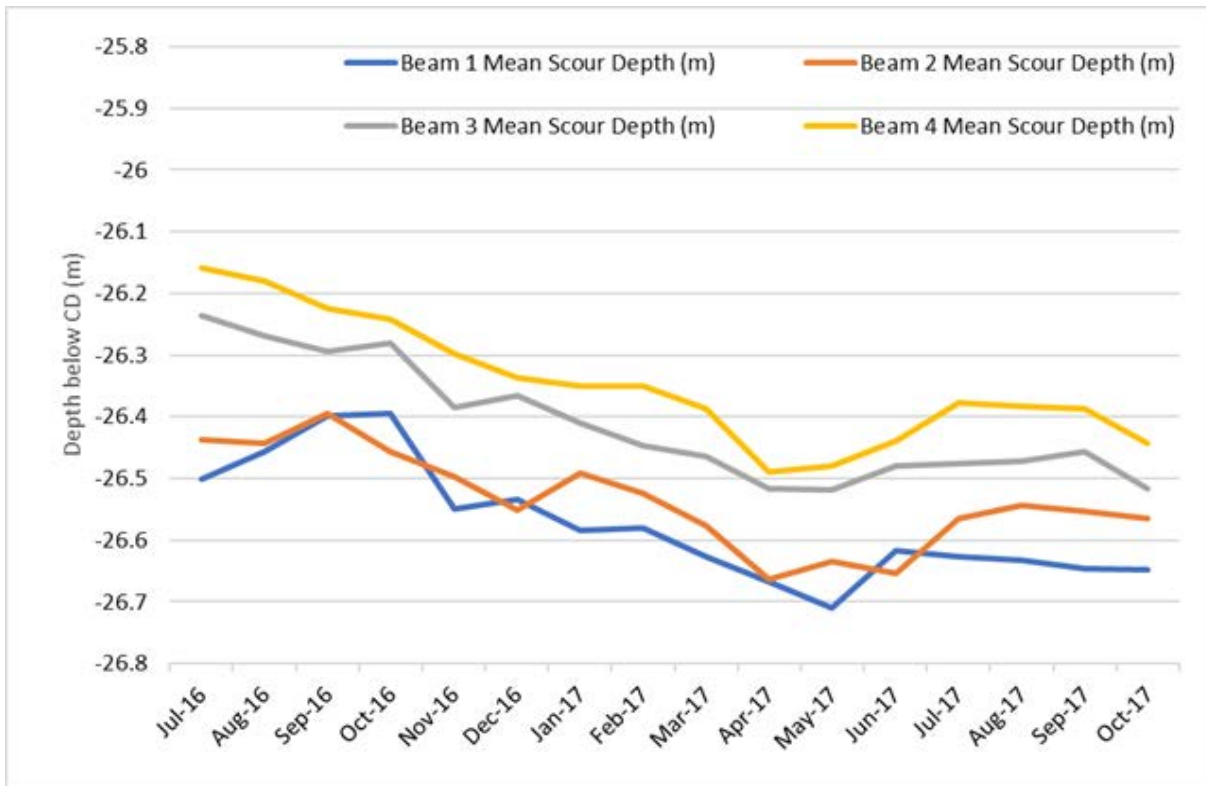
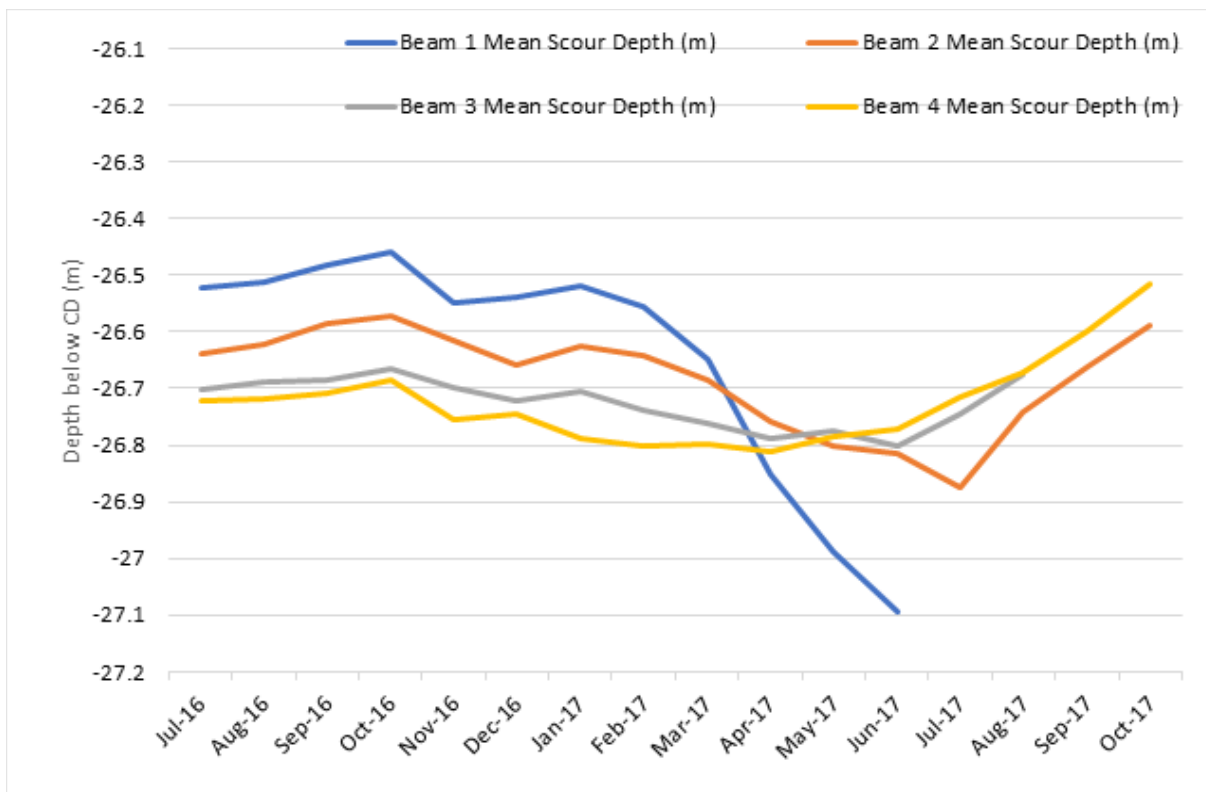
Figure 11. Mean scour depth of each beam per month.
