# Marine Shipwrecks and Corrosion - Potential Impact of an Oil Spill on Corrosion in the Gulf of Mexico

Brenda Little and Jason Lee

U.S. NAVAL  
RESEARCH  
LABORATORY

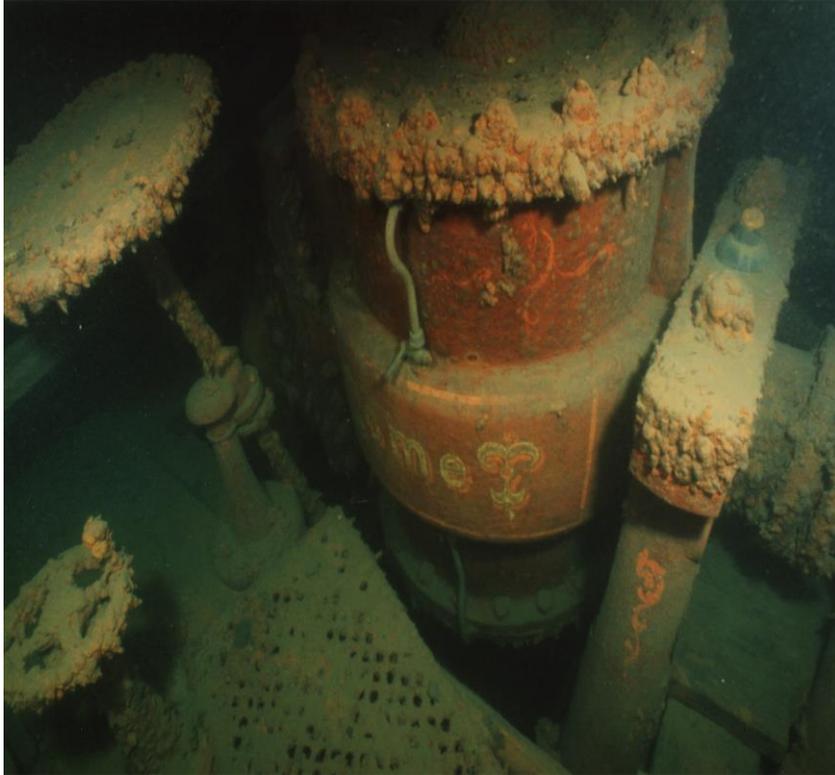
***Comet***  
**Sank in 1875,**  
**Lake Superior, 70 m**

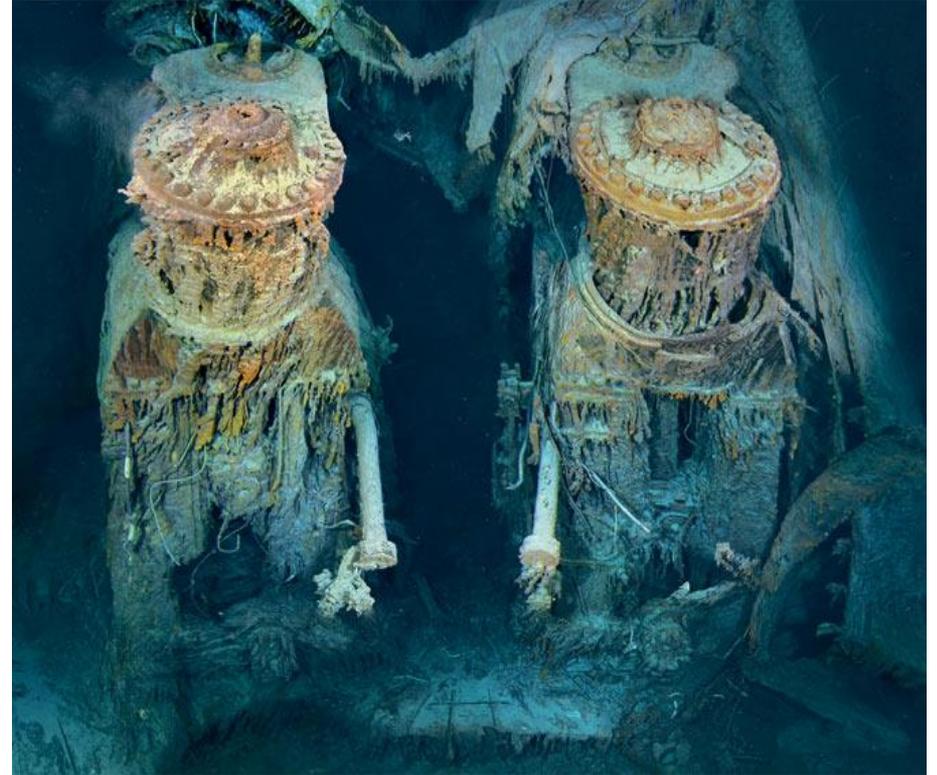
***RMS Titanic***  
**Sank in 1912,**  
**North Atlantic, 3800 m**

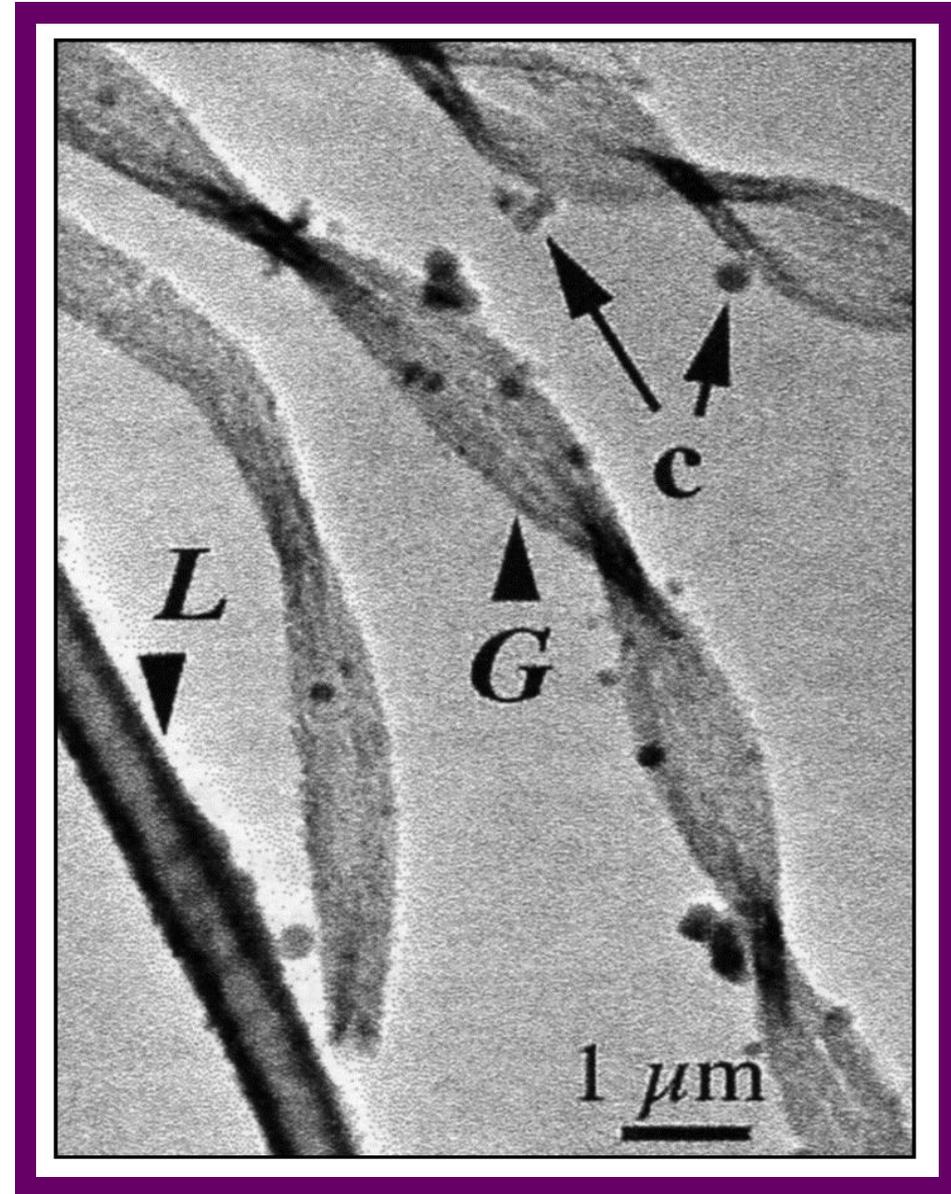
# TEM Image of IOB

Gallionella – G

Leptothrix – L

Colloidal aggregates - C

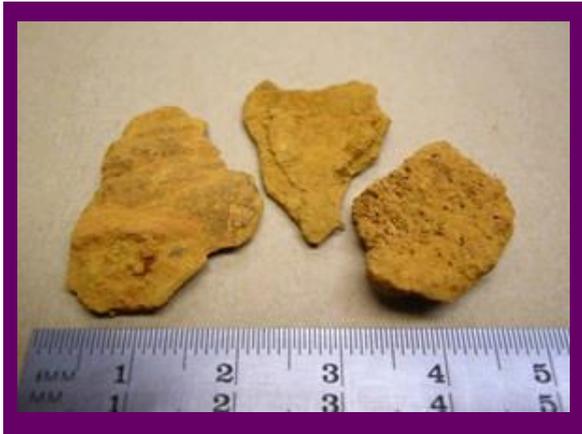
# Rusticles from GOM Ship Wrecks

*Gulf Penn*

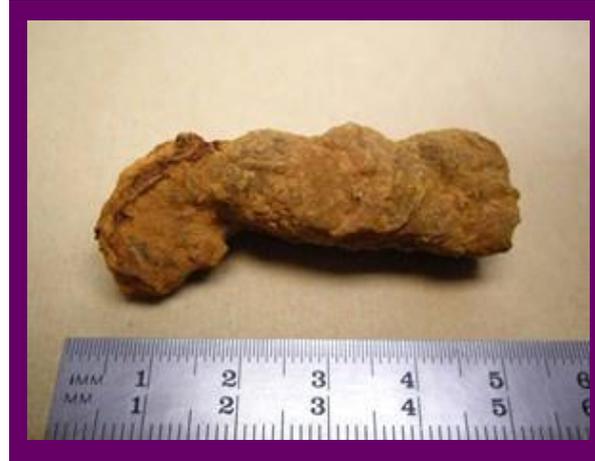
*Robert E. Lee*

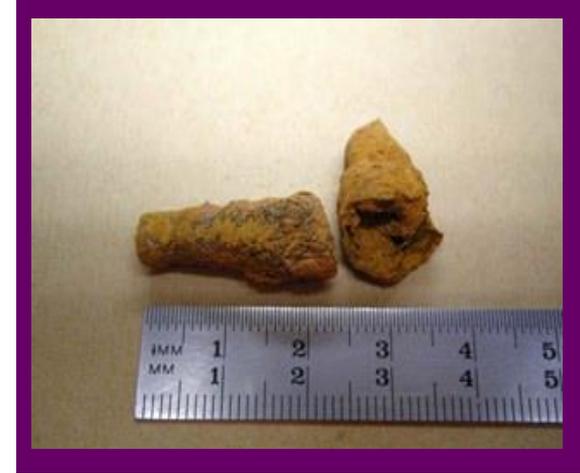
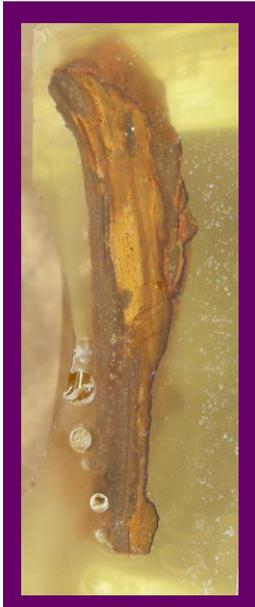
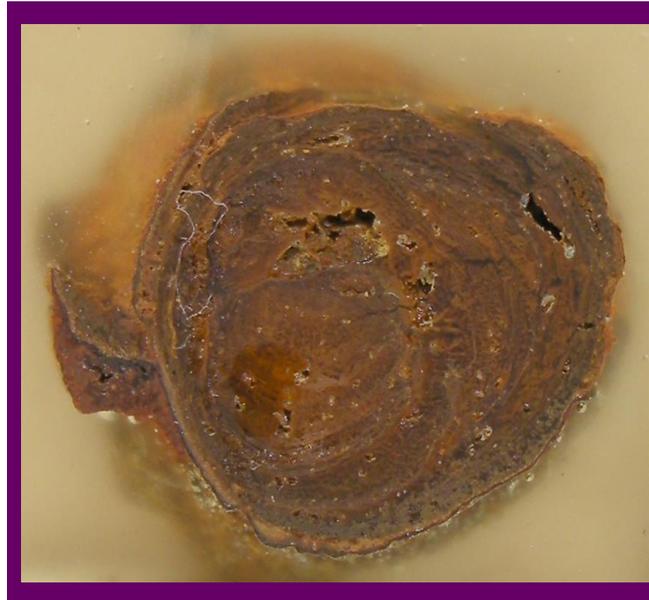
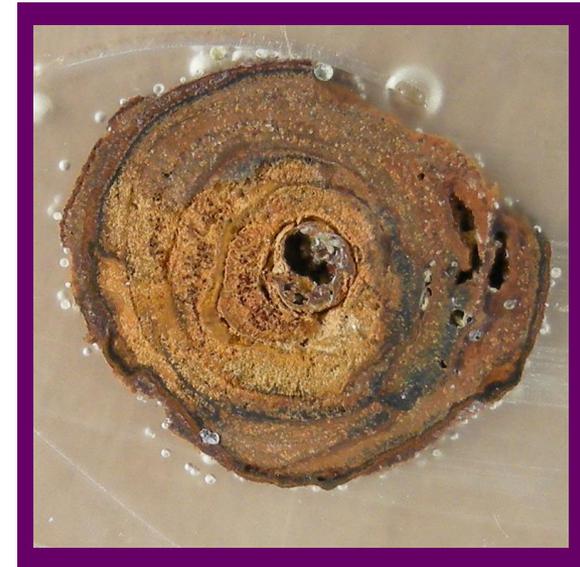
*ALCOA Puritan*

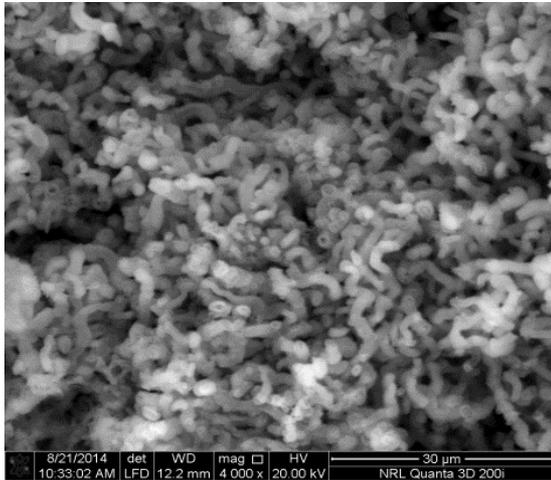
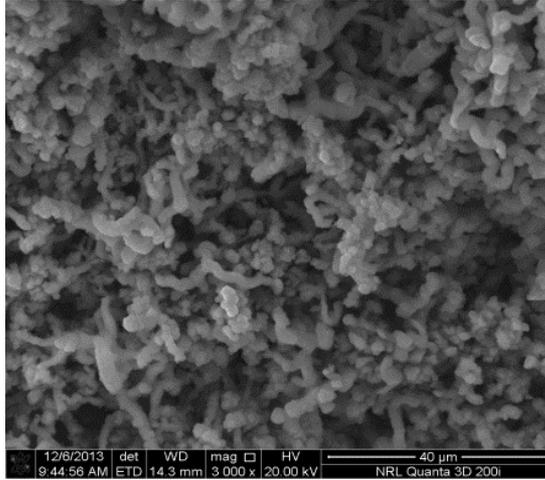
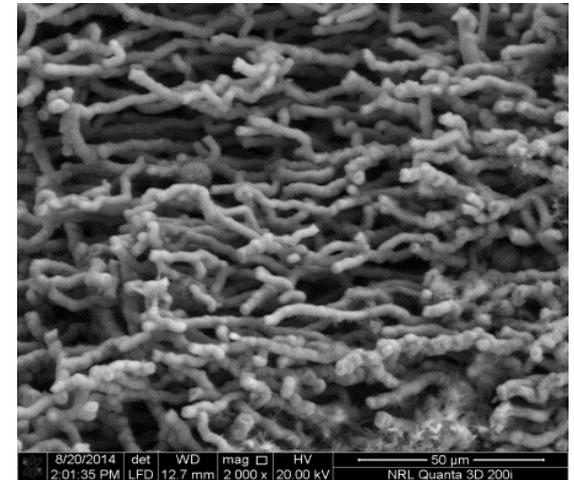
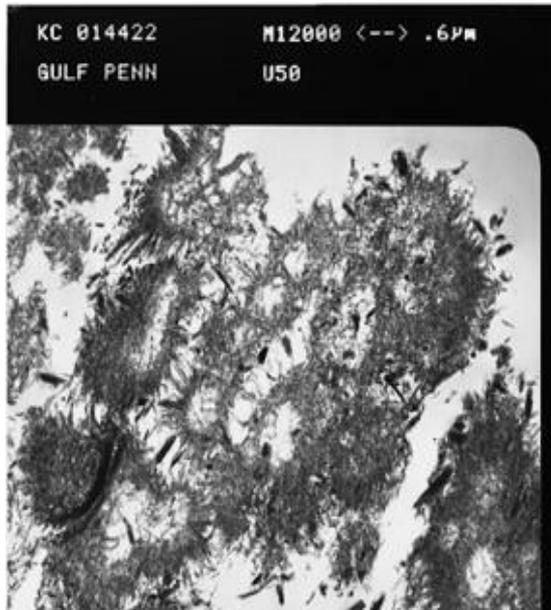
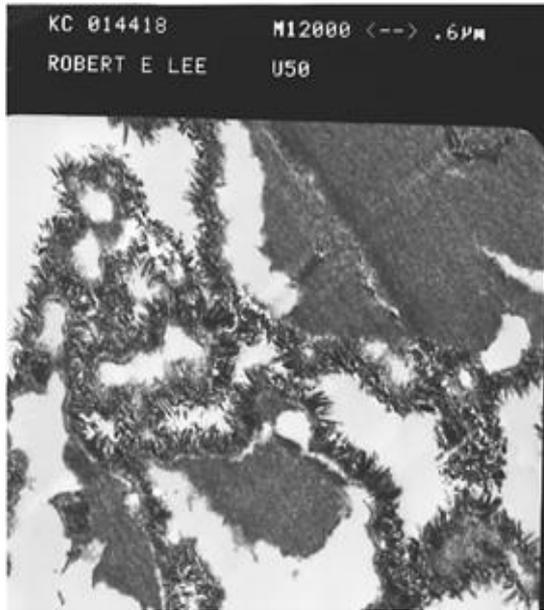
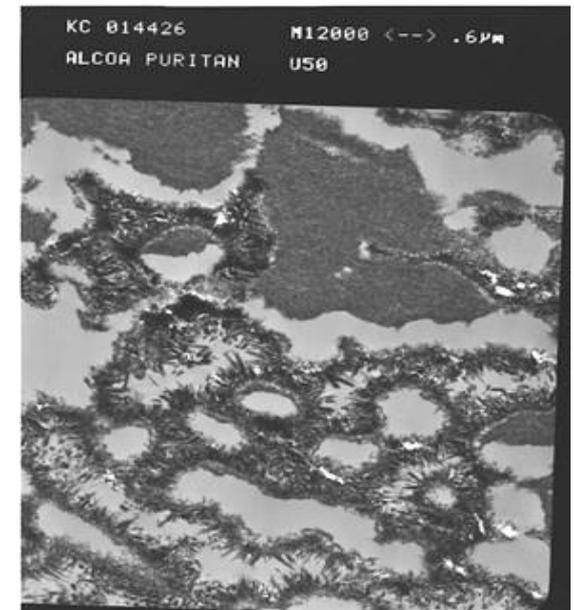
# SEM Images of Iron Corrosion Products

*Gulf Penn*

*Robert E. Lee*

*ALCOA Puritan*

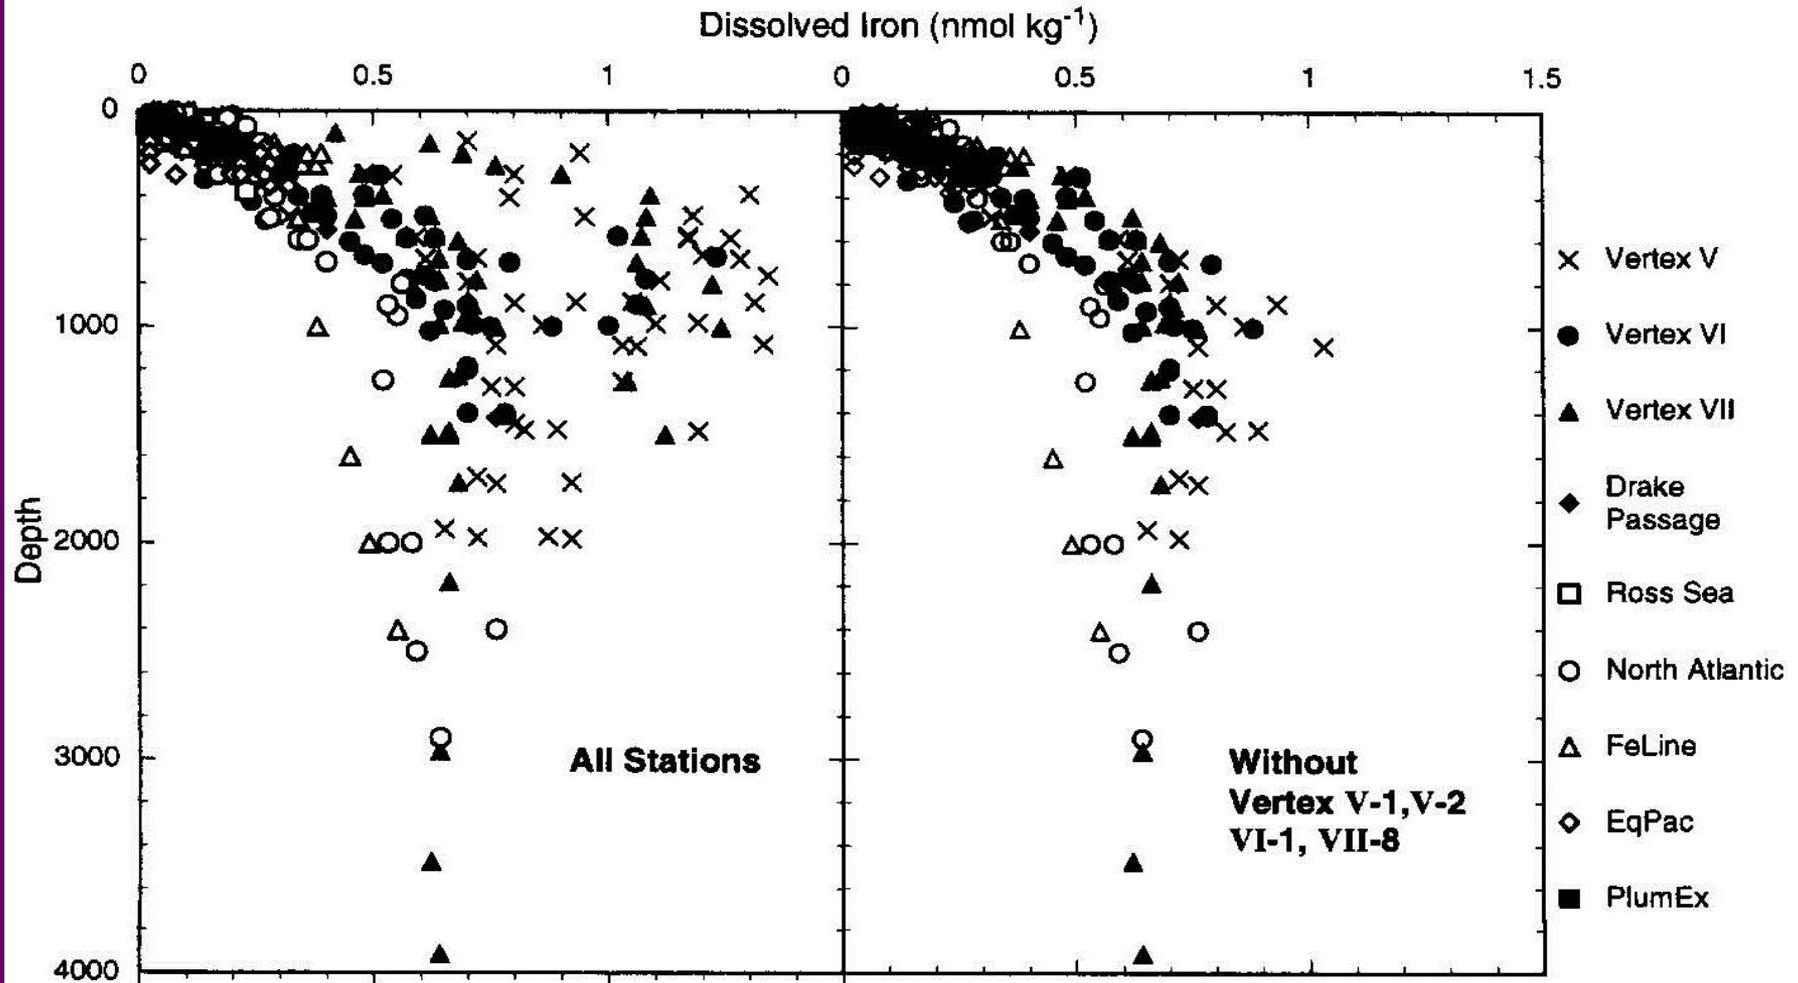
# Iron Concentrations: Ocean Water Column

(A) Dissolved ( $<0.4 \mu\text{m}$ ) iron concentrations measured in 354 samples at stations more than 50 km from the continental coastline. (B) Dissolved ( $<0.4 \mu\text{m}$ ) iron concentrations as in (A), but excluding the 4 stations closest to shore (VERTEX V-1, V-2, VI-1, VII-8) in the North Pacific.

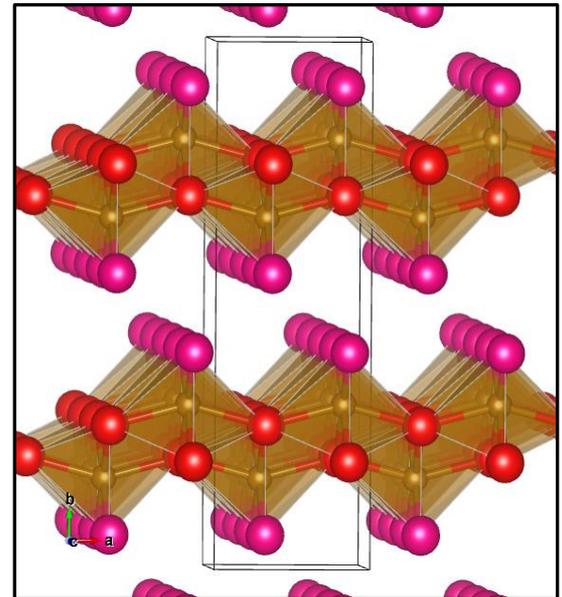
$\gamma\text{-FeO}(\text{OH})$  - Iron-centered oxygen octahedra joined by sharing edges into two-dimensional infinite layers, with successive layers held together by hydrogen bonds.
