FINAL ENVIRONMENTAL ASSESSMENT

**FLAGLER COUNTY
DUNE/BEACH NOURISHMENT PROJECT**

FLAGLER COUNTY, FL

**July 2025
FINAL ENVIRONMENTAL ASSESSMENT
FLAGLER COUNTY DUNE/BEACH NOURISHMENT PROJECT
FLAGLER COUNTY, FL**

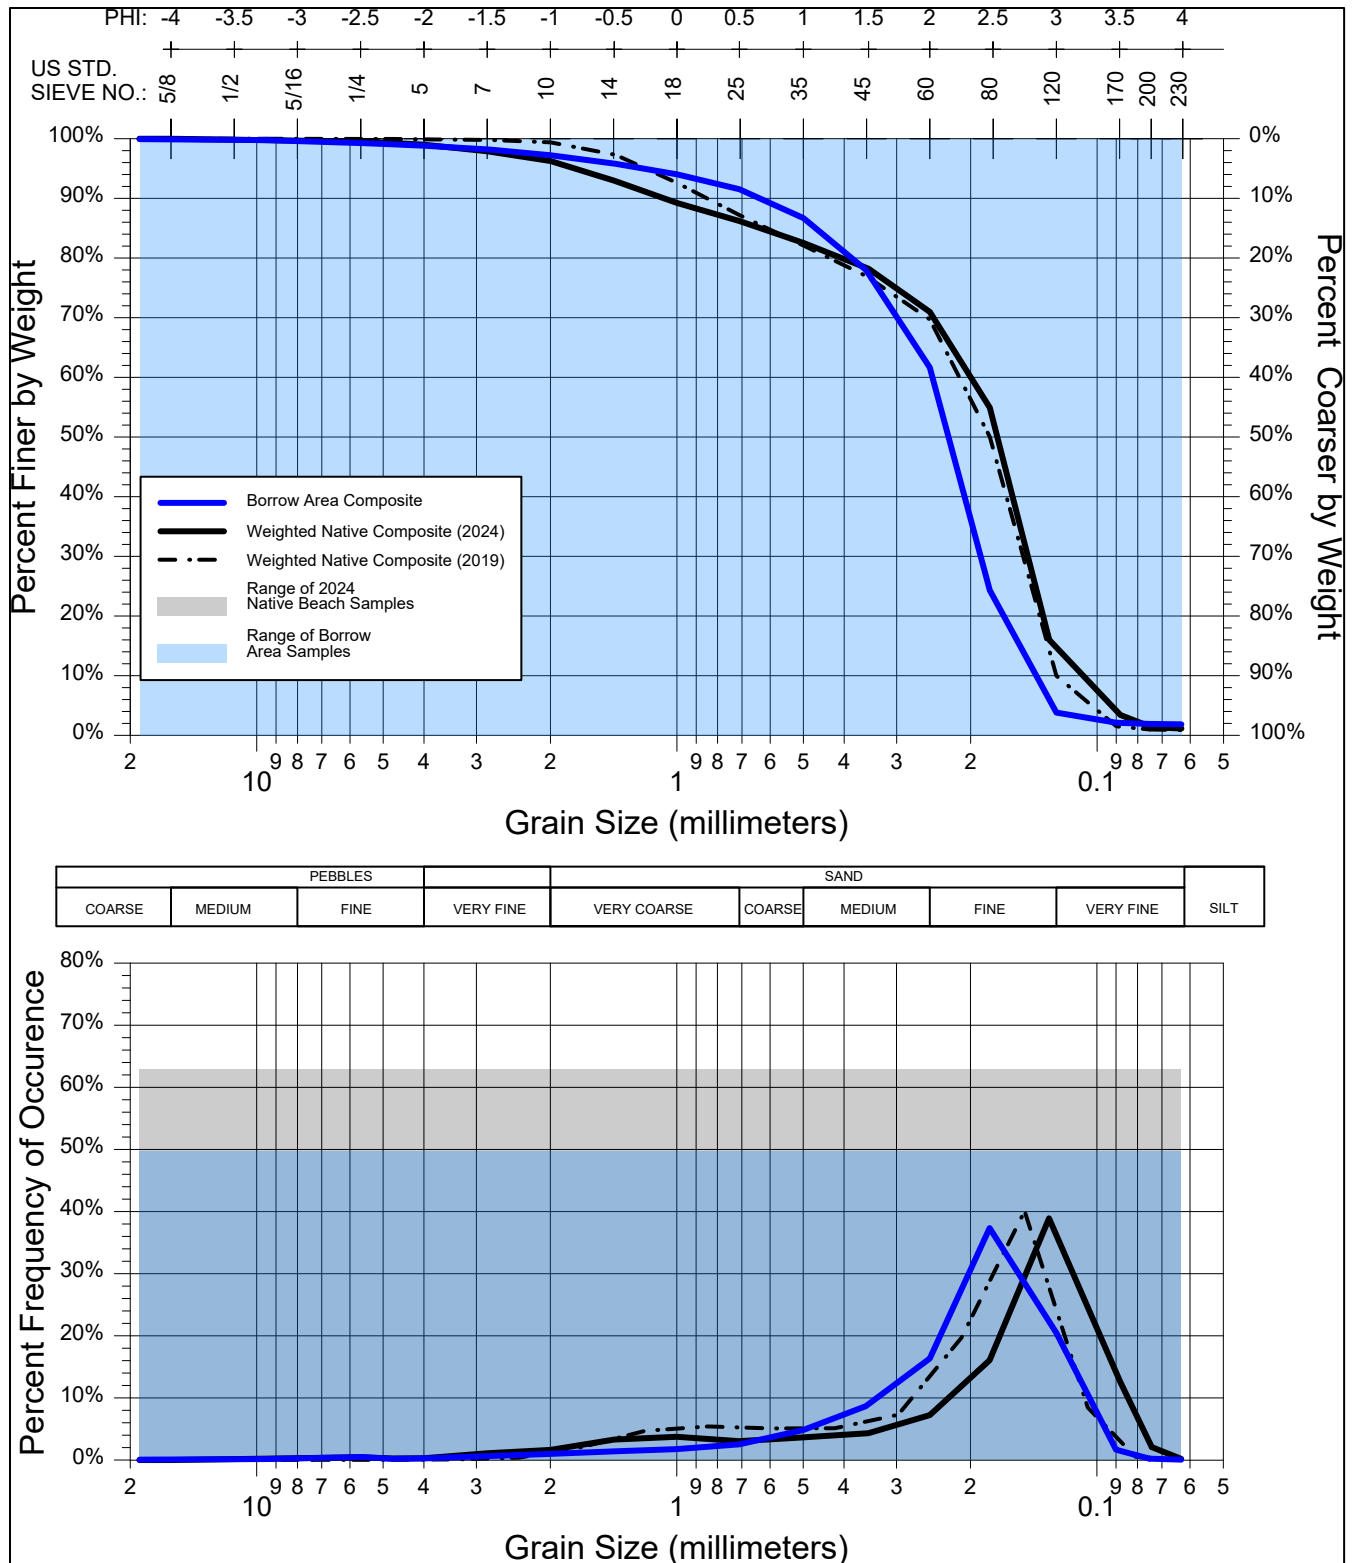
Figure 19. Cumulative grain size curves for the borrow area and existing beach sediments.

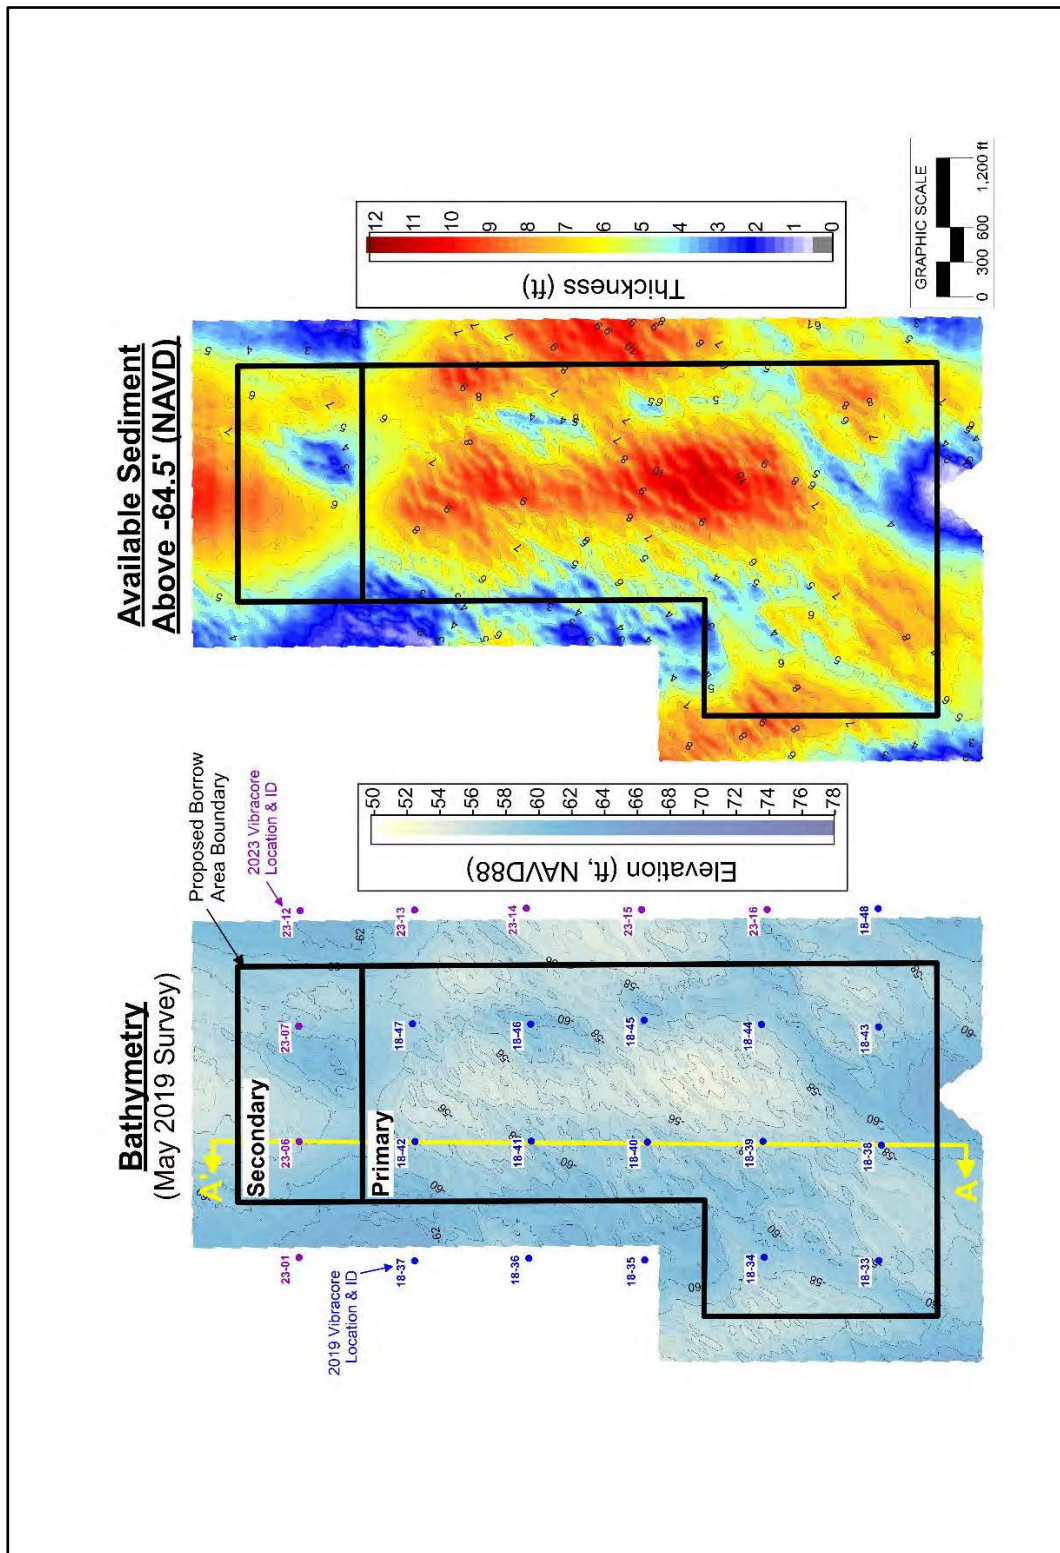
Figure 2b. Bathymetry of the proposed Phase 2 borrow area (left) and sediment layer thickness in feet above -64.5 ft, NAVD88 (right). Bathymetric contours are represented by the May 2019 multibeam survey (Arc Surveying & Mapping, Inc.).

The Phase 2 borrow area is located approximately 10 NM offshore of the City of Flagler Beach shoreline on the OCS in the BOEM South Atlantic Planning Area, Daytona Beach Protraction Area (NH17-08), Blocks 6471, 6472, and 6522 (**Figures 1, 2a/b**). The Phase 2 borrow area lies within a large sand deposit previously delineated by the USACE as part of the Flagler County Hurricane and Storm Damage Reduction Project Feasibility Study and EA (USACE, 2015). This larger area is known as Borrow Area 3A. The Phase 2 borrow area within Borrow Area 3A occupies roughly 1,545 acres (625 hectares) of seabed (**Figures 1, 2a/b**). The Phase 2 borrow area contains bathymetric peaks and ridges on the seascape rather than level sea bottom. The sand ridges are elongated shoals comprised of mostly sandy sediments (**Figure 2a**). The ridges tend to be semi-permanent features that have slowly formed into linear mounds by currents over time. Existing water depths within the Phase 2 borrow area typically range from -50 to -66 ft NAVD88.

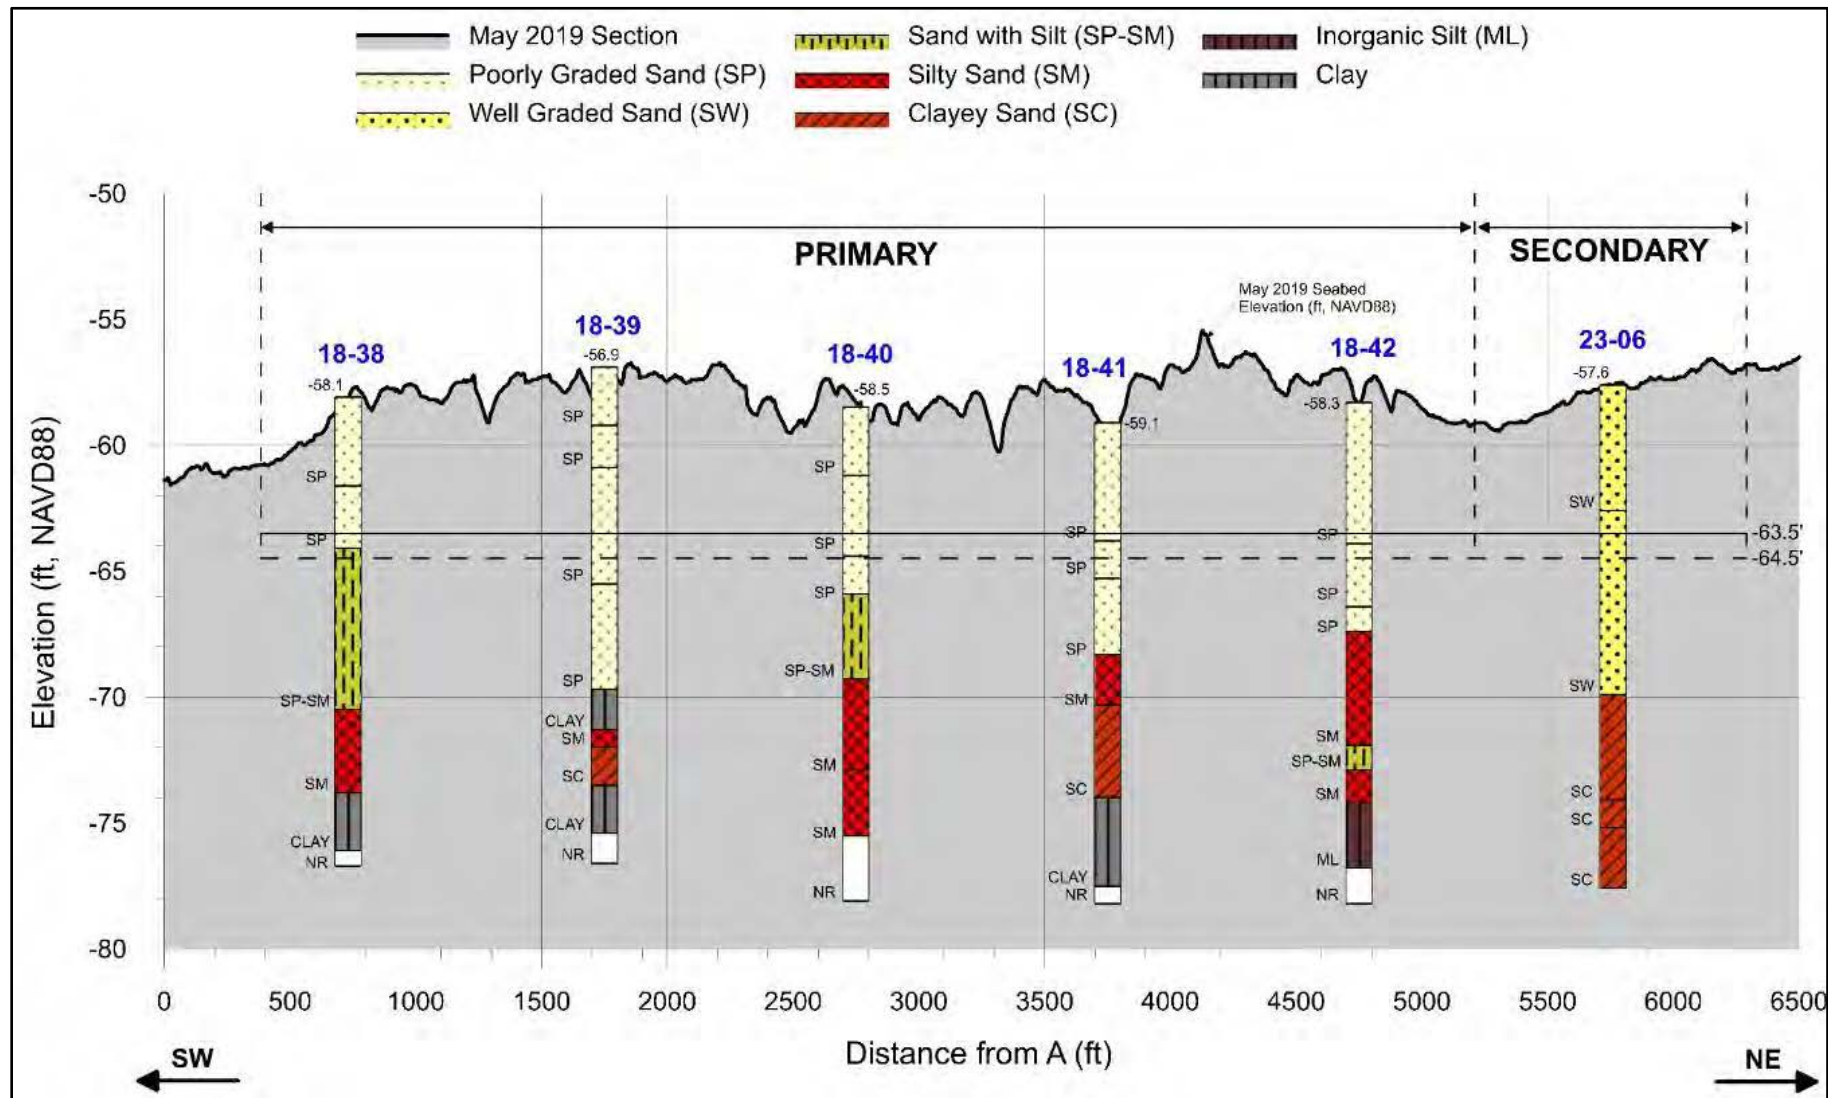
Figure 4. Fence plot of vibracore detail demonstrating the makeup of the Phase 2 Borrow Area material based on the record provided in the vibracore logs.

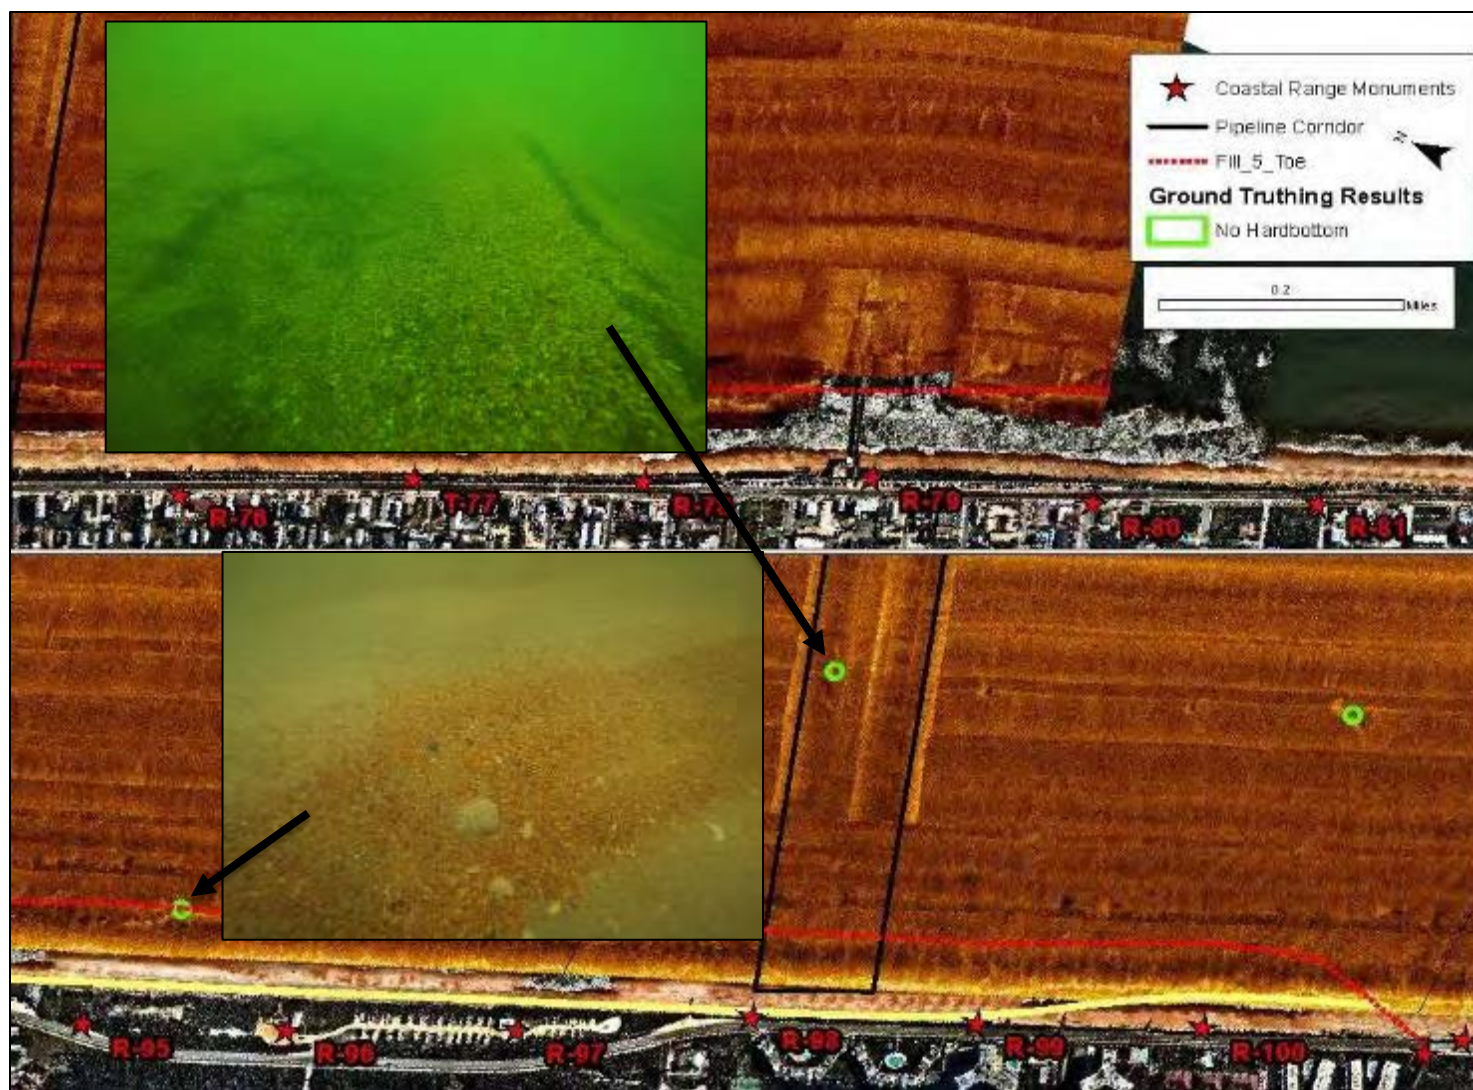
Figure 9. 2019 side scan sonar imagery in the PAA with images of representative ground-truthing sites. No Hardbottom was found in the 2019 field investigations.

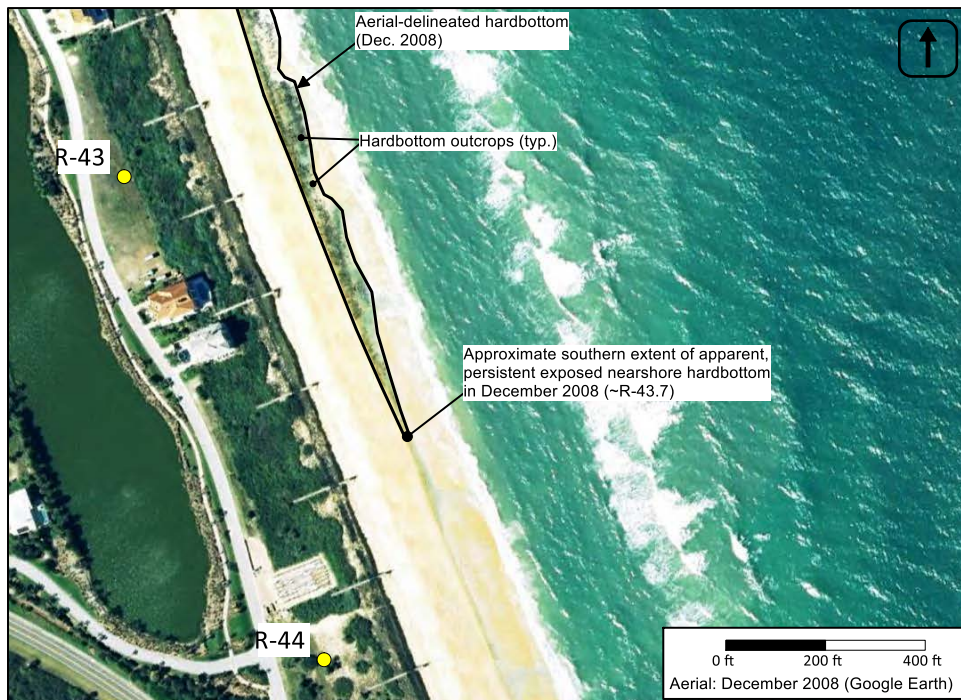
Figure 21.9a: Approximate southerly extent of apparent, persistent exposed nearshore hardbottom in December 2008.

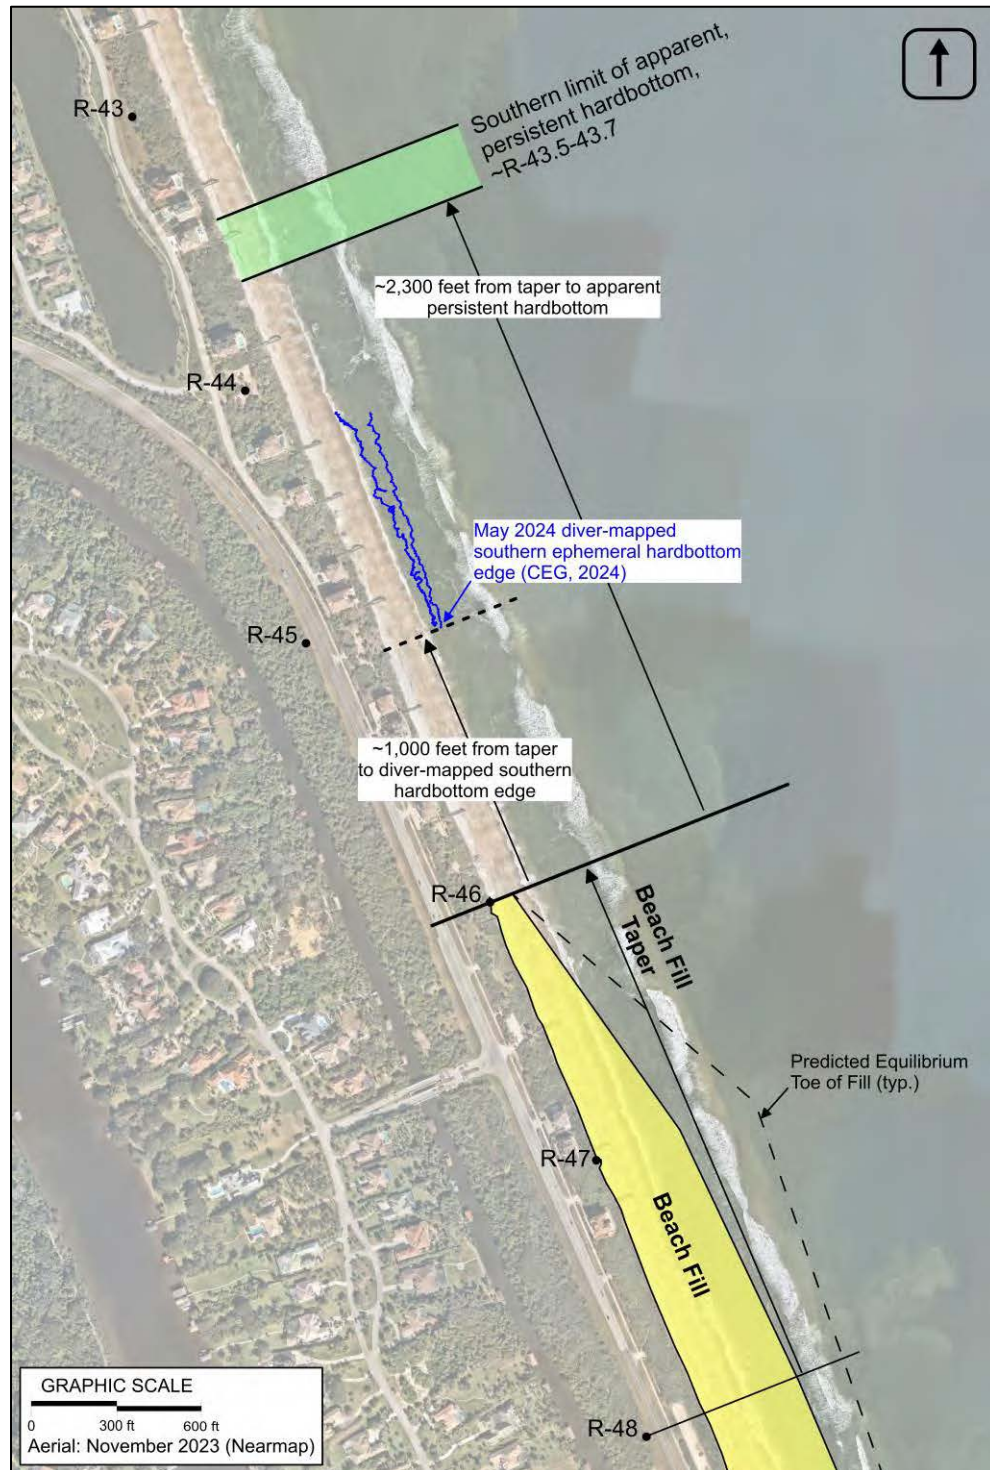
Figure 21.10: Location of May 2024 diver-mapped southern ephemeral hardbottom edge (mapped by Coastal Eco Group, Inc.) and southerly limit of apparent persistent hardbottom at approximately R-43.5 relative to the proposed beach fill northern taper.
