Survey Report for US Wind, Inc.

High Resolution Geophysical, Geotechnical, and Environmental Survey Report

US Wind Export Cable Route Survey Offshore Maryland and Indian River Bay, Delaware

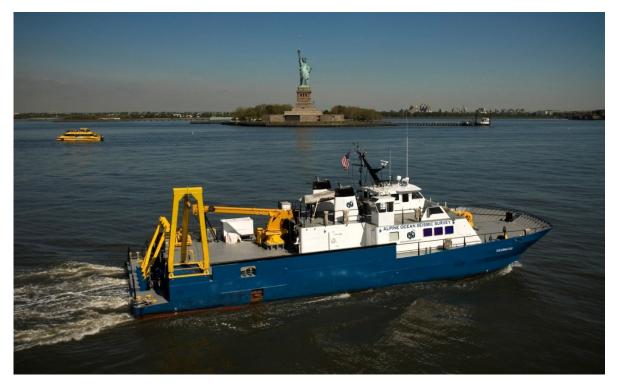
Figure 2.1 Vessel RV Shearwater

RV Shearwater Vessel Specifications		
Class	Multi-Role Survey	
Flag	USA	
Built	1981 (reconfigured 2011)	
Length OA	33.5m	
Breadth OA	11.9m	
Draft	2.7m	
GT	198t	
Endurance	21 days (nominal)	
Main Engine	2 x 526 HP John Deere Model 6125AFM	
Bow thrust/Stern Thrust	Thrustmaster 100 HP / Hydraulically Driven "Z" Drives	
Accommodation	20 Berths

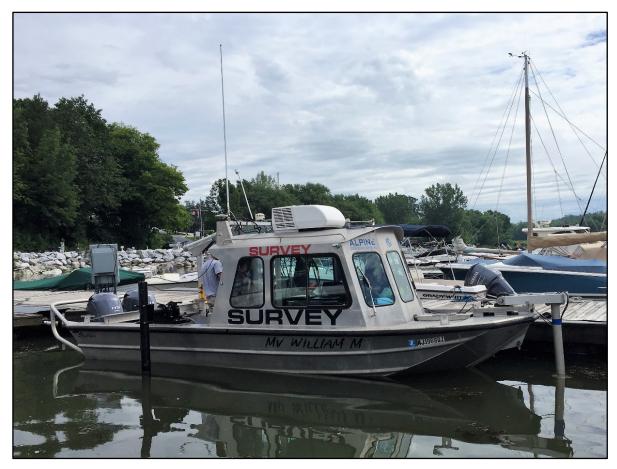
Figure 2.2 Vessel MV William M

MV William M Vessel S	Specifications	Performance	
LOA	22 ft.	Top Speed	30 kts
Beam	8 ft.	Cruise	25 kts
Draft	2 ft.	Range	100 nm
Fresh Water Capacity	N/A	Generator	3kW
Power	Twin Yamaha 115	Fuel Capacity	60 Gal

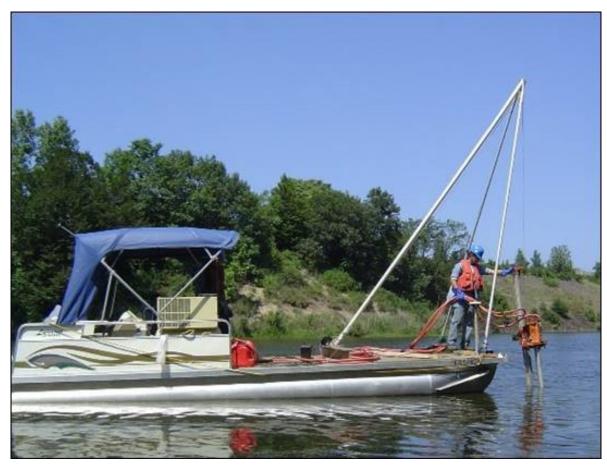
Figure 2.3 Vessel MV George

MV George Vessel Sp	ecifications	Performance	
LOA	24 ft.	Top Speed	20 kts
Beam	8 ft.	Cruise	15 kts
Draft	2.5 ft.	Range	50 nm
Fresh Water Capacity	N/A	Generator	3kW
Power	Mercury 115 HP	Fuel Capacity	20 Gal
