Submitted by: **Dominion Energy Services, Inc.** 707 E. Main Street, Richmond, VA 23219 Prepared by: **Tetra Tech, Inc.** 4101 Cox Road, Suite 120 Glen Allen, VA 23060 Submitted To: **Bureau of Ocean Energy Management**45600 Woodland Road
Sterling, VA 20166

Project Coastal Virginia Offshore Wind Commercial Project

Wetland Delineation Report – Naval Air Station Oceana

Coastal Virginia Offshore Wind Project, Virginia Beach, Virginia

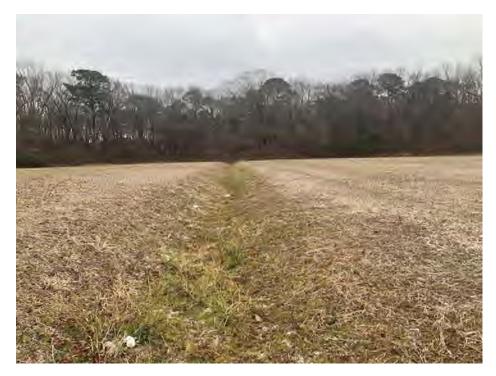
noa001

Redox (S5)		Piedmont Fl							
	Matrix (S6)						A 149A, 153C	, 153D)		
☐ Dark Su	rface (S7) (LRR P,	S, T, U)								
Restrictive	Layer (if observed):								
Type: Dr	ain tile									
Depth (in	ches): 4.0 in						Hydric Soil	Present?	Yes	No X
Remarks:	· ·						1			<u> </u>

Facing East

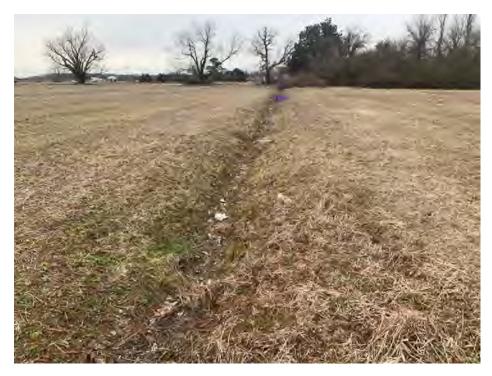
noa002

Gleyed Matrix (S4)	-,-,	Reduced Ve			0A, 150B)				
	Redox (S5)		Piedmont Flo							
	Matrix (S6)						RA 149A, 153C	, 153D)		
☐ Dark Su	rface (S7) (LRR P,	S, T, U)		_						
Restrictive	Layer (if observed):								
Type: Dr	ain tile									
Depth (in	ches): 4.0 in						Hydric Soil Present? Yes No X			
Remarks:										
D	rain tile prese	ent at 4 in	ches likely of	due to d	lrainin	g Agric	ultural fiel	ds.

Facing North

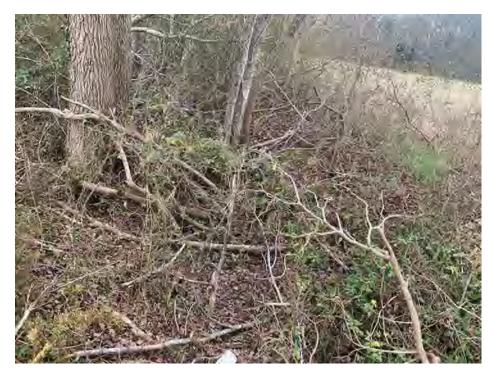
noa003

ark Surface (A12)		Iron-Mangan	ese Masse	es (F12) (LRR O, P,					
	rairie Redox (A16)					', U)		wetland hydrology must be present,			
	Mucky Mineral (S1)	(LRR O, S)	Delta Ochric	(F17) (ML	.RA 151)		unl	ess disturbed or problematic.			
Sandy C	Gleyed Matrix (S4)		Reduced Ve	rtic (F18) (MLRA 15	60A, 150B))				
Sandy F	Redox (S5)		Piedmont Flo	oodplain S	oils (F19)	(MLRA 14	49A)				
Stripped	d Matrix (S6)		Anomalous E	Bright Loar	ny Soils (F20) (MLF	RA 149A, 153C	c, 153D)			
Dark Su	ırface (S7) (LRR P,	S, T, U)									
	Layer (if observed):									
Type: Dr	ain tile										
Depth (in	ches): 6.0 in						Hydric Soil Present? Yes No X				
Remarks:	,										
	rain tile prese	ent at 6 ir	nches likely o	lue to c	drainin	a Aaric	ultural fiel	ds.			
_			,			3 - 3

Facing East

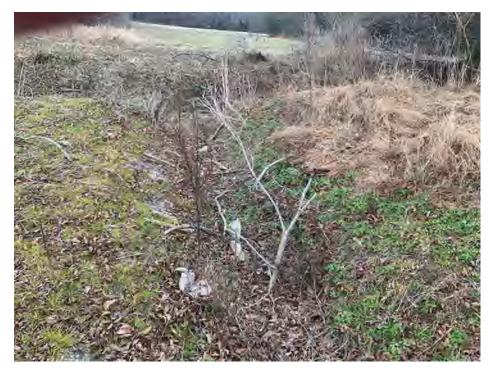
noa004

_	Gleyed Matrix (S4)	-,-,	Reduced Ve			0A, 150B)				
_	Redox (S5)		Piedmont Fl							
	d Matrix (S6)						A 149A, 153C	, 153D)		
☐ Dark Su	ırface (S7) (LRR P,	S, T, U)		-						
Restrictive	Layer (if observed):								
Type: Dr	ain tile									
Depth (in	ches): 4.0 in						Hydric Soil	Present?	Yes	No X
Remarks:							1			
D	rain tile prese	ent at 4 in	ches likely of	due to d	raining	g Agric	ultural fiel	ds.		
			_

Facing East

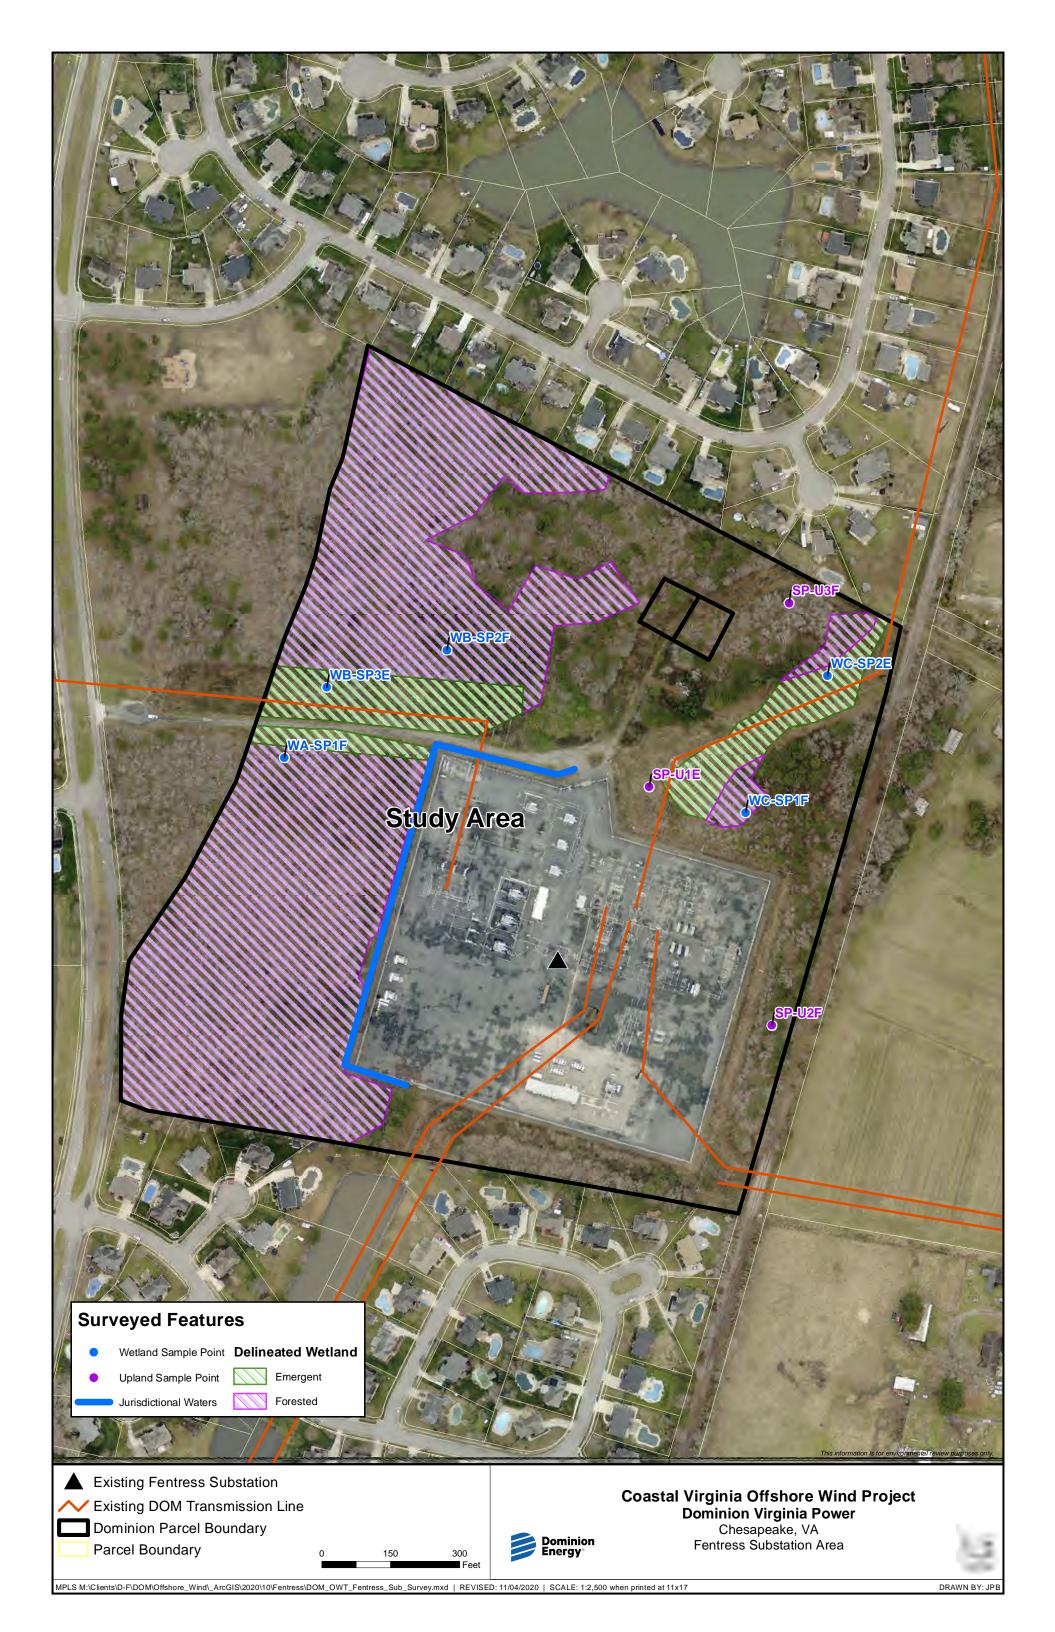
Photo 1: View looking east at palustrine forested (PFO) wetlands at the Site from wetland data point WA-SP1F.

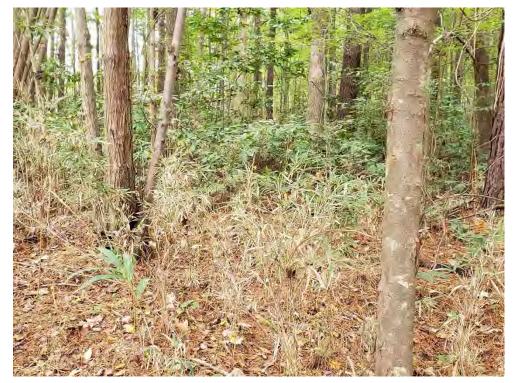
Photo 1: View looking east at palustrine forested (PFO) wetlands at the Site from wetland data point WA-SP1F.
