Observing Cable Laying and Particle Settlement During the Construction of the Block Island Wind Farm

US Department of the Interior
Bureau of Ocean Energy Management
Office of Renewable Energy Programs

March 2017

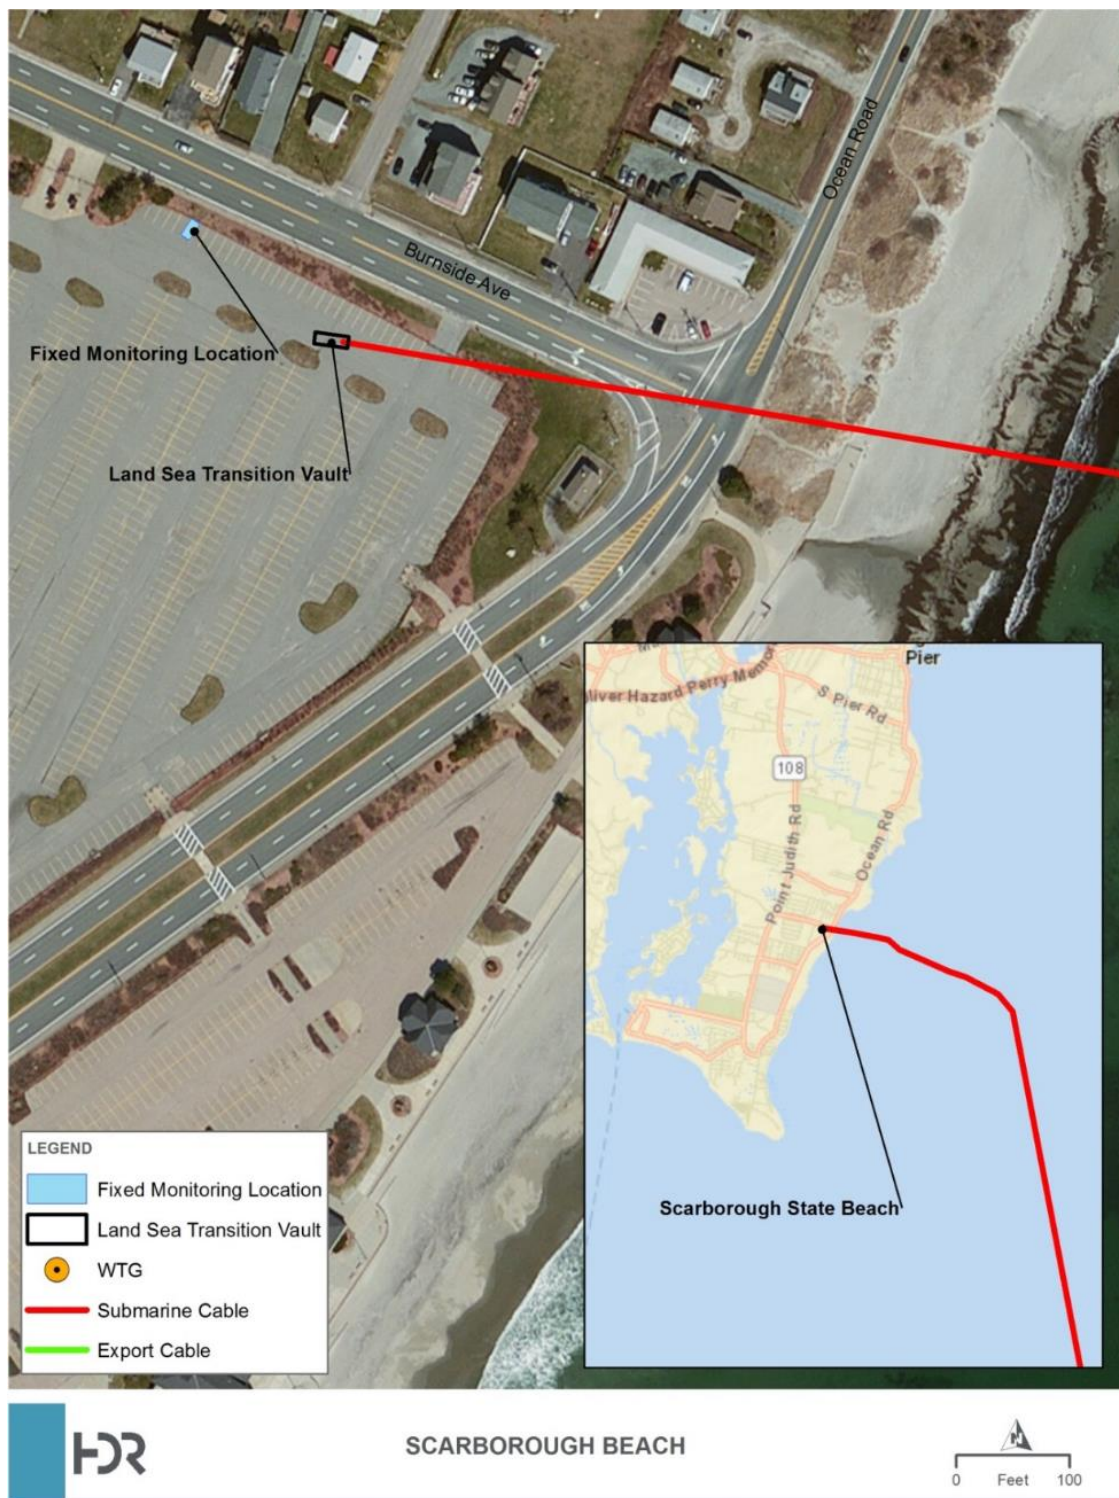
Figure 7. Onshore Monitoring Scarborough State Beach

Figure 7 below shows monitoring position on the mainland at Scarborough State Beach parking lot utilized for monitoring and the cable transition to land. The land sea transition vault was a rectangle shaped hole dug in the parking lot used to connect the BITS cable to the terrestrial cable. An underground conduit for the BITS cable at the beach and the intersection of Ocean Road and Burnside Avenue was already complete upon the team's arrival.

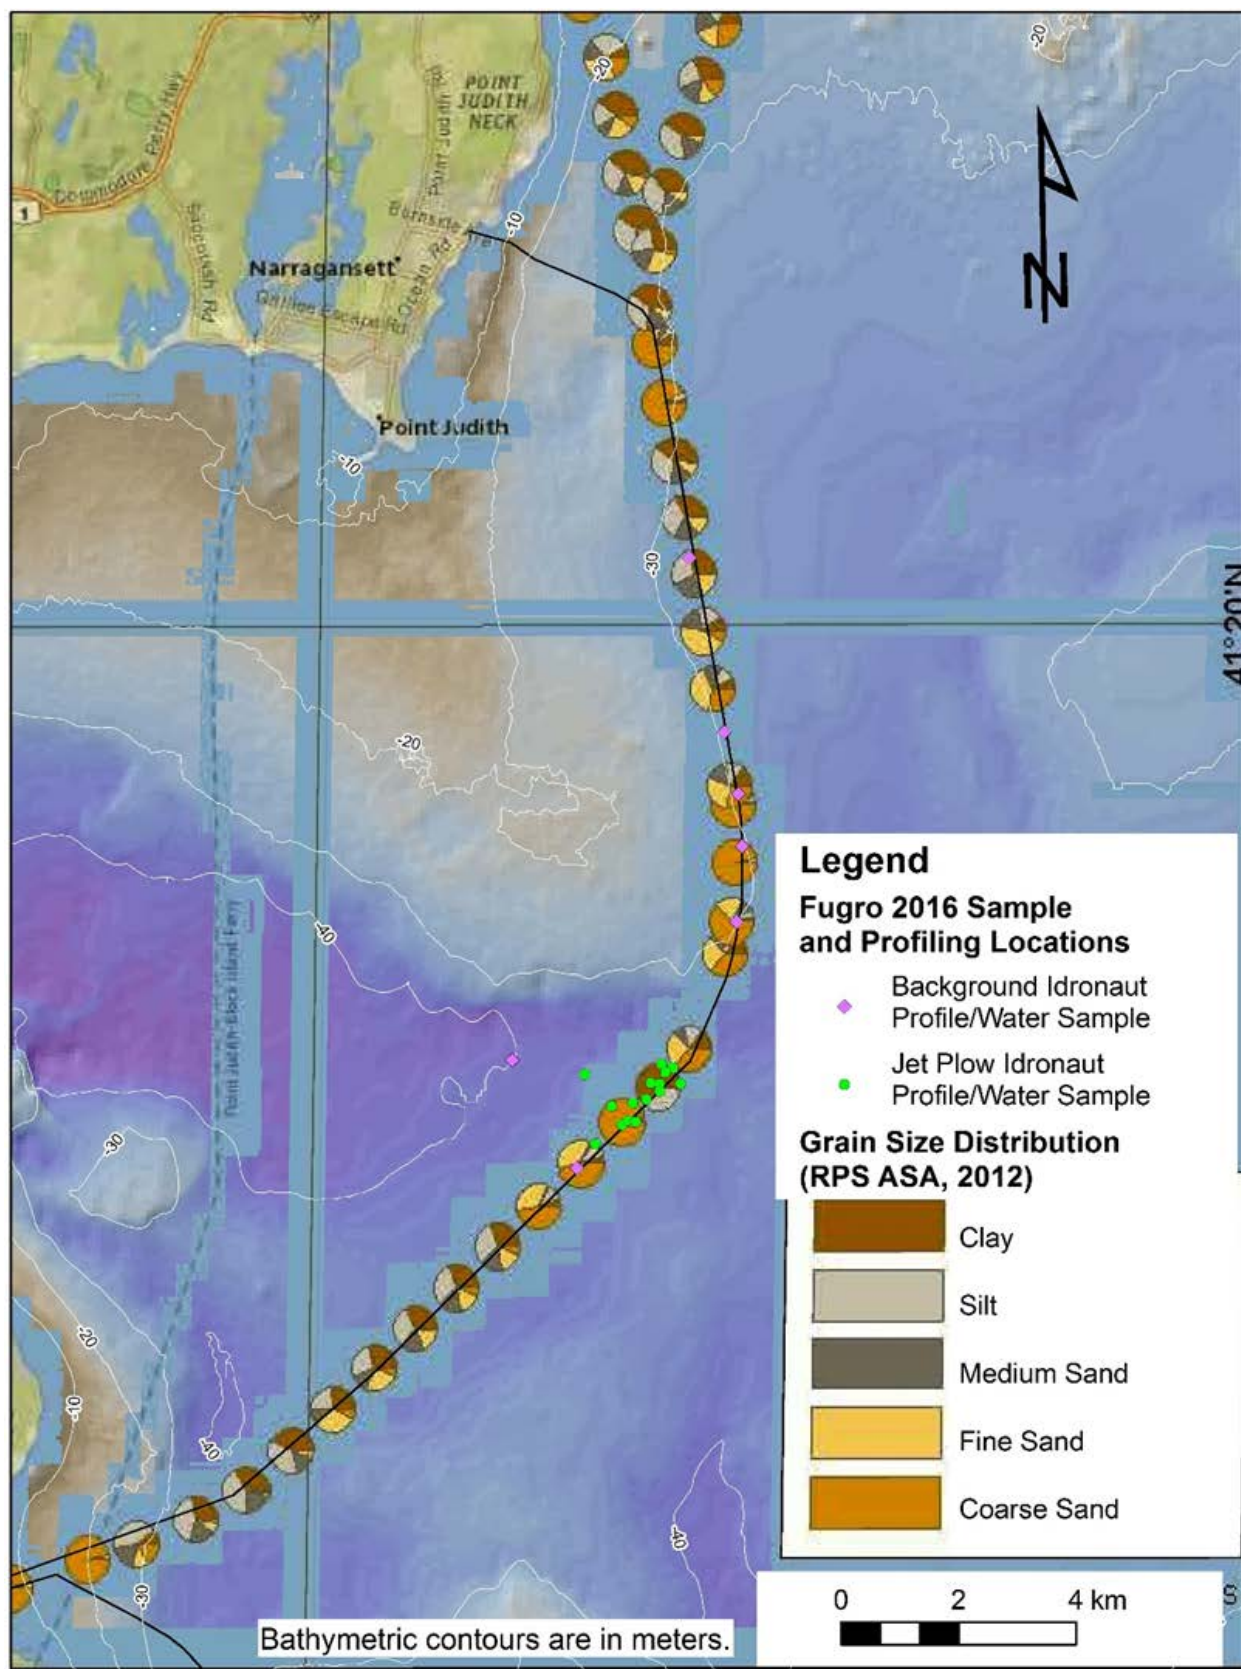
Figure 14. Seafloor sediment characteristics along cable route.

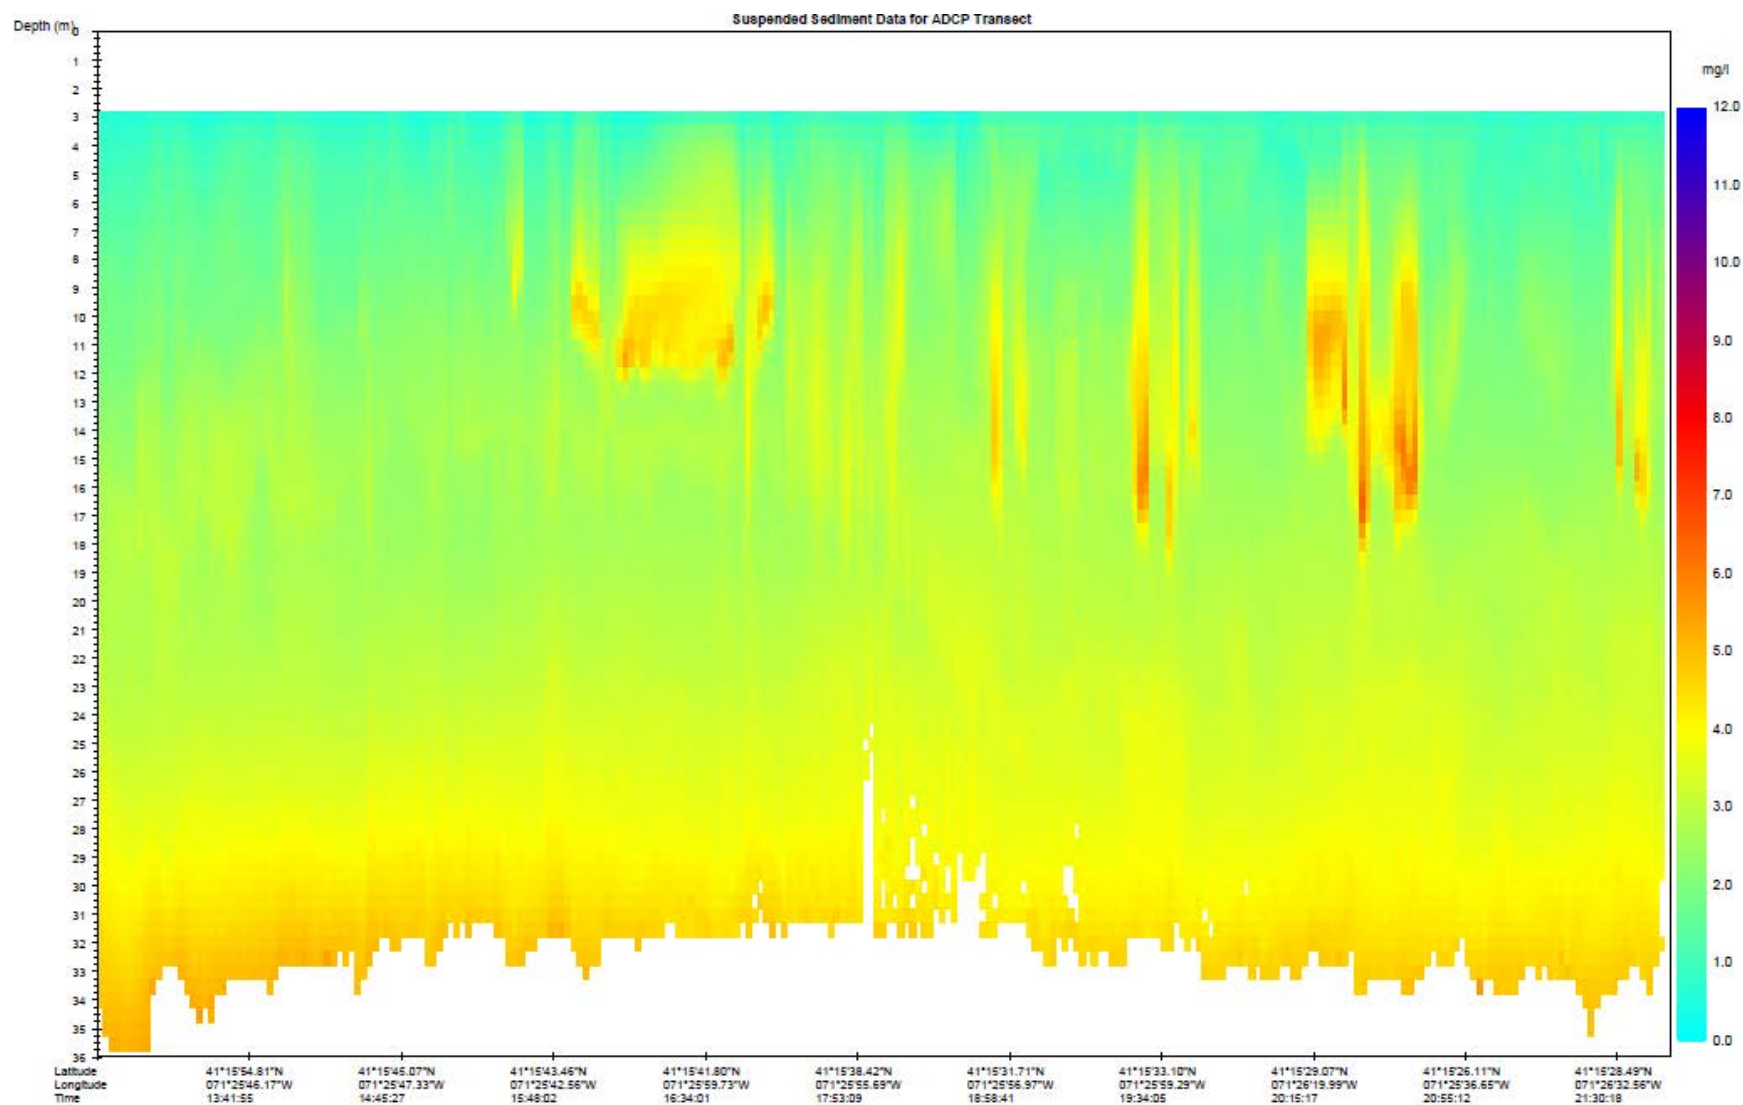
Figure 23. ADCP data showing increased turbidity as a result of instrumentation passing vessel thrusters

Elevated levels of acoustic signal return were observed in both the ADCP and multibeam echosounder (MBES) datasets down to approximately 16 m depth when the instruments passed by the dynamic positioning thrusters from the Big Max. The ADCP data shown in **Figure 23** illustrate this. Increased suspended sediment concentrations were not observed in the Idronaut profiles suggesting that this acoustic return was caused by bubbles rather than sediment. This turbulence on site was photographed and is displayed in **Figure 24**.

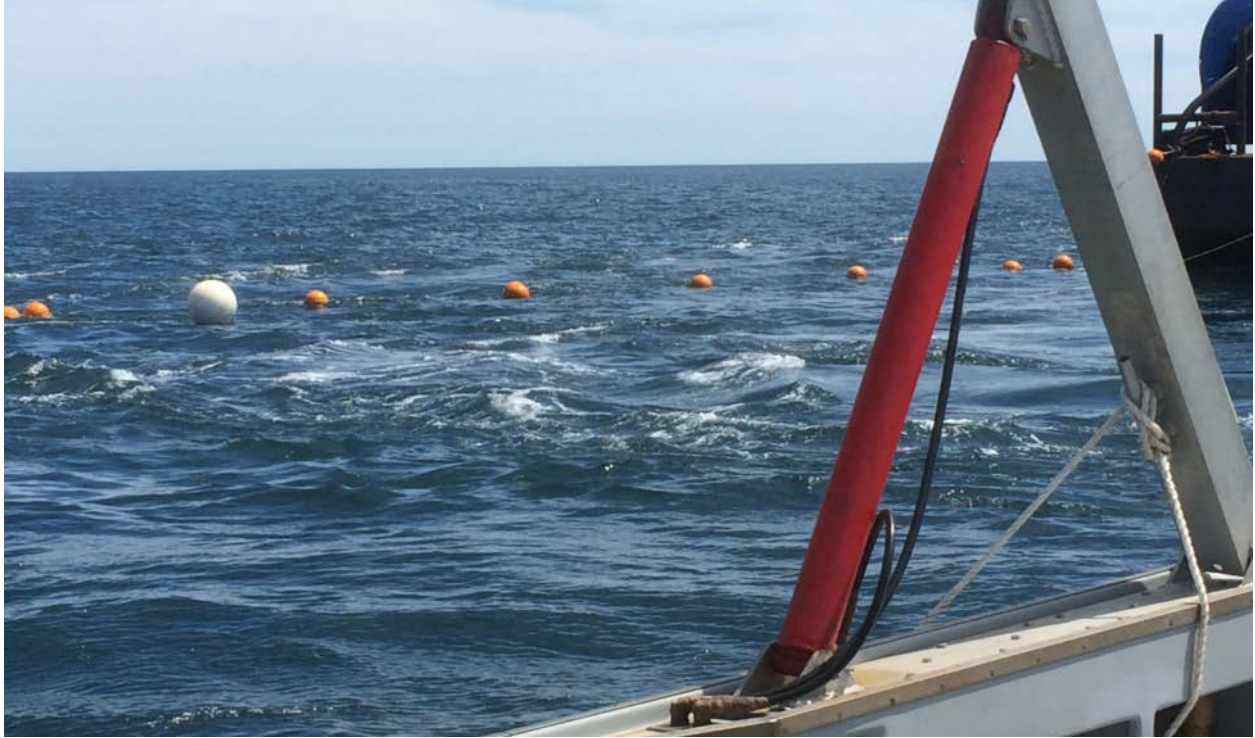
Figure 24. Turbulence around the jet plow caused by vessel thrusters

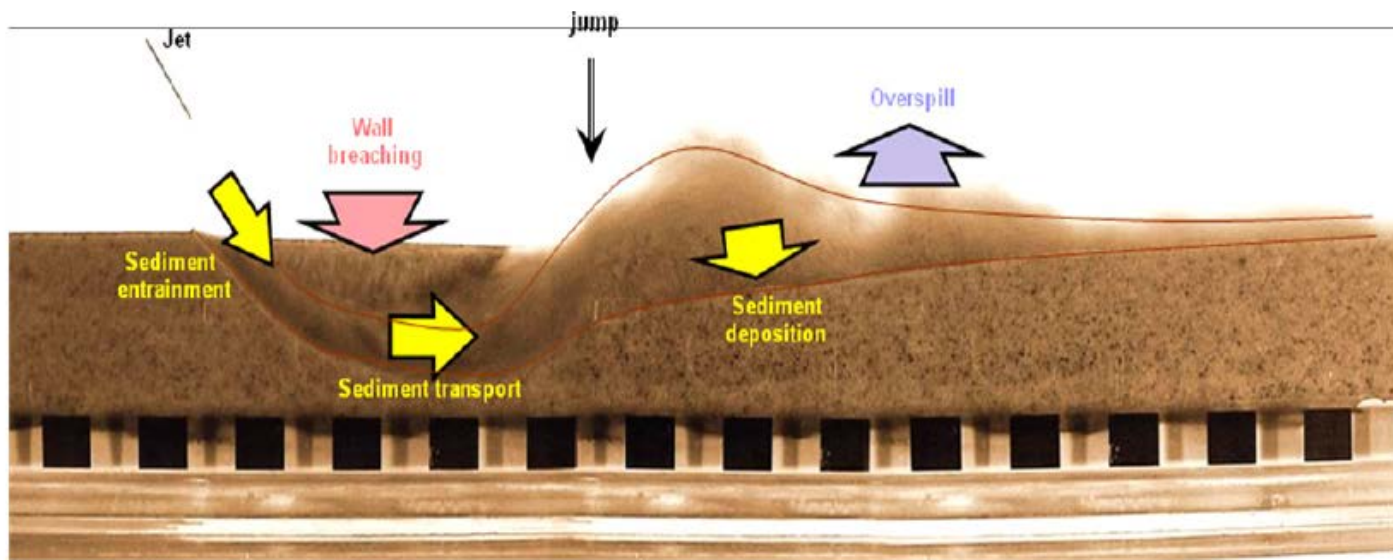
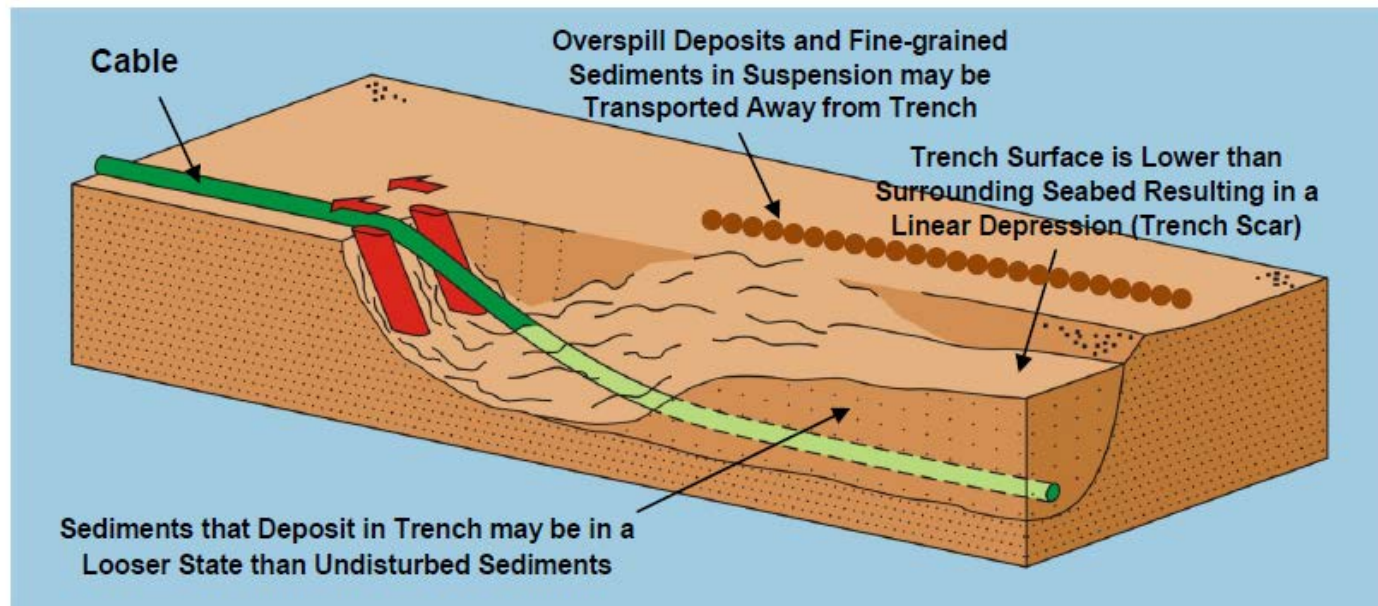
Figure 28. Schematic of jet-trenching process and trench morphology

2. Lateral Processes. Lateral processes include erosion by the breaching and collapse of the trench side walls. This will occur to a greater extent in looser sediments and those with lower fines contents. Overspill occurs beyond the internal hydraulic jump once the upper boundary of the turbid current exceeds the trench wall. Once the turbid water rises above the trench wall, the plume expands laterally, and some sediment will redeposit outside the trench. The amount of sediment that deposits outside the trench will largely depend on the sediment particle sizes,

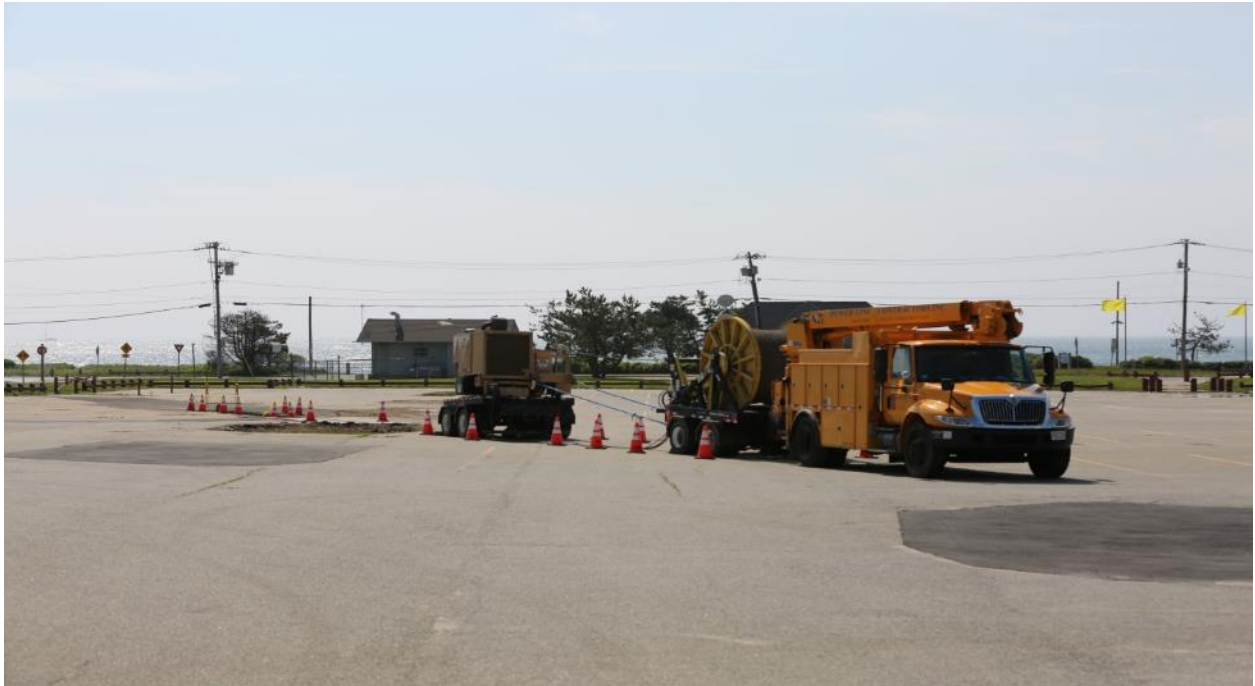
6/6/2016 Scarborough Beach State Park – Photo 0074: Utility truck, winch spool, and winch prepared for BITS cable pull to shore. The land sea transition vault is surrounded by cones.

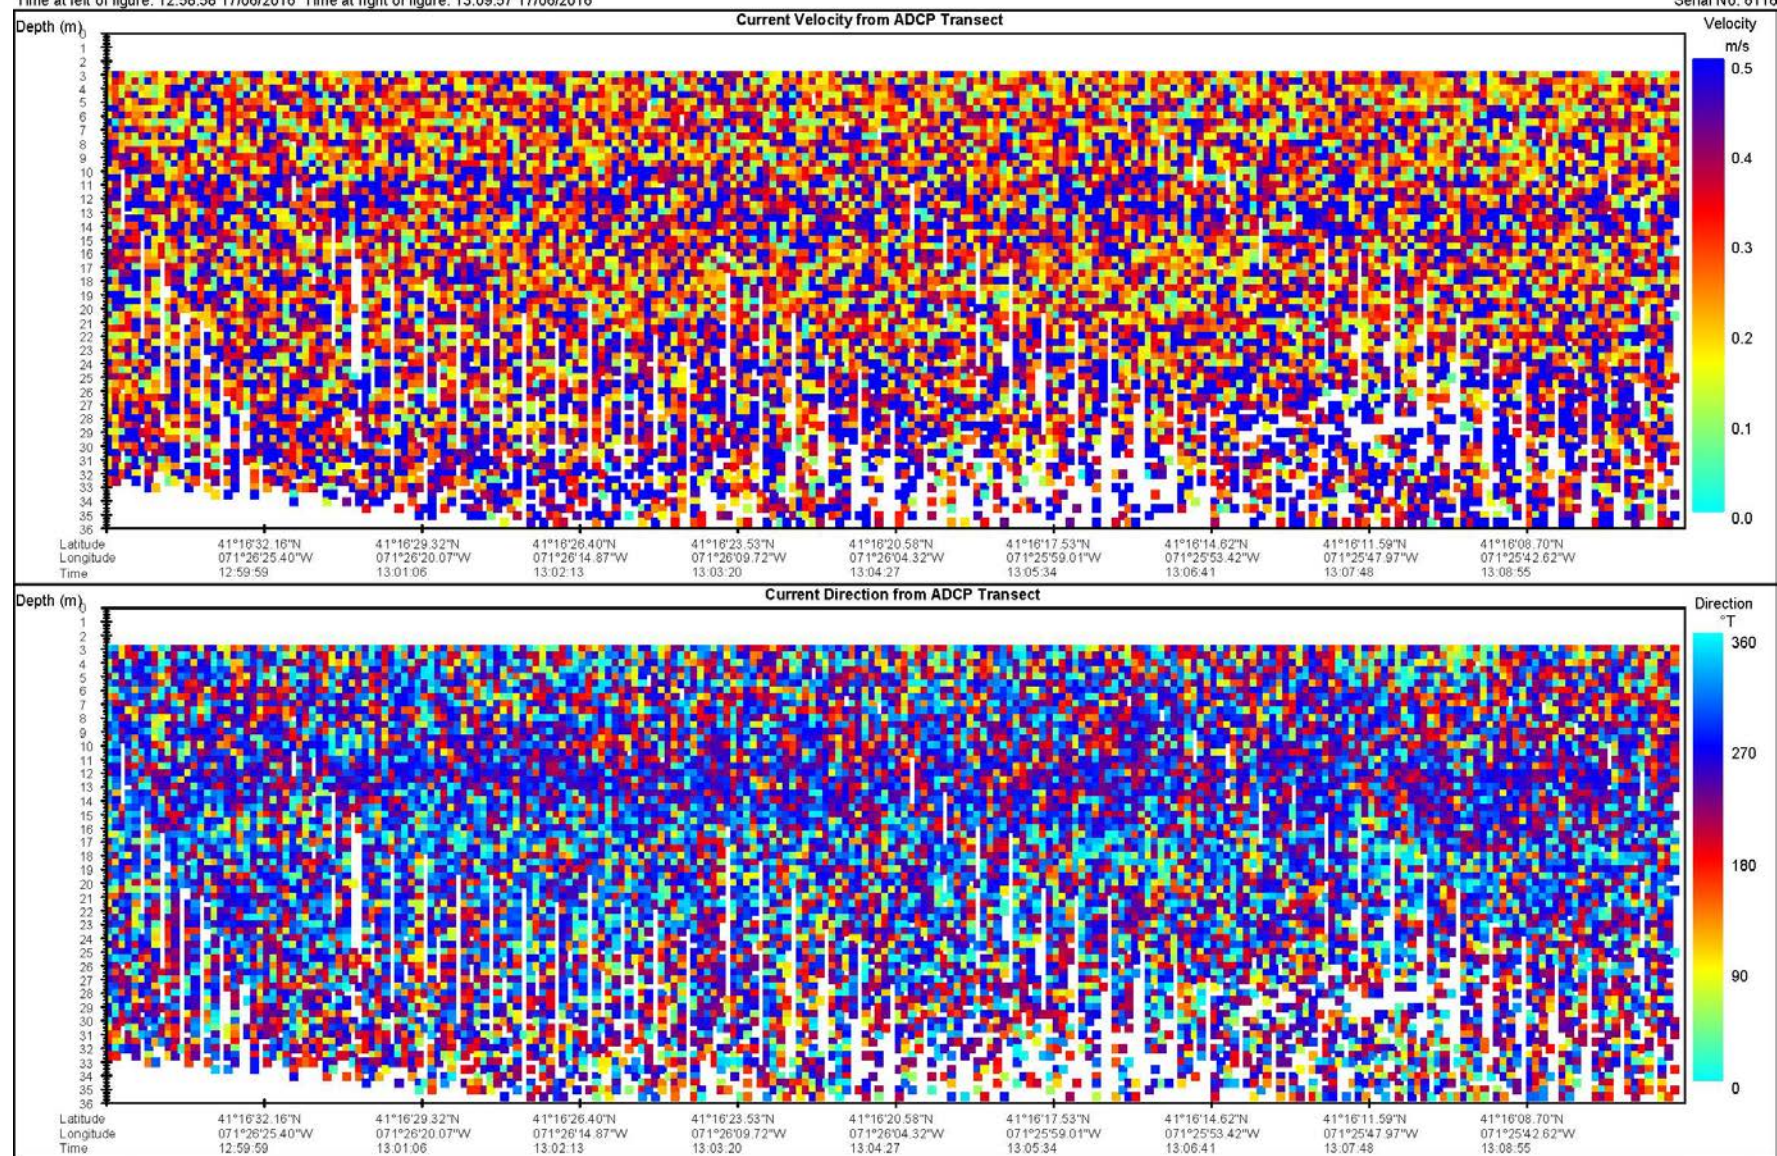
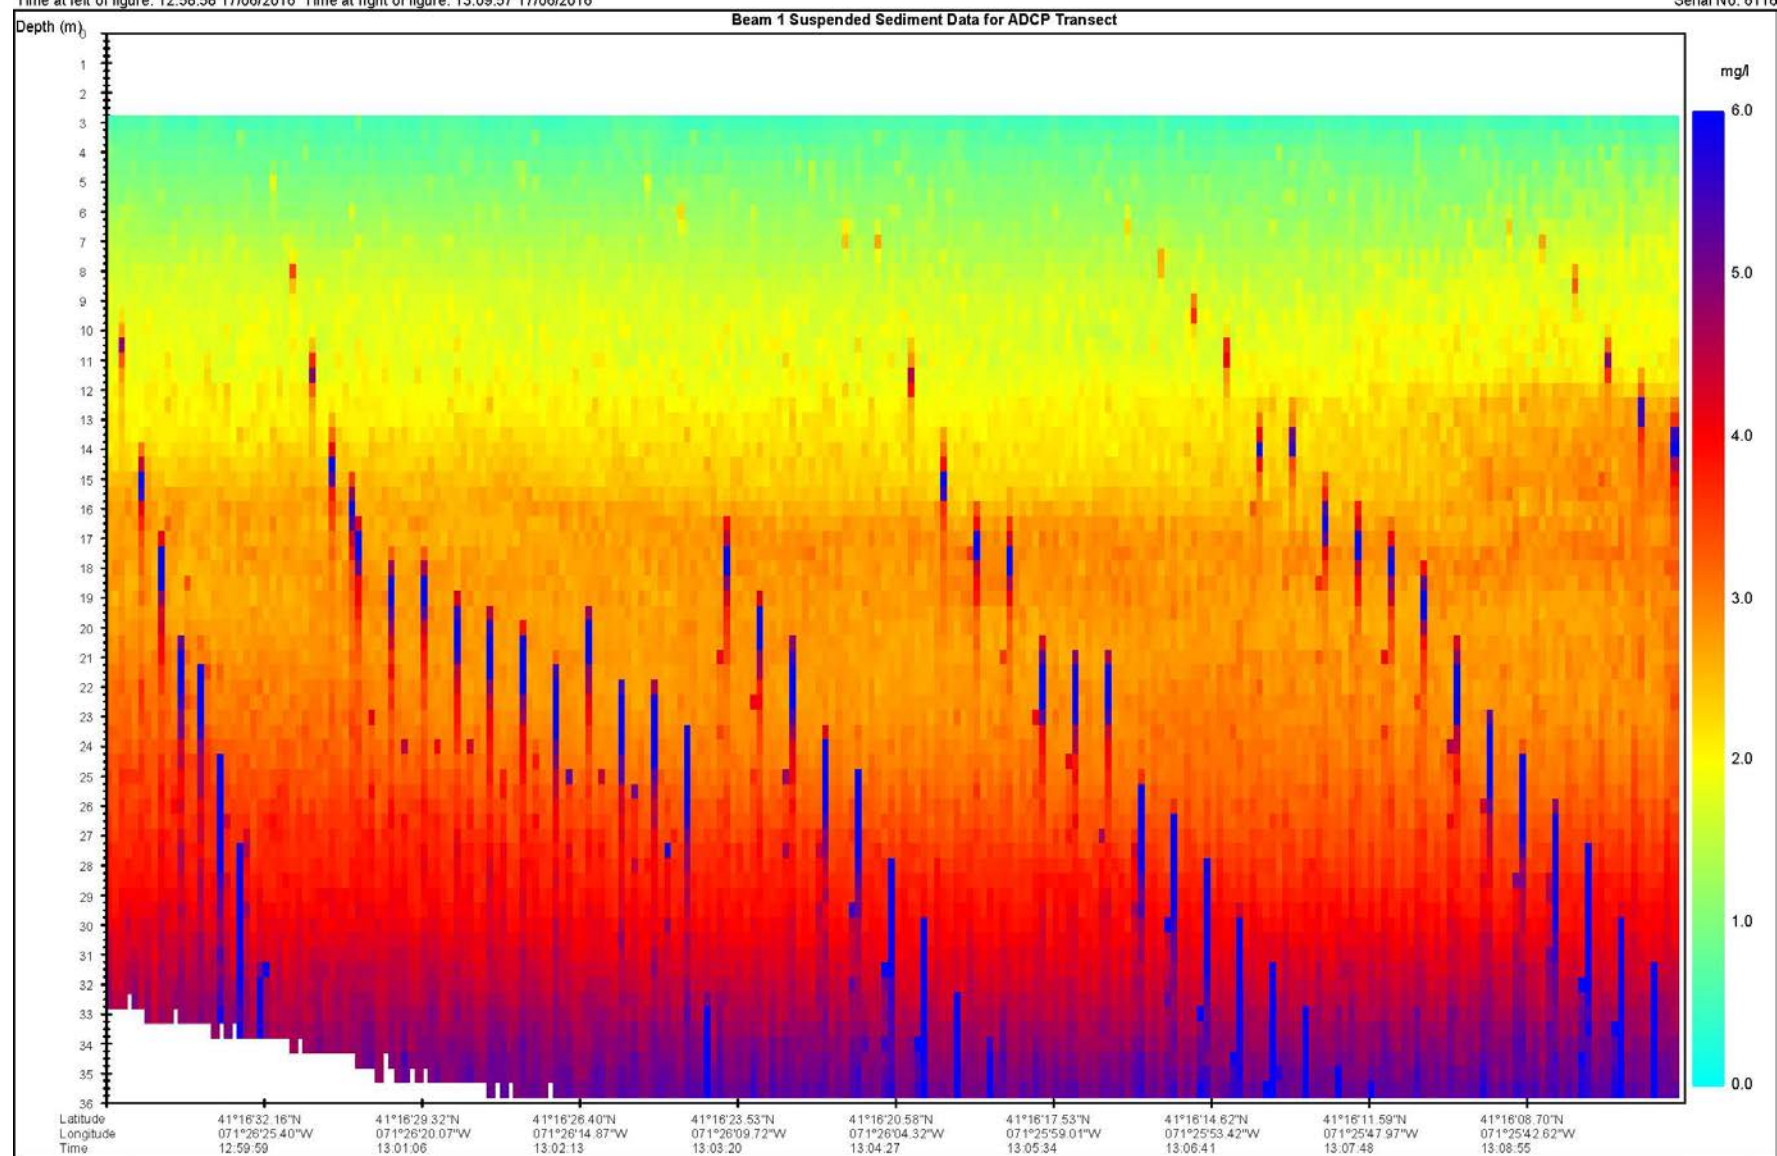
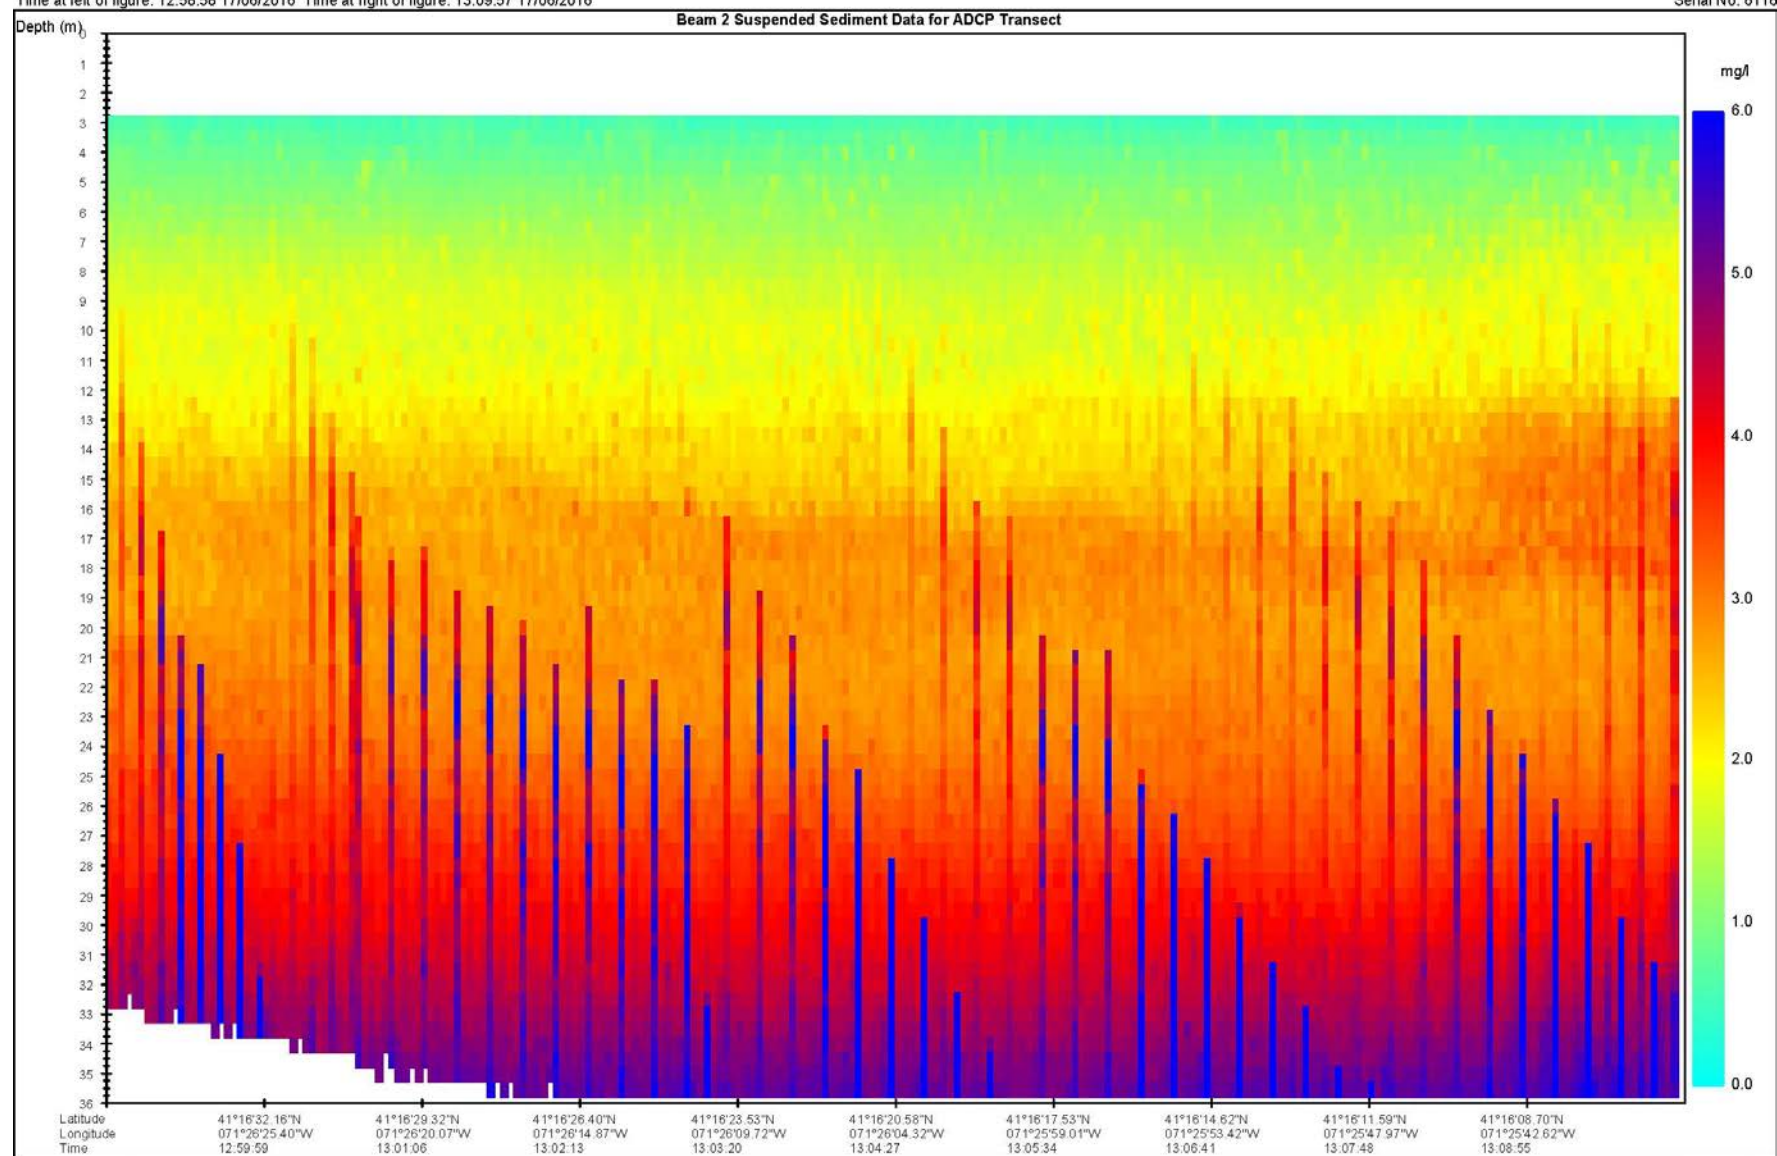
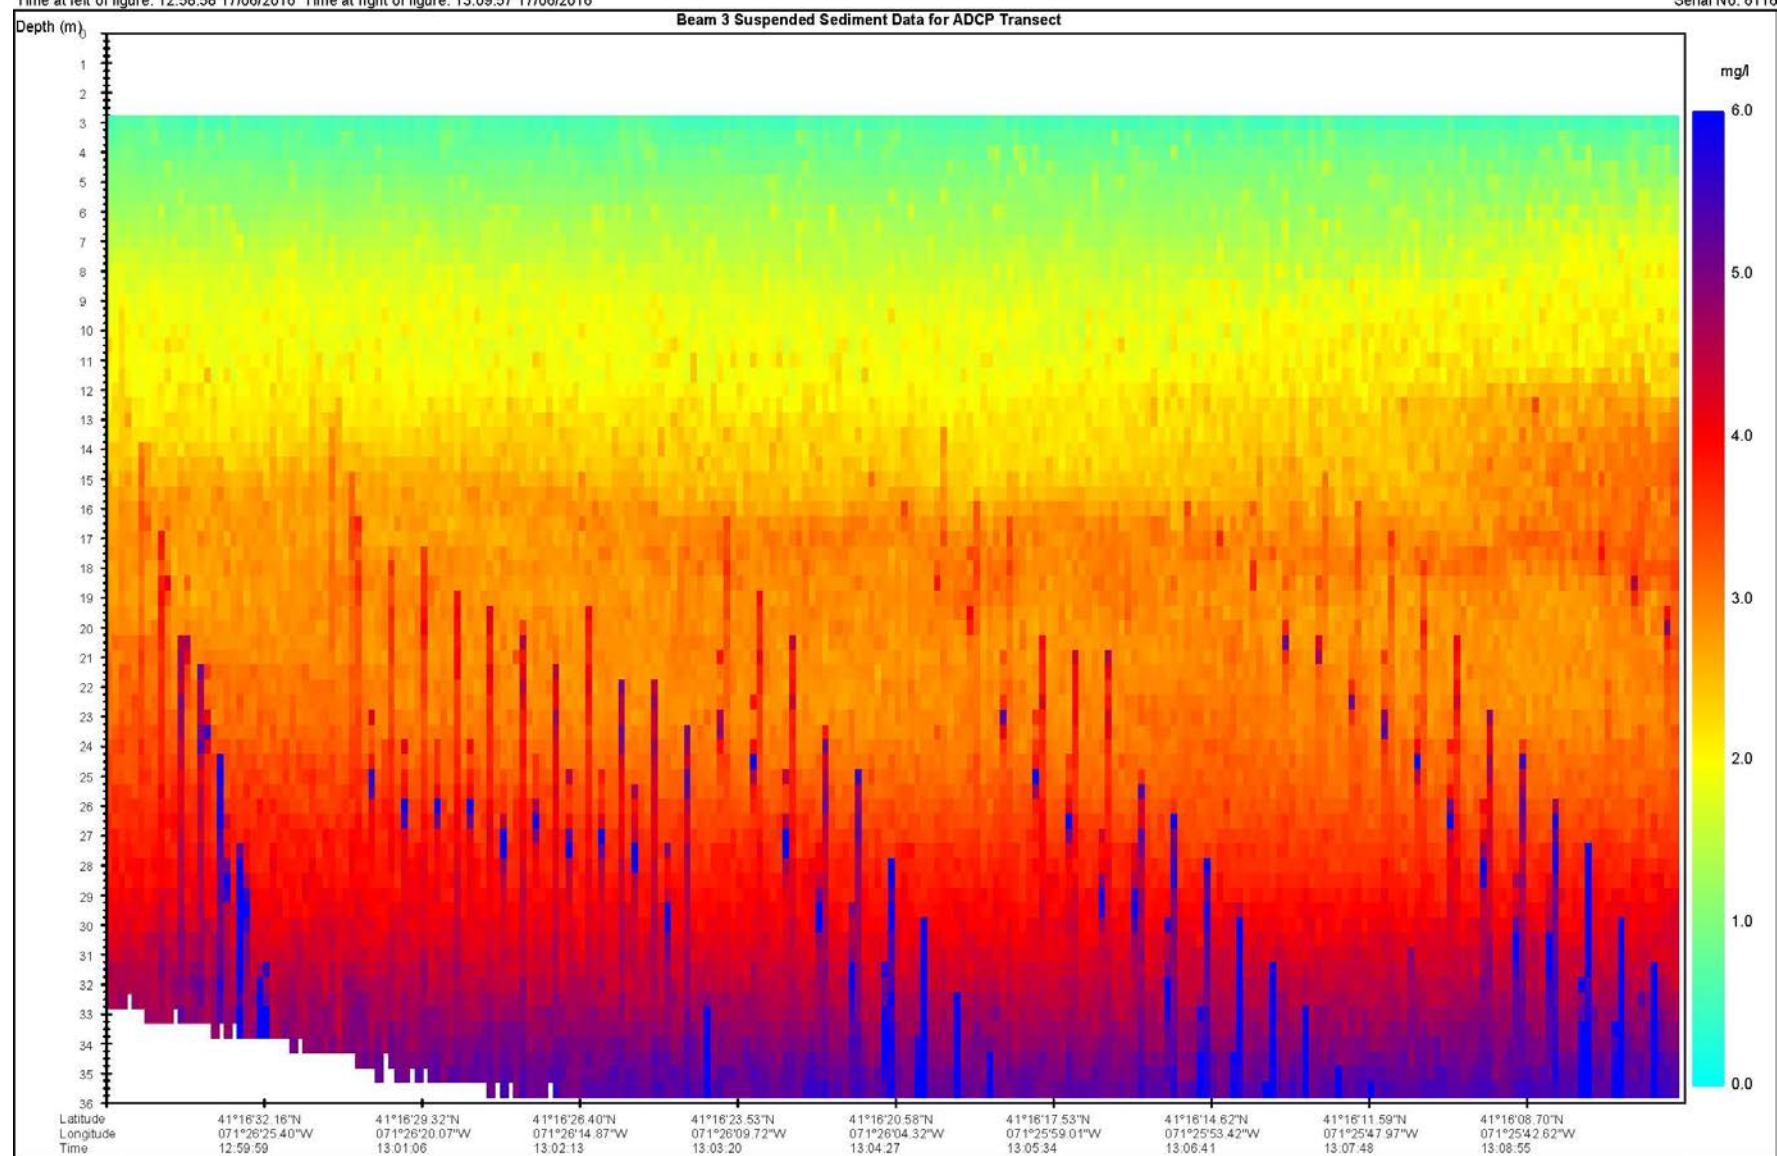
Transect Start: Lat: 41°16'34"N Long: 071°26'30"W Transect End: Lat: 41°16'06"N Long: 071°25'37"W
 Time at left of figure: 12:58:58 17/06/2016 Time at right of figure: 13:09:57 17/06/2016

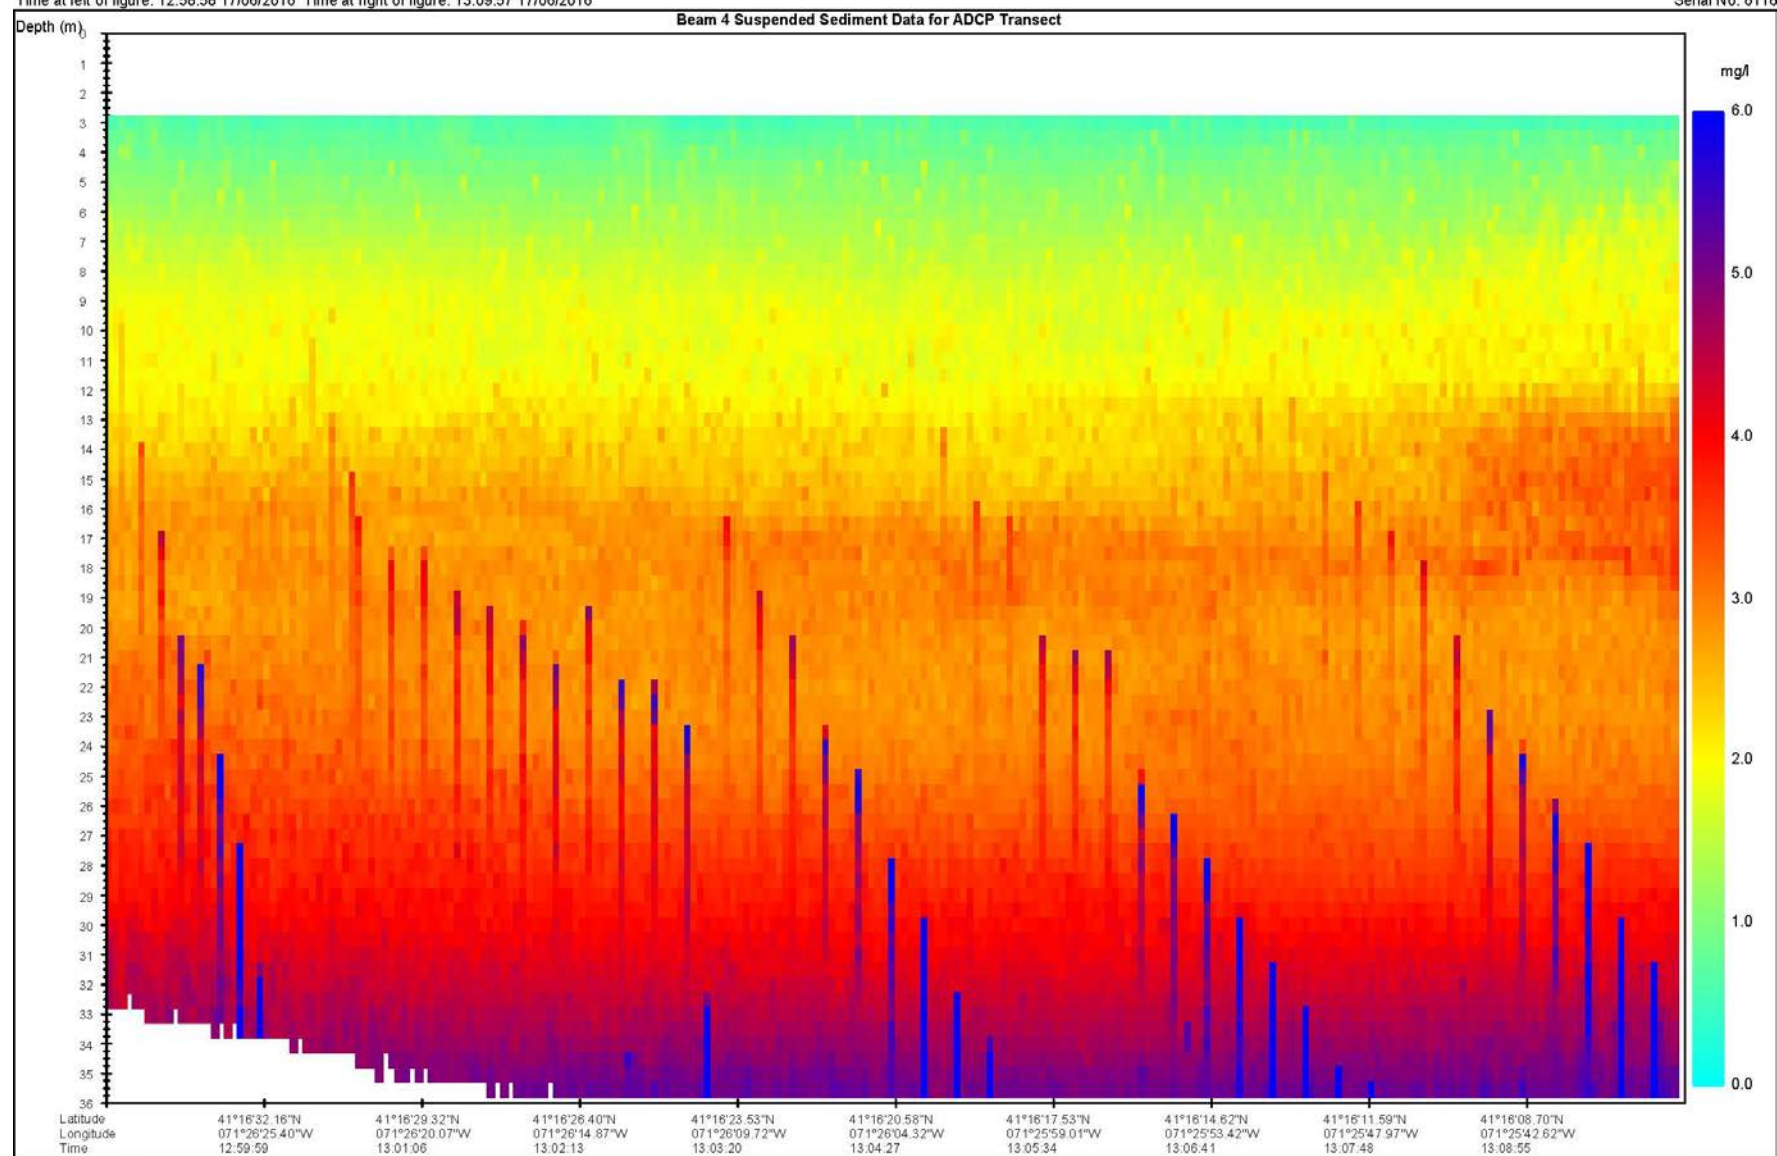
Colour Contour Plots of Current Speed and Direction Block Island Sediment Plume Monitoring, Jet Plow 2
