Observing Cable Laying and Particle Settlement During the Construction of the Block Island Wind Farm

US Department of the Interior
Bureau of Ocean Energy Management
Office of Renewable Energy Programs

March 2017

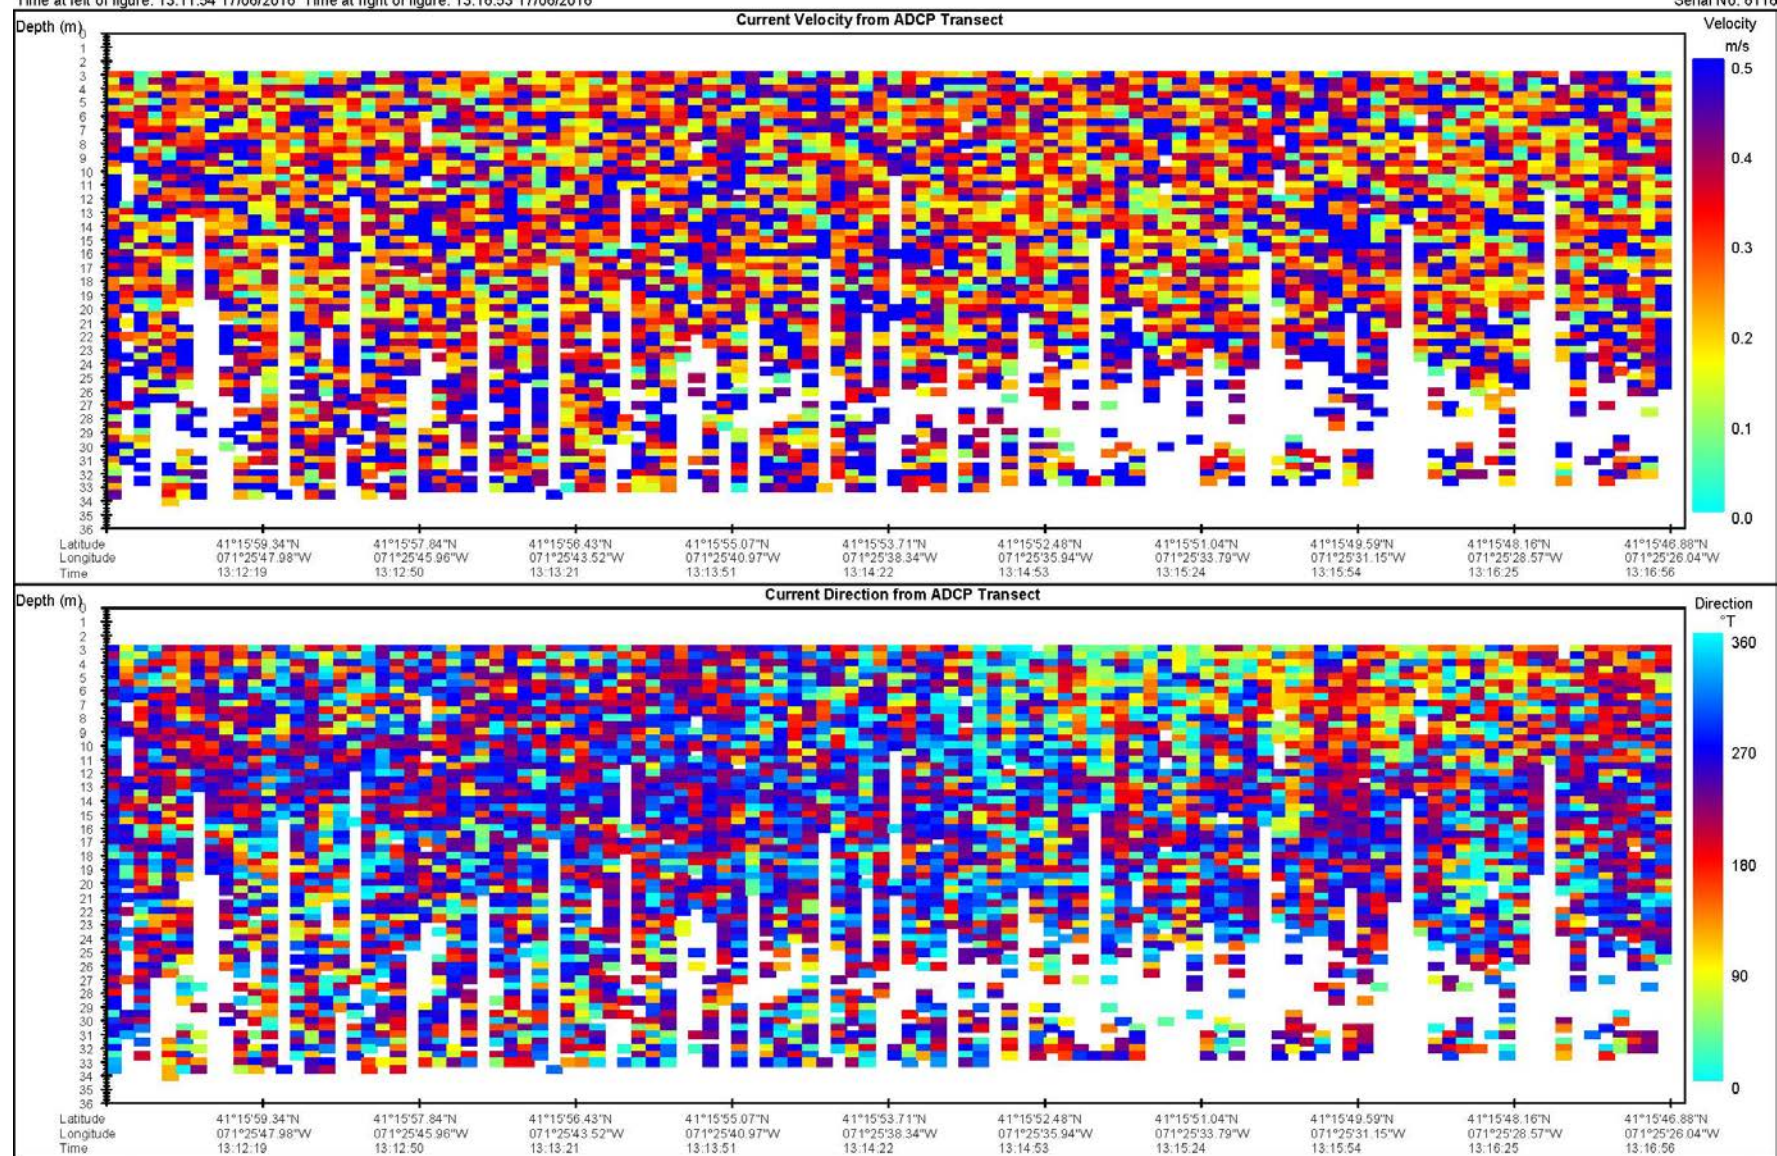
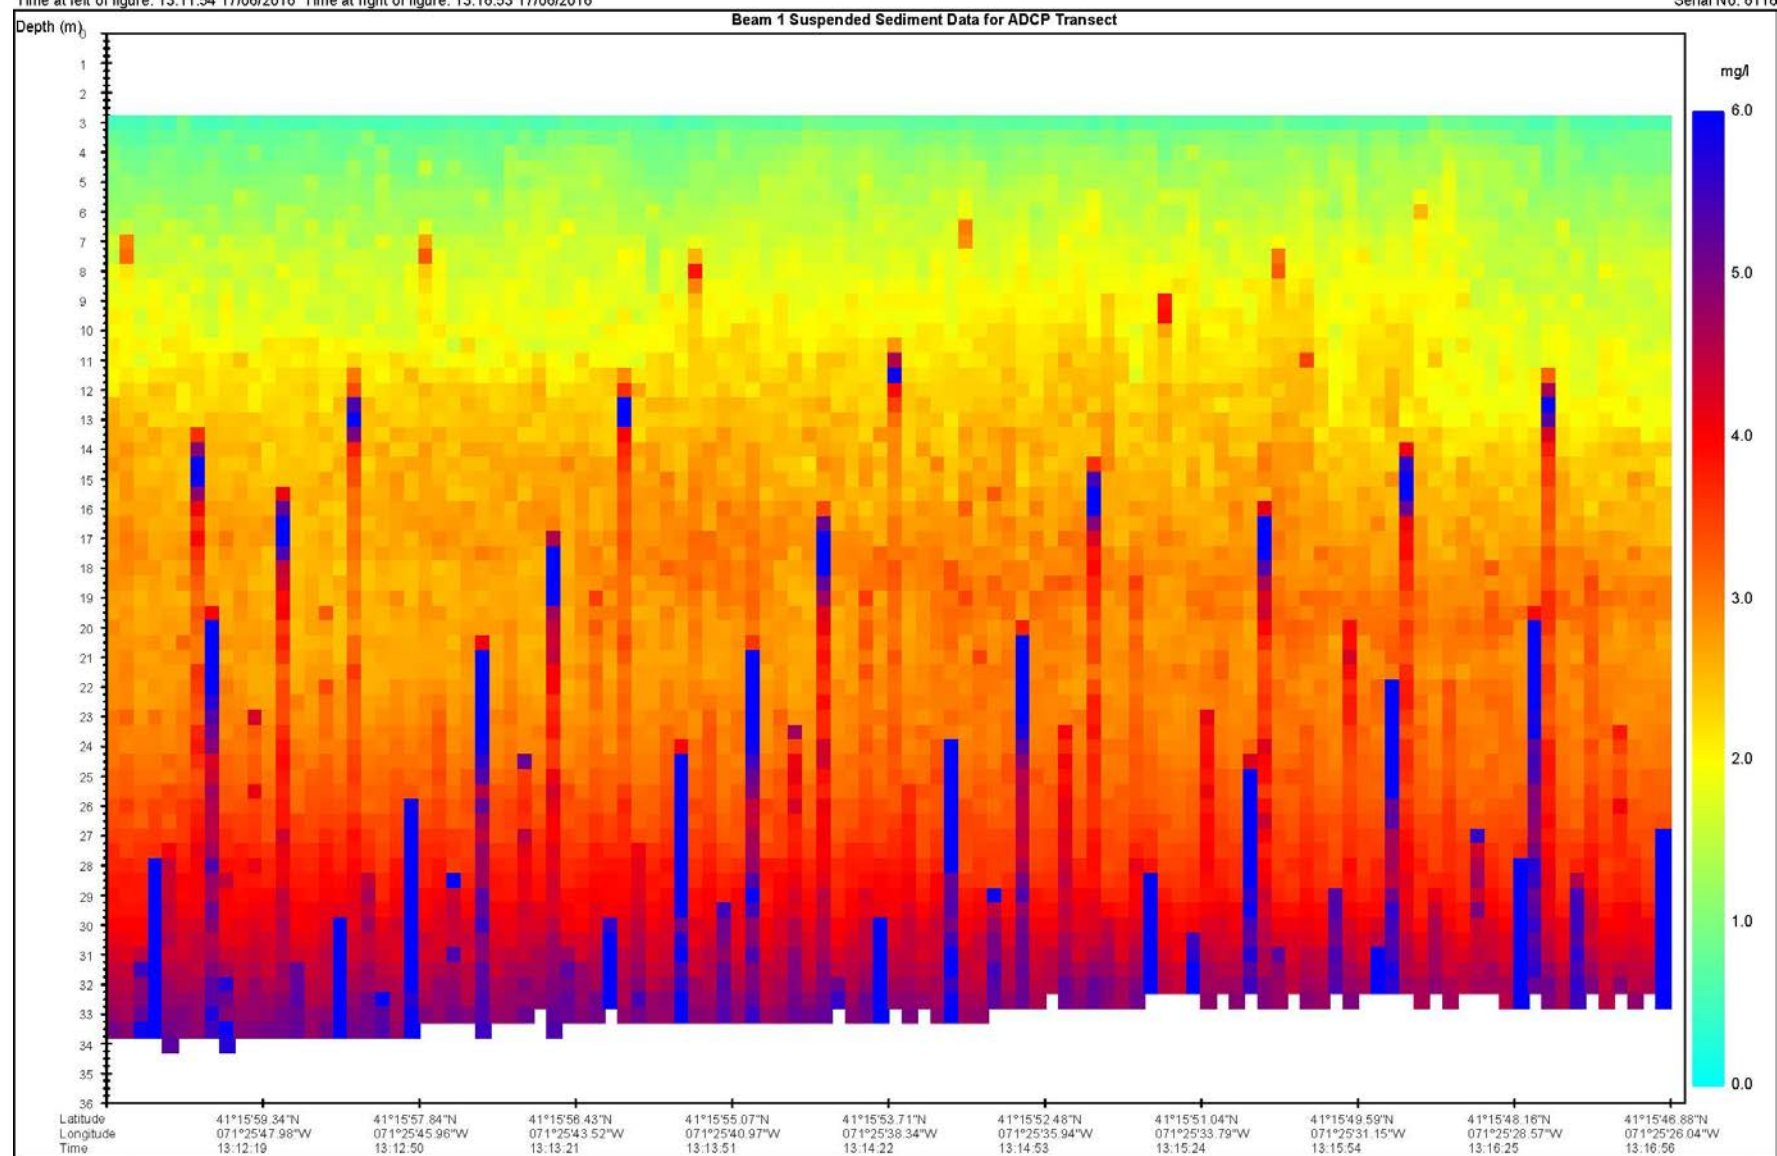
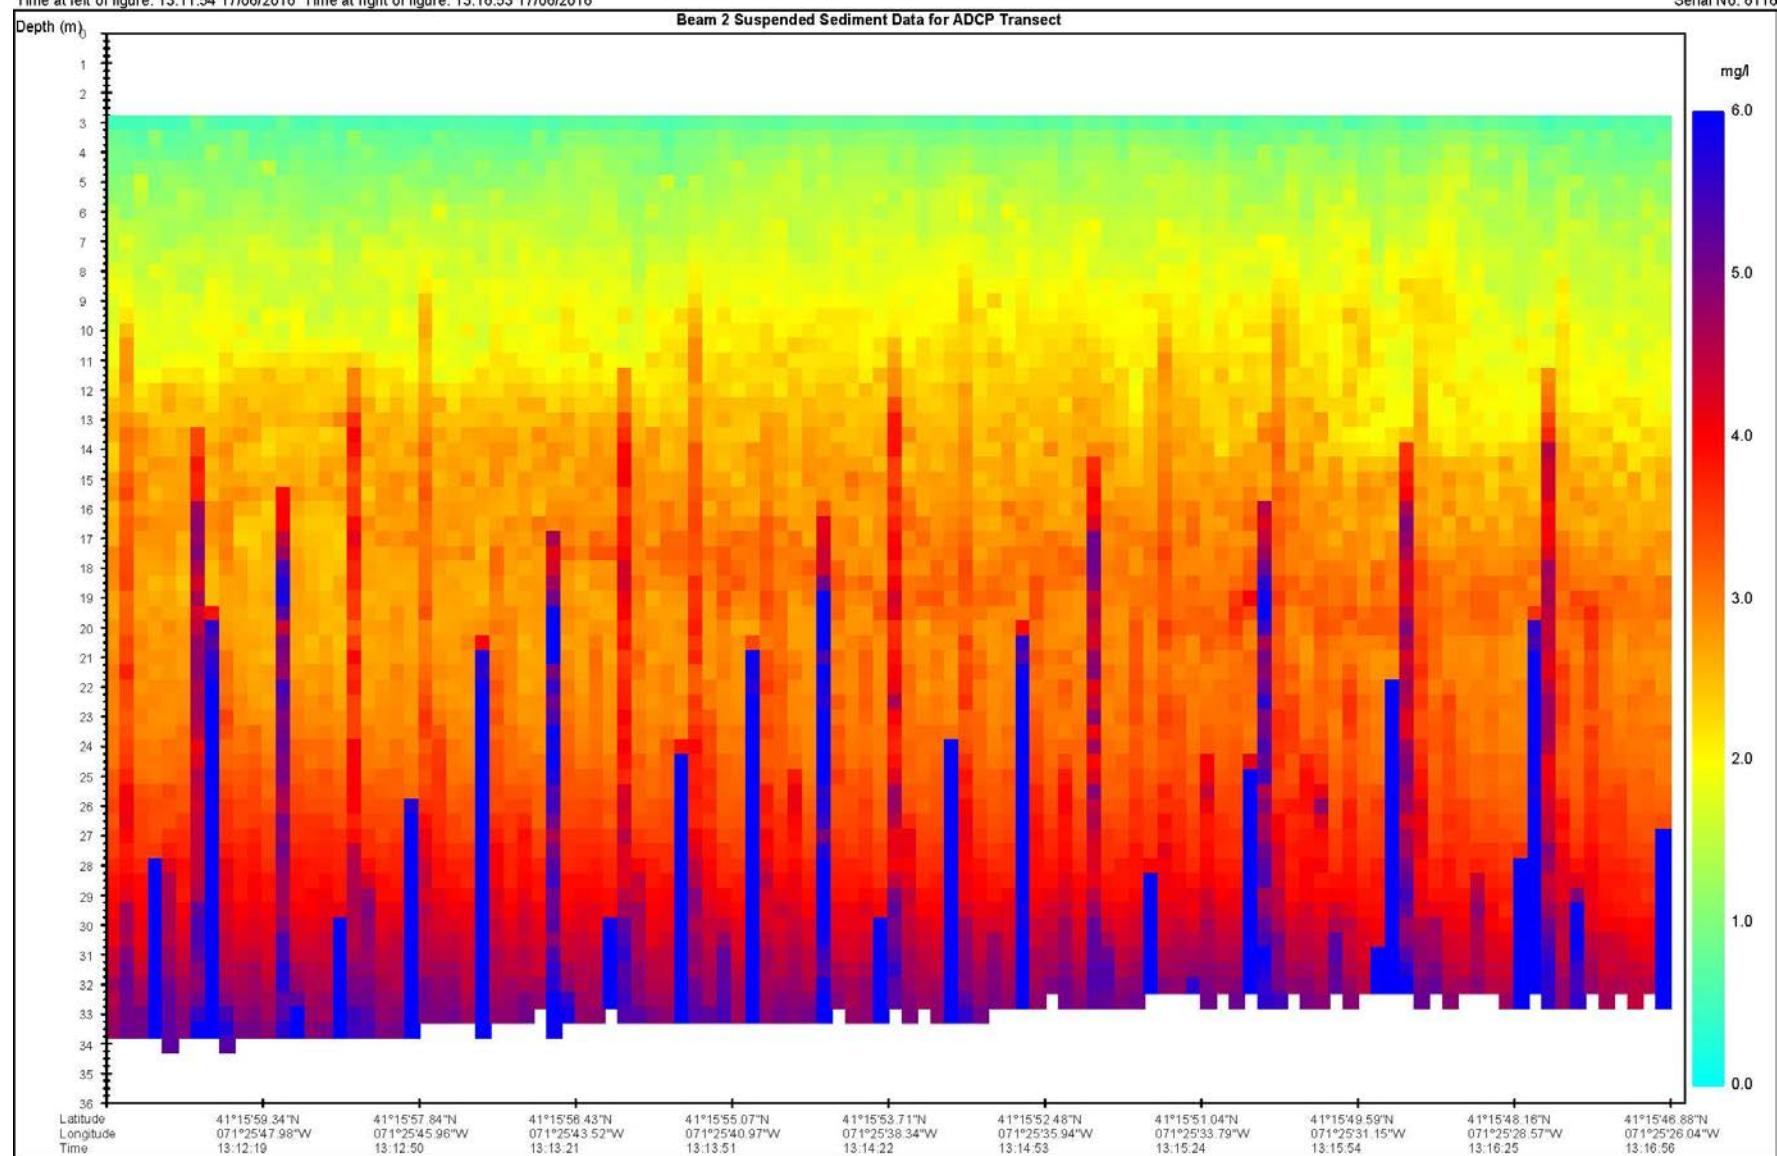
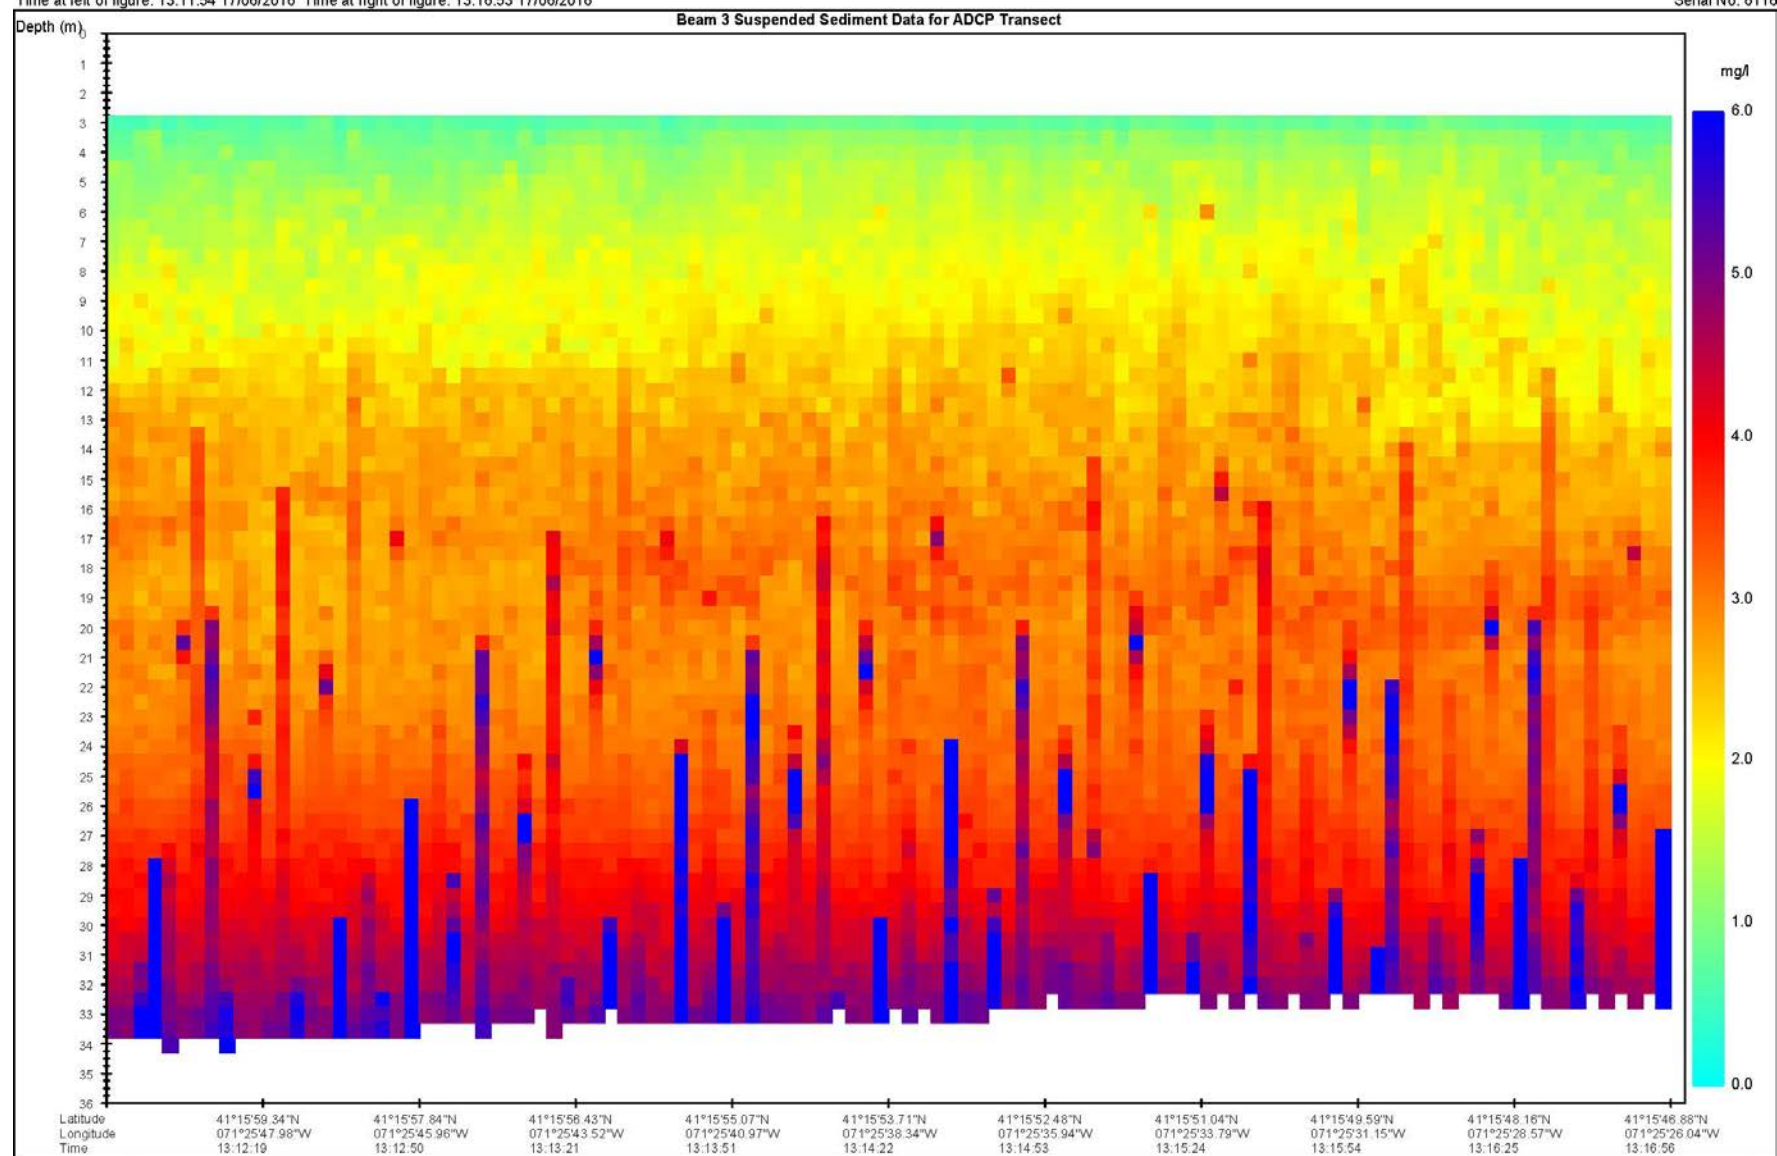
Transect Start: Lat: 41°16'01"N Long: 071°25'47"W Transect End: Lat: 41°15'46"N Long: 071°25'26"W
 Time at left of figure: 13:11:54 17/06/2016 Time at right of figure: 13:16:53 17/06/2016
