**Investigation of Fatal Accident  
Lift Boat-Coil Tubing P&A  
Main Pass Block 98, Well No. 3  
OCS-G 5694  
12 August 2005**

Gulf of Mexico  
Off the Louisiana Coast

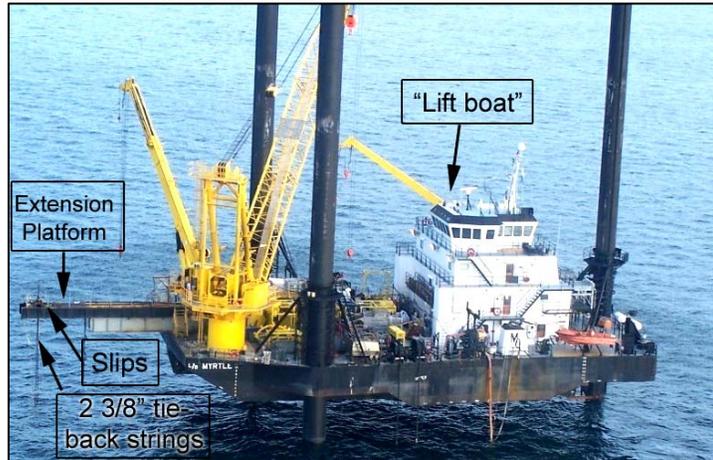
*Figure 2: Lift boat, extension platform*

On 11-12 August 2005, operations to P&A the subject Well were continuing on the modified lift boat, *Myrtle* (the Lift Boat). To P&A the bent well, the caisson and casing had been cut below the mud line (BML) and tie-back tubing strings had been attached to the 2 3/8-inch production tubing. The tie-back strings were secured by slips into a tubing holding device, the “False Rotary” or “Slip Bowl,” mounted on a temporarily constructed extension deck

platform (the Extension Platform) attached to the bow of the Lift Boat (*see figure 2*). A coil tubing unit was being rigged up on one of the tie-back strings above the Slip Bowl, preparatory to washing mud and testing the tie-back overshot connection.

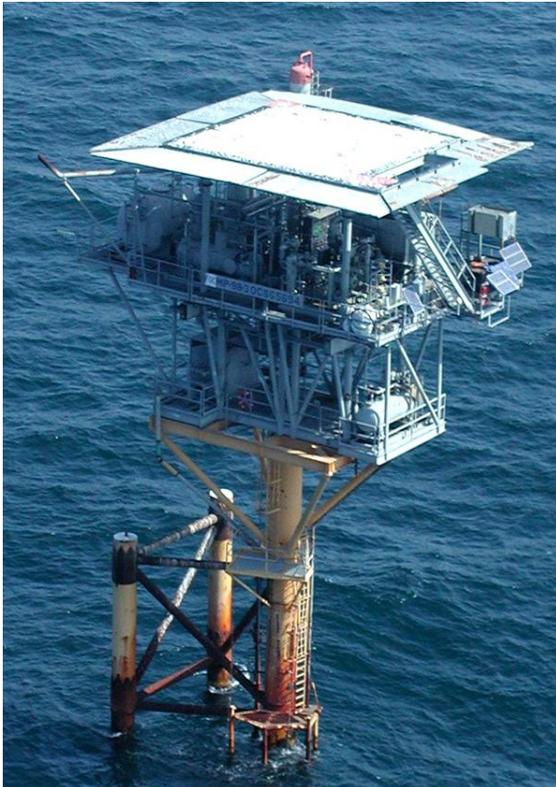
**Figure 4: MP-98 Well #3, pre Hurricane Ivan**

The Well was drilled from a three-well production platform set in 78 ft of water in 1986 and completed as a dual well with two strings of 2 3/8-inch production tubing, the “long string” (LS) and the “short string” (SS). In 1998, Hurricane George damaged the platform to the extent that two of the three producing wells on it were P&A’d with only the #3 Well being salvaged. On the #3 Well, the drive pipe was bent by the storm, but was straightened somewhat by using a derrick barge. A large overdrive caisson (the Caisson) was installed but found to be skewed. After two pin piles and braces straightened the Caisson to acceptable standards, production decks were welded on the Caisson and production equipment was spotted on the decks (see figure 4).

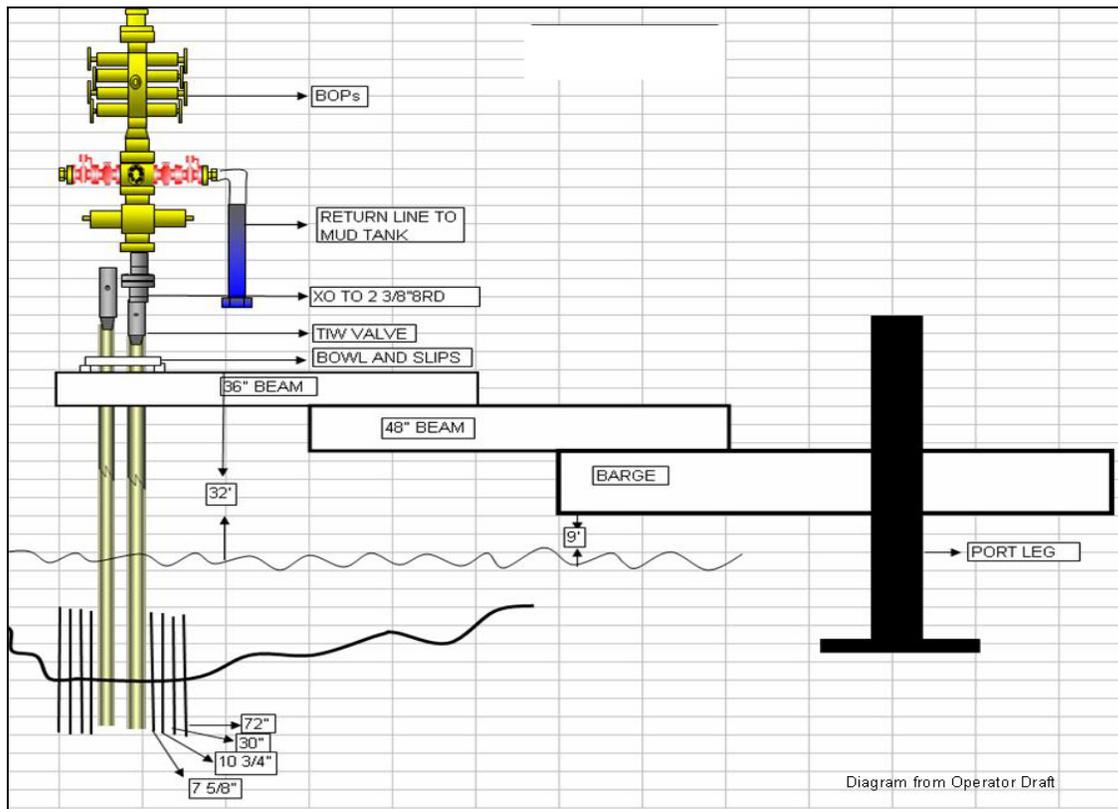
**Figure 6: Diagram of lift boat, tie-back tubing, well head**

- (6) Use a diver to guide the packoff overshots on the end of the two tie-back strings into place within the Caisson stub, and securely attach the overshots to the tops of the two production tubing strings.
- (7) Once the tie-back string overshots were securely attached to the production tubing, the tie-back strings were to be placed in 5,000-lb tension and hung off in the Slip Bowl. The connection and seal between tie back and production tubing were to be confirmed and pressure tested (*see figure 6*).

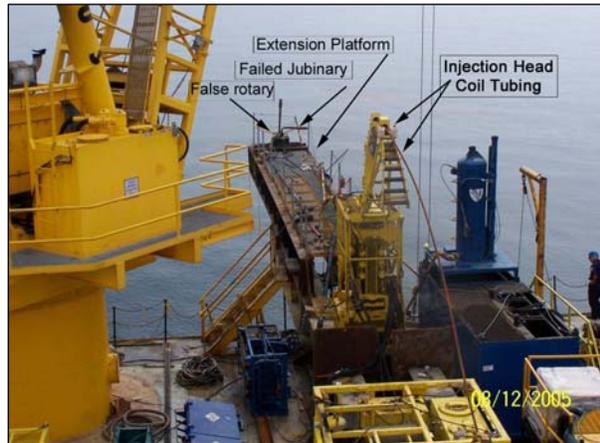
**Figure 7: Extension platform, CTU injection head**

The Operator assigned a Completion Engineer (CE) to design the Plan to P&A the Well and to solve the problem of direct vertical access to the Well. The CE spent considerable time solving the access problem. The solution approved by Operator review was to attach an extended temporary work platform (Extension Platform) to the bow of a large lift boat (*see figure 7*).

The end of the Extension Platform was equipped with a False Rotary, or Slip Bowl, to hold the tie back tubing in tension. The Lift Boat selected was equipped with two cranes, one of which was “oversized” [testimony] with a boom long enough to reach over the well center at the end of the Extension Platform. This crane acted in lieu of the traveling block of a conventional rig.

The CTU supervisors observed working conditions on the Extension Platform to be unsatisfactory for coil tubing operations. The ends of the tie-back strings topped by the Texas Iron Works (TIW) valves were over 30 ft above the False Rotary. No hand rails were installed on the Extension Platform and large openings were present around the False Rotary.

After meeting with the Company Man and discussing the work conditions, the Slip Bowls were shimmed and H-beams and angle iron were installed to support the False Rotary and prevent its movement independent of the motion of the Lift Boat. Some grating was installed to reduce the size of open holes around the False Rotary. A wire rope hand rail was installed. A joint of tubing was removed from each tie-back string and the Lift Boat was re-positioned so that the end connections of the tie-back string assemblies were approximately 3.5 ft above the slips. The TIW valves were re-installed atop both tie-back tubing strings.

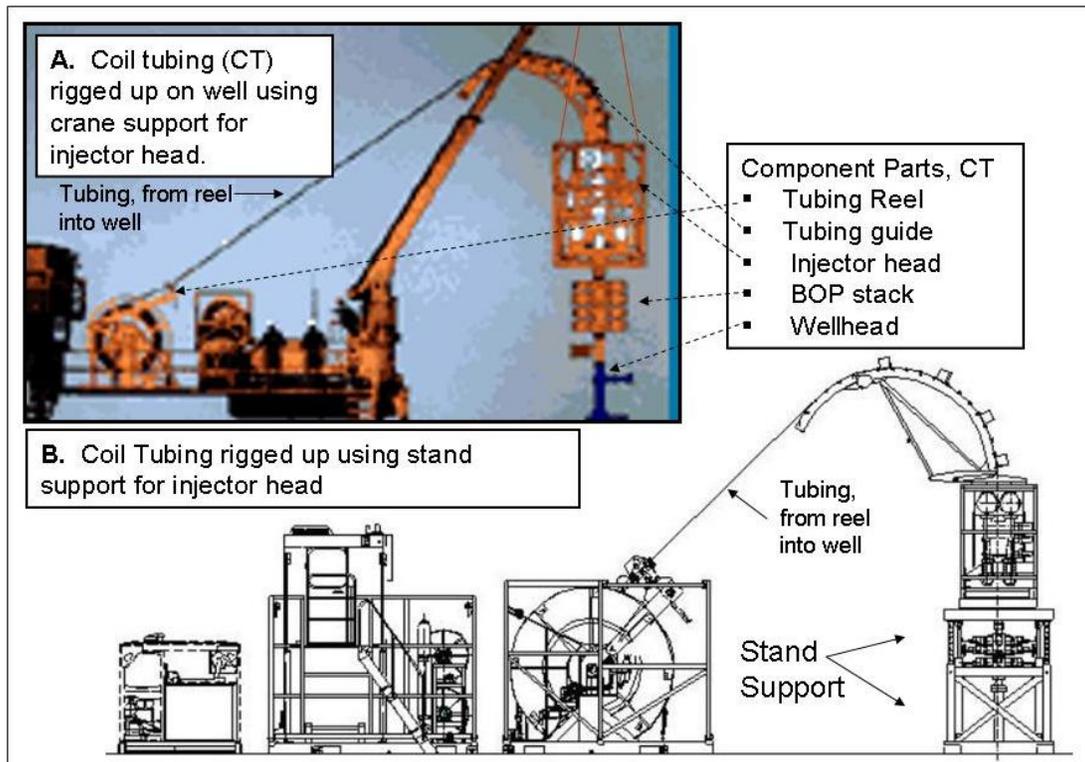
**Figure 10: Coil tubing unit components**

The coiled tubing unit is an assembly of the major equipment components needed to perform a continuous-length tubing service. These basic equipment components usually include a tubing reel, tubing guide, injector head, control console, power supply, and well control stack or BOP Assembly (see figure 10).
