Seafloor Disturbance and Recovery Monitoring at the Block Island Wind Farm, Rhode Island – Summary Report

March 2020

Prepared under BOEM Award
Contract No. M15PC00002
Task Order No. M17PD00015
By
HDR
9781 S Meridian Boulevard, Suite 400
Englewood, CO 80112

**US Department of the Interior
Bureau of Ocean Energy Management
Office of Renewable Energy Programs**

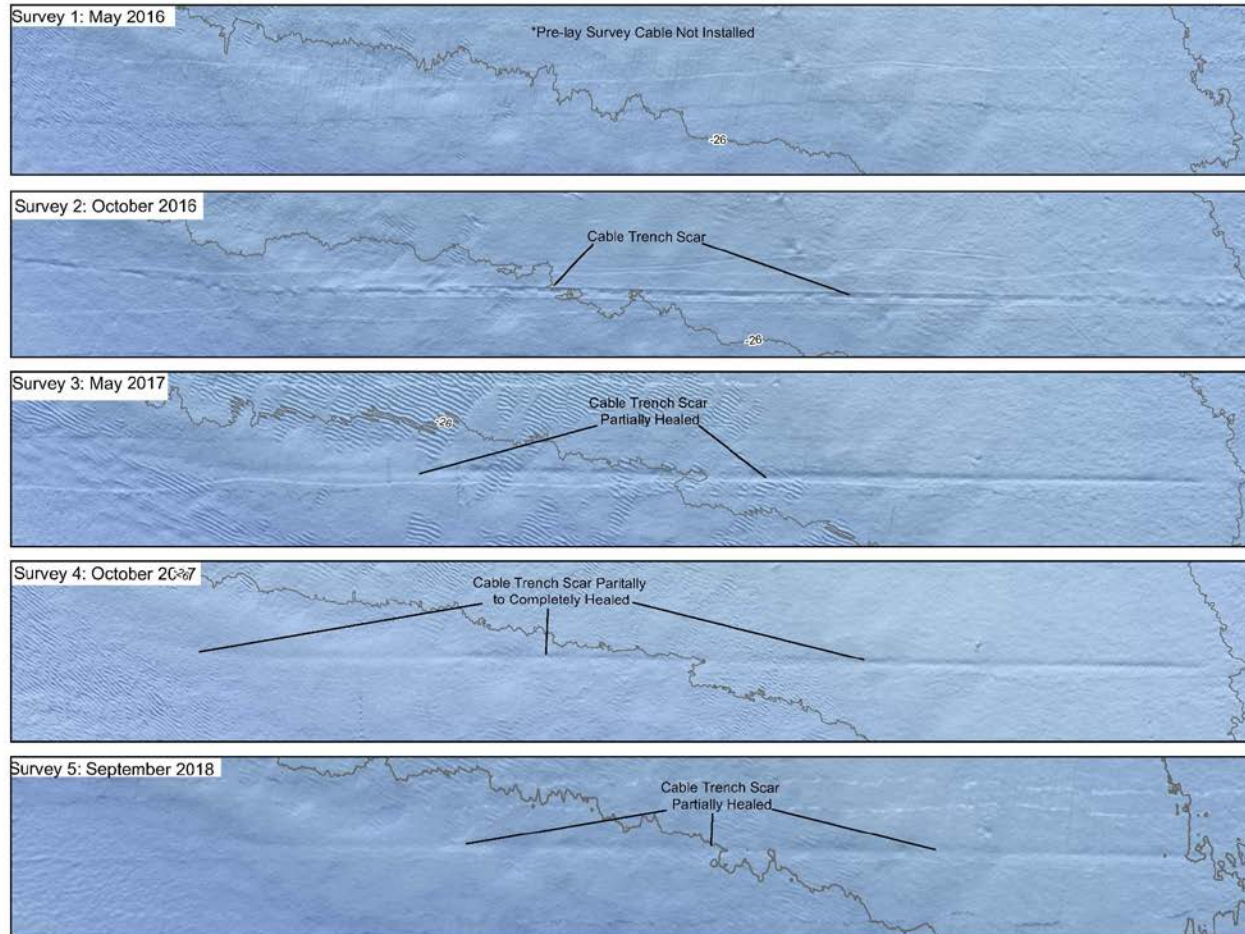
Figure 5. Inter-array cable trench seafloor recovery patterns.

The comparison of the inter-array cable from the four surveys (May 2016 through October 2017), indicate that cable trench scar has partially healed. The inter-array cable was installed between June and July 2016, and Survey 2 (Oct. 2016) showed that the trench scar was up to approximately 10 cm in depth in this area. Survey 3 (May 2017) showed in this same area that portions of the cable trench had completely healed while other areas were up to 7 cm deep. Survey 4 (Oct. 2017) showed that most of the cable trench in this extent had healed, with a few areas up to approximately 5 cm in depth.

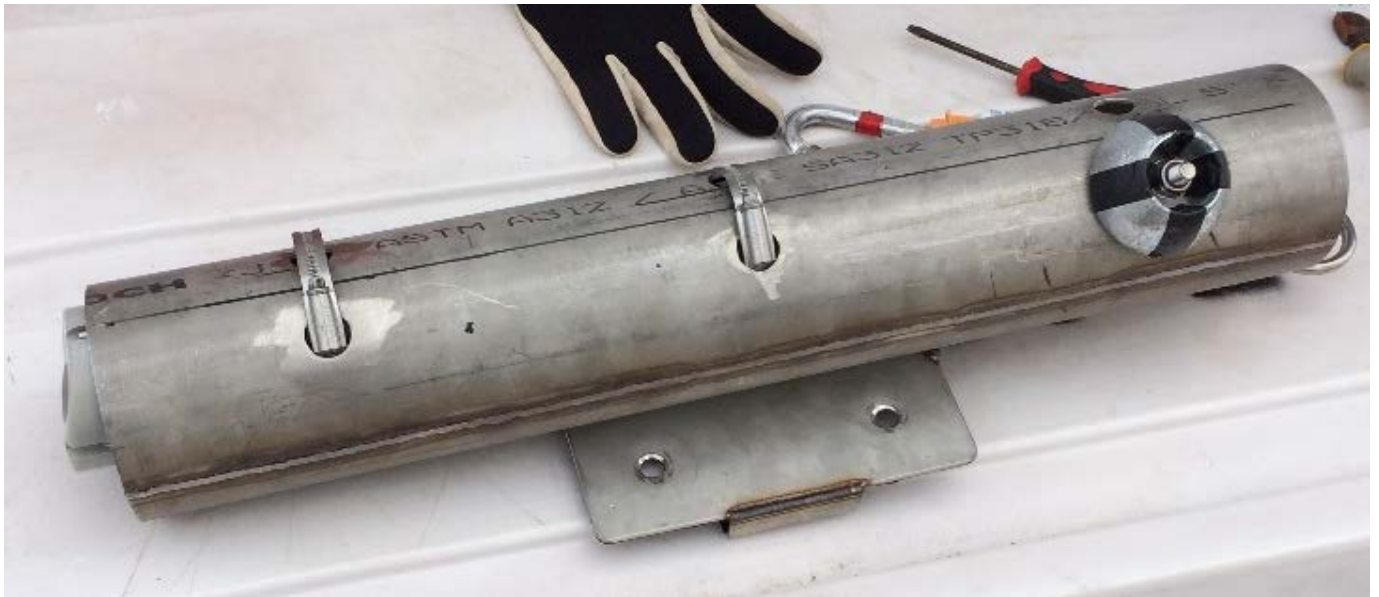
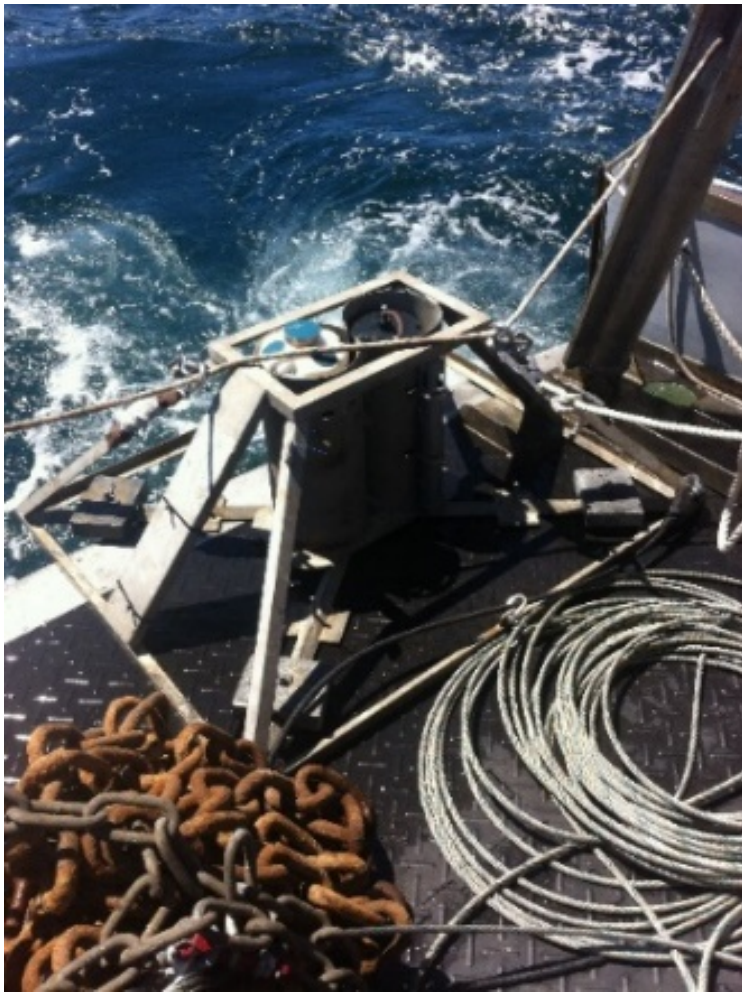
Figure 8. Scour monitor in bracketing (top); seafloor frame and AWAC (bottom).

Two innovative scour monitors (**Figure 8**) were installed on the foundation of Turbine 3, and changes in seafloor levels (scouring patterns) near this foundation were tracked in real time over an approximately 14-month period.³ The units were serviced every 3 months. A frame-mounted acoustic wave and current profiler (AWAC) also was simultaneously deployed on the seafloor approximately 500 m (1,640.4 ft) southeast of Turbine 3 (**Figure 8**). Site-specific oceanographic data collected by the AWAC supported analyses and interpretation of data obtained from scour monitors.

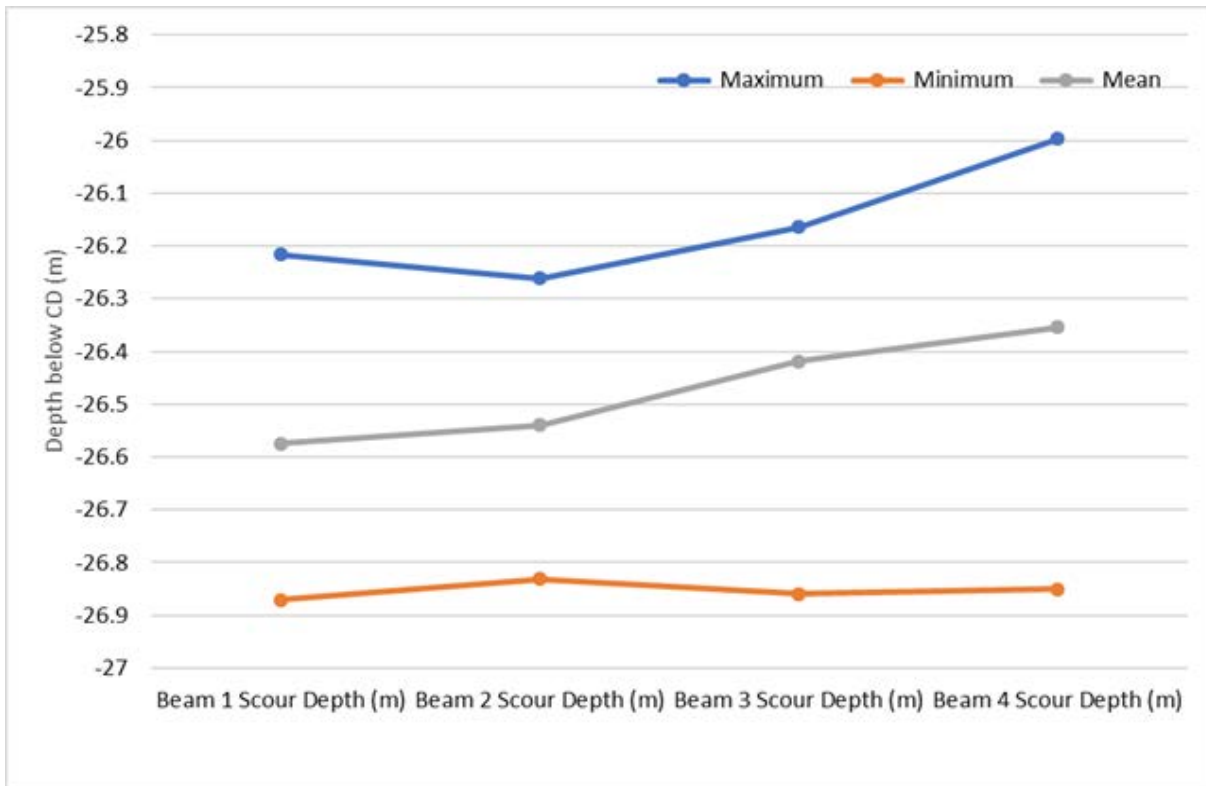
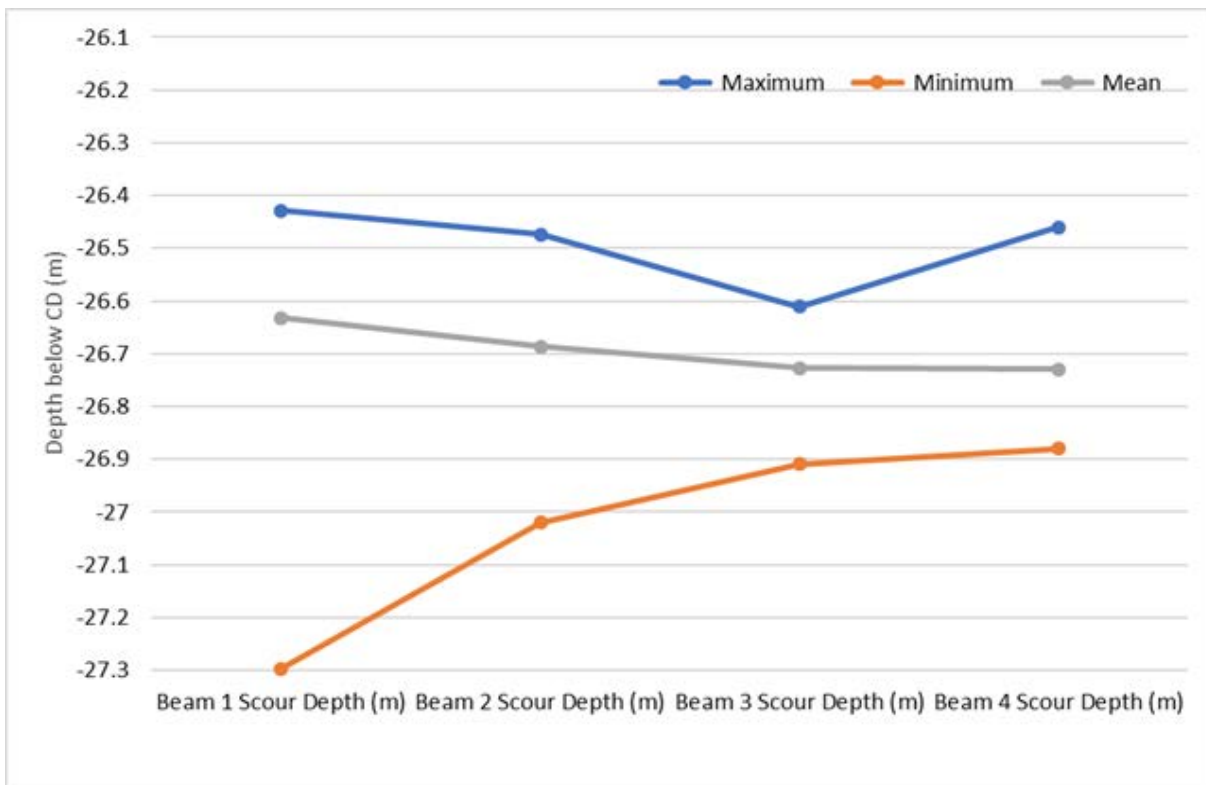
Figure 12. Summary mean scour profile.

Mean scour depth of each beam per month is shown in **Figure 11**, and a summary mean scour profile is presented in **Figure 12**. Beam 1 was orientated at an angle of 5° and, therefore, represents measurements taken closest to the turbine. In contrast, beam 4 was orientated at an angle of 20°, and it represented measurements taken farthest from the turbine.

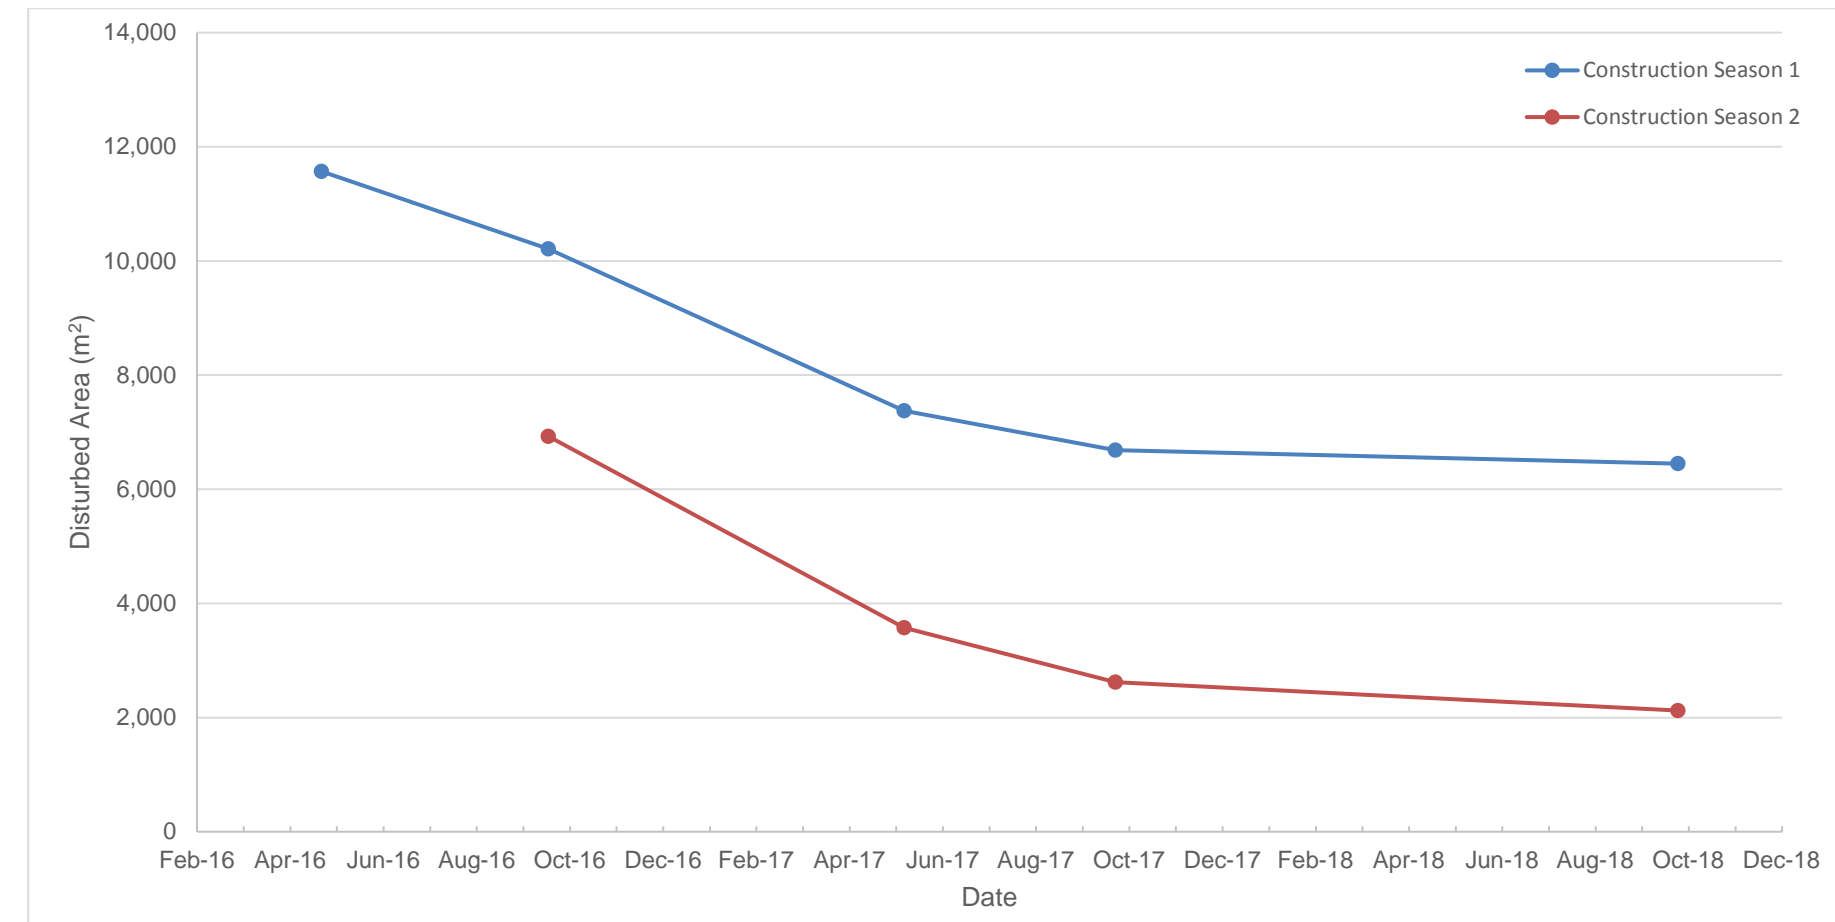
^b Twenty-one scour features were identified from the Construction Season 1 disturbances which results in a total of 160 disturbance features from Season 1. Two new scour features were identified from Construction Season 2 disturbances which results in a total of 103 disturbance features from Season 2. Scour features formed as a result of installing wind turbine foundations or concrete mattresses. The scour features are not included in the recovery statistics since they are likely to be present as long as the structures (e.g. foundations and concrete mattresses) are present.

Inset graph (left) presents a summary of the disturbed seafloor area interpreted from each survey.

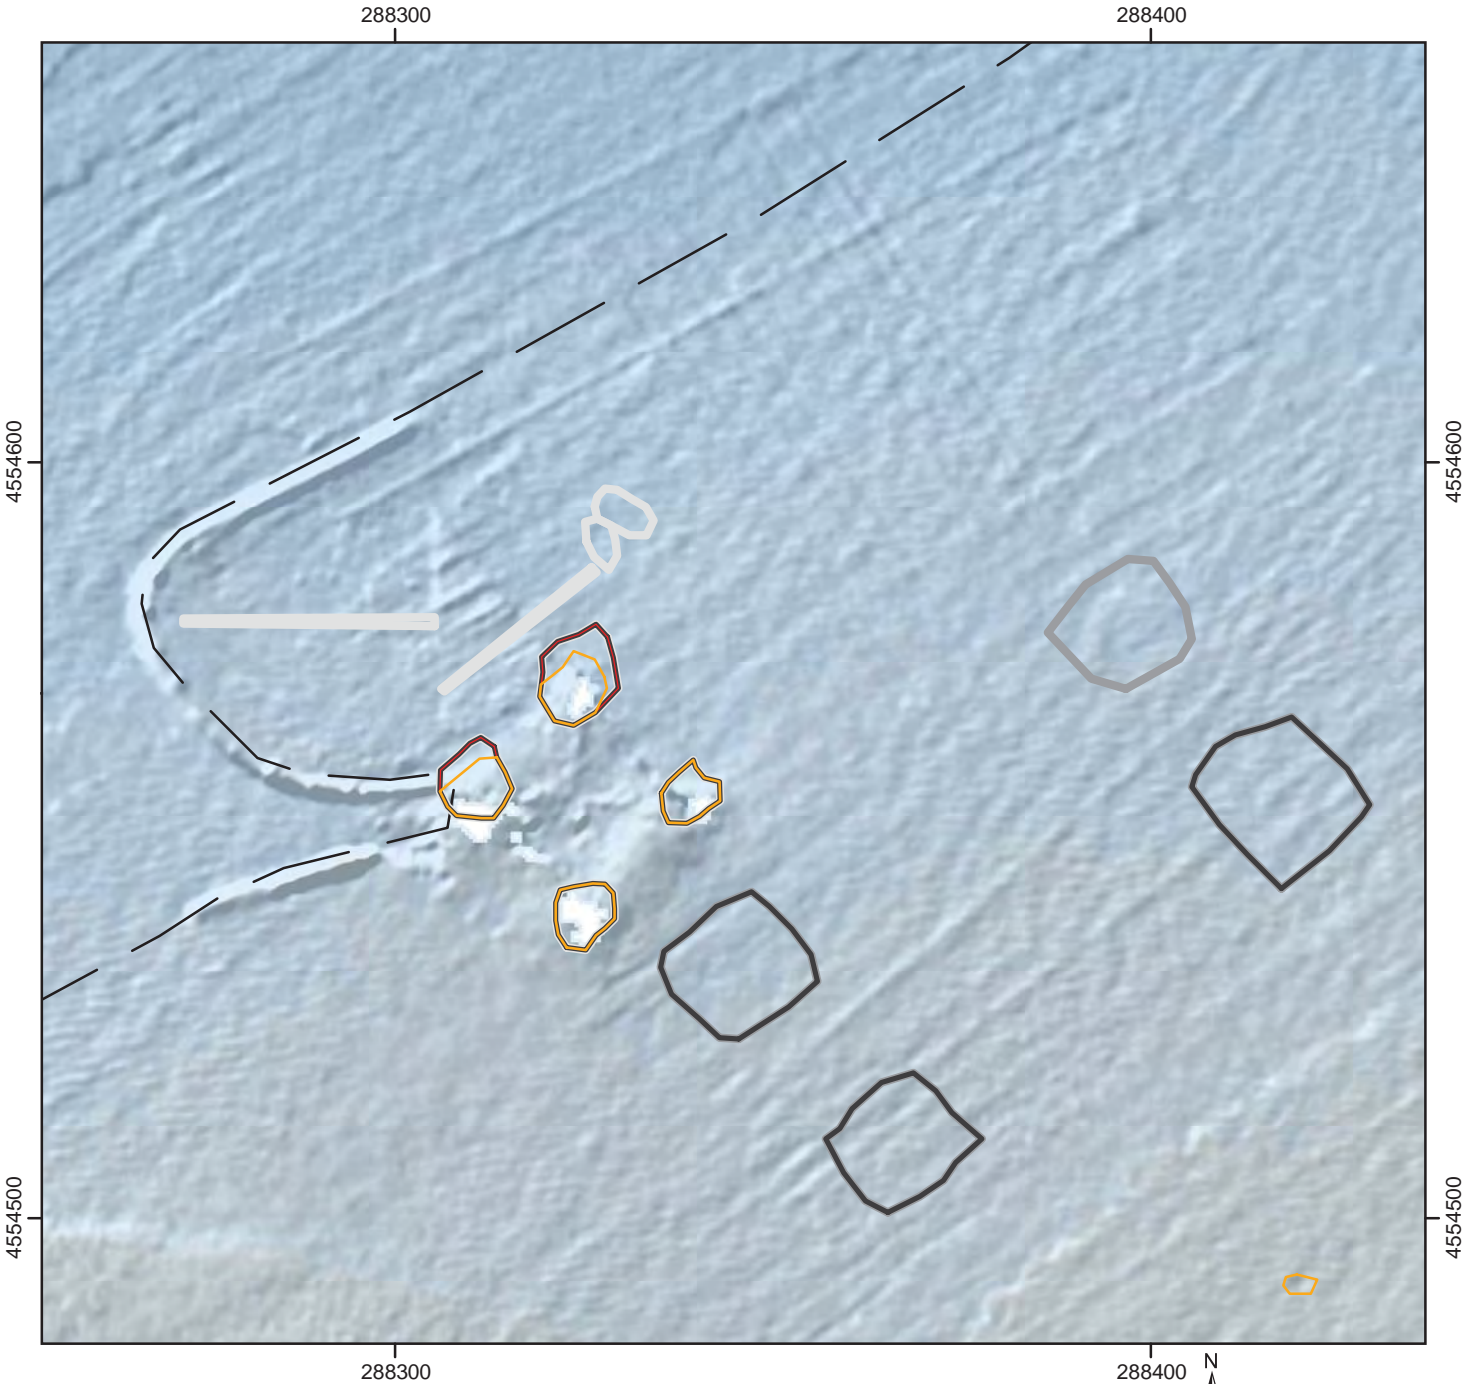
**SEAFLOOR DISTURBANCE PER SURVEY
WIND TURBINE GENERATOR NO. 3**
Seafloor Monitoring Study
Block Island Wind Farm and Transmission Project
Offshore Rhode Island

Construction Season 2 Features: The four spud depressions (Features F168-171) that were identified from the Construction Season 2 baseline survey (Survey 2—Oct. 2016) and associated with the L/B *Brave Tern* all appear to be completely healed in the September 2018 (Survey 5) survey data (Figures 5b, 5c, Figure 11, and Table C-1). Survey 2, the first survey that recorded the depressions, indicated they were between 70 and 110cm deep at one point. They infilled significantly (80 to 85%) between Surveys 2 and 3 (Figures 8 and 11).

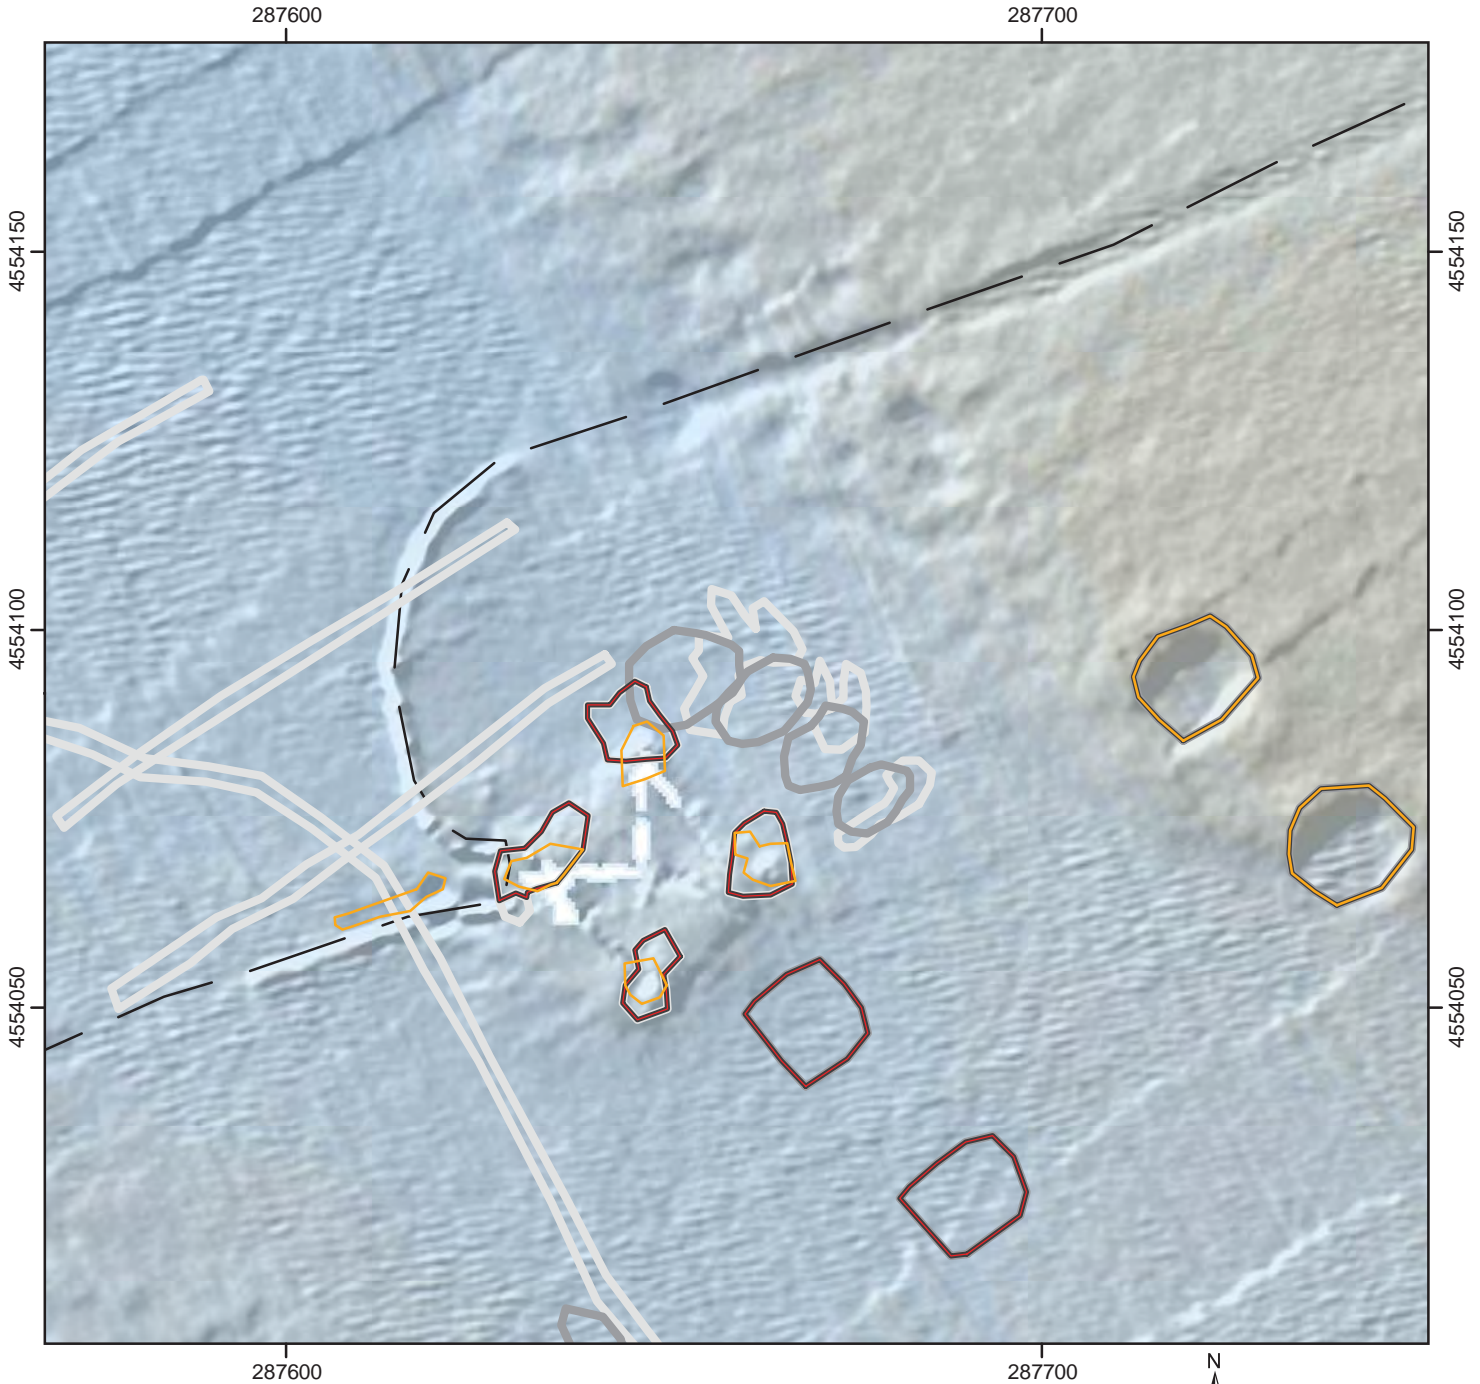
SEAFLOOR DISTURBANCE PER SURVEY
WIND TURBINE GENERATOR NO. 4
 Seafloor Monitoring Study
 Block Island Wind Farm and Transmission Project
 Offshore Rhode Island

Construction Season 2 Features: Eight of the 10 Construction Season 2 features (F174-175 and F246-251) appear to have completely healed and are not discernable in the September 2018 (Survey 5) survey data (Figure 6c and Table C-1). The remaining two features (F172-173) are two of the four spud depressions attributed to the L/B *Brave Tern* (F172-175) (Figures 6b and 12). Two of these spud depressions (F174 and 175) have completely healed, while the two northeastern spud depressions (F172-173) appear to have experienced very little infilling since Survey 4 (Figure 6b and Figure 12). The differing infill rates of the L/B *Brave Tern* leg depressions is remarkable. The two southwestern leg depressions that have completely healed are located in a ripple field that is actively changed between surveys. The ripples changed in orientation and extent and indicates higher rates of sediment reworking than where the two northeastern depressions are located. The spud can depressions were observed to be up approximately 60cm deep during Survey 2. The northeastern spud depressions are approximately 40 to 50 percent infilled at the time of Survey 5 (Figure 12).

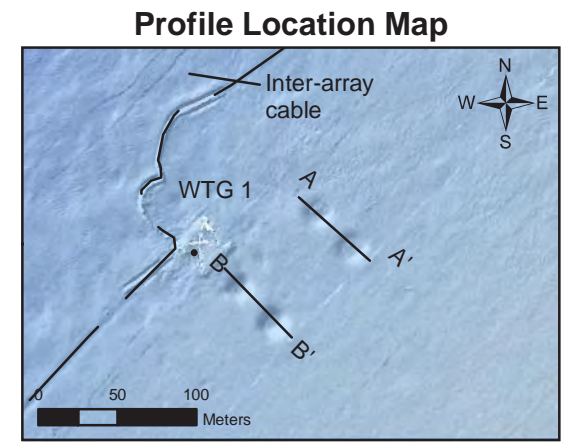
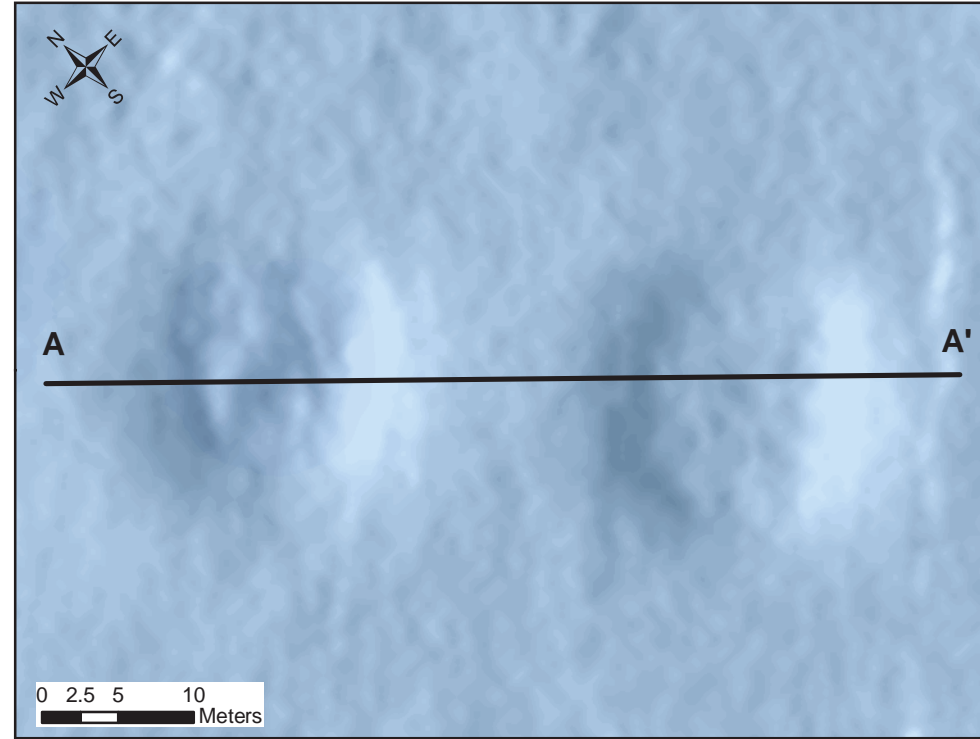
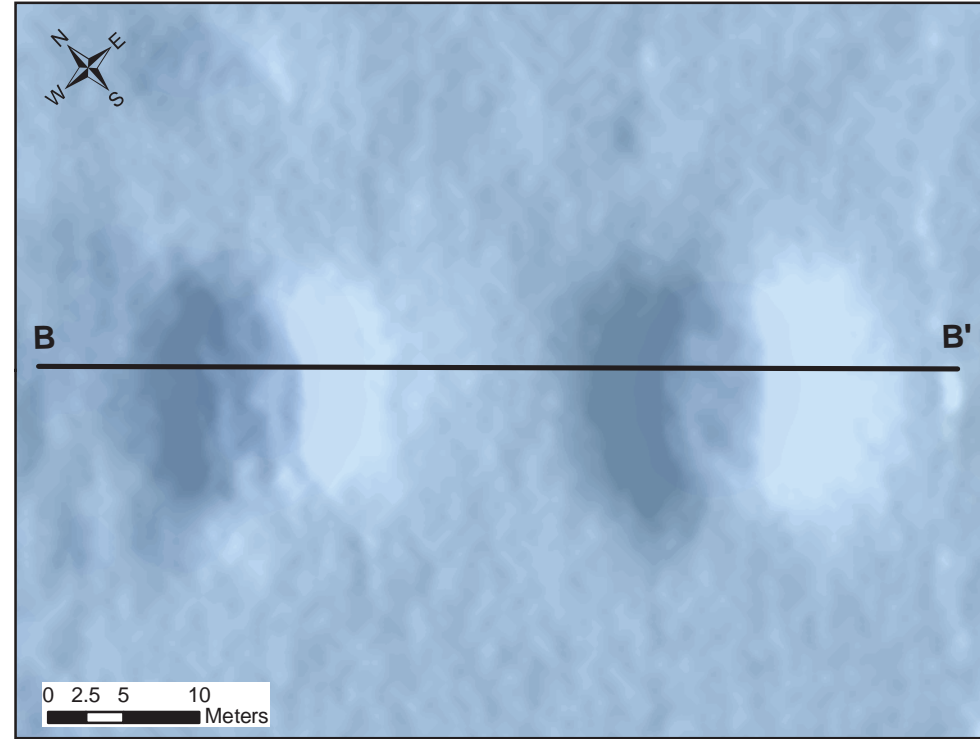
**EXAMPLE OF SEAFLOOR RECOVERY
WIND TURBINE GENERATOR NO. 1**
Seafloor Monitoring Study
Block Island Wind Farm and Transmission Project
Offshore Rhode Island

Notes:
The depressions shown in this figure were created by the L/B Brave Tern vessel while installing the wind turbine during Construction Season 2 that occurred in between Surveys 1 and 2. Bathymetry data shown in the plan views are from Survey 5.

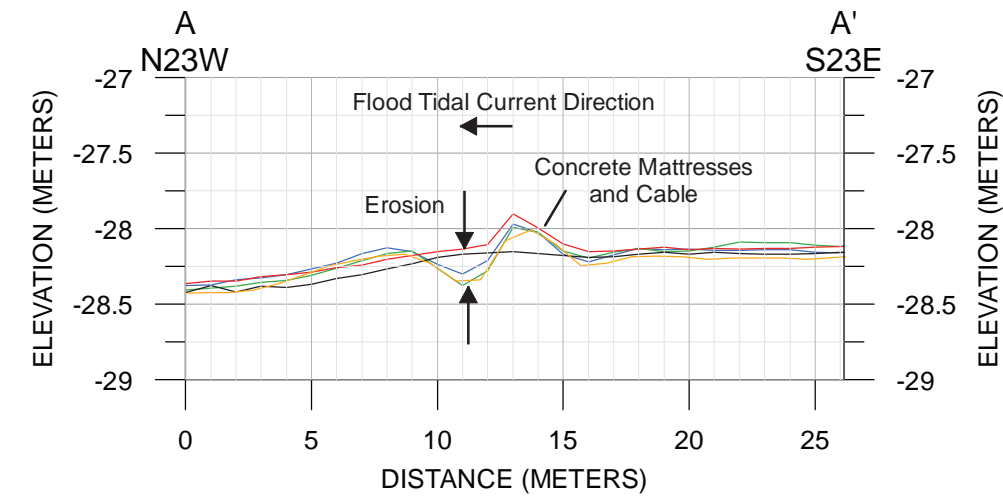
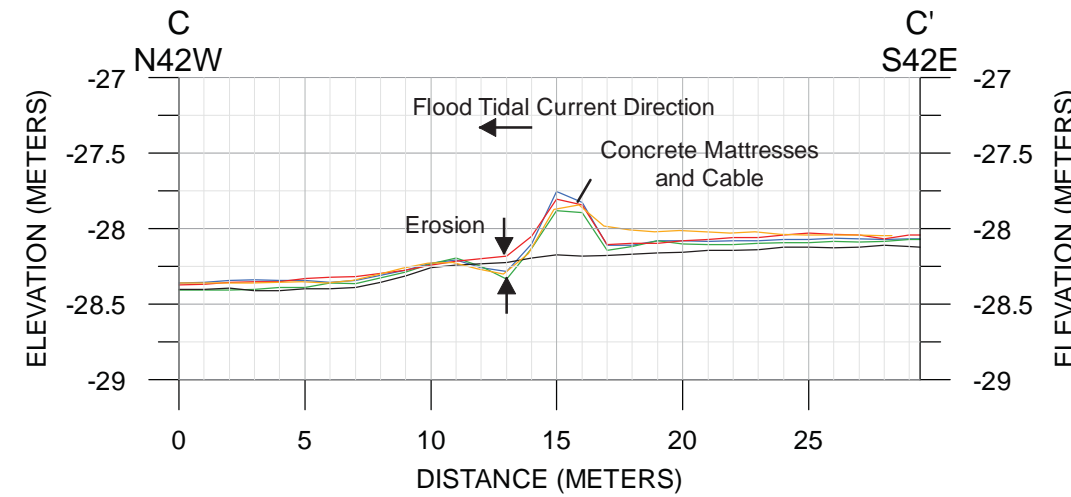
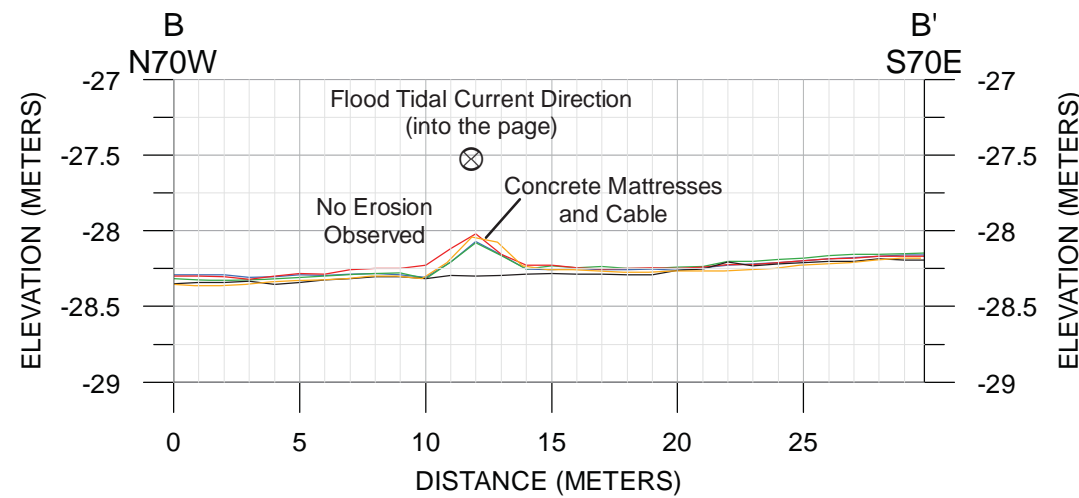
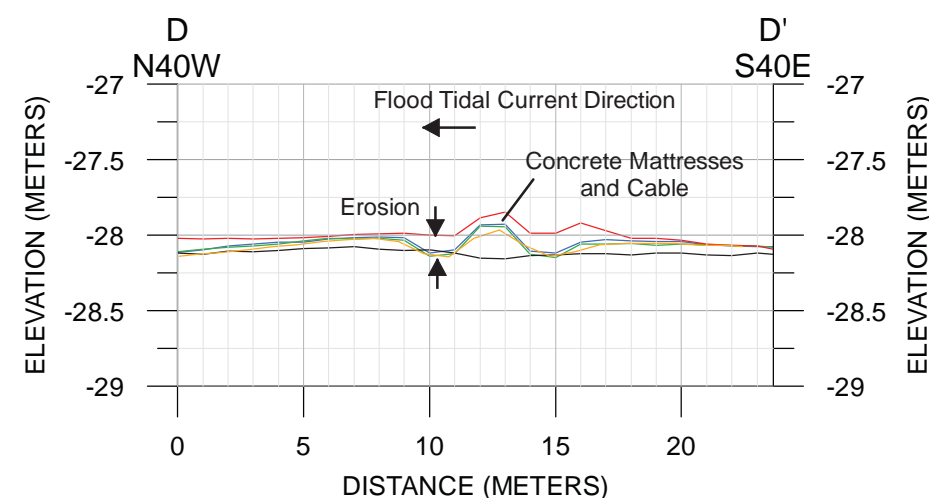
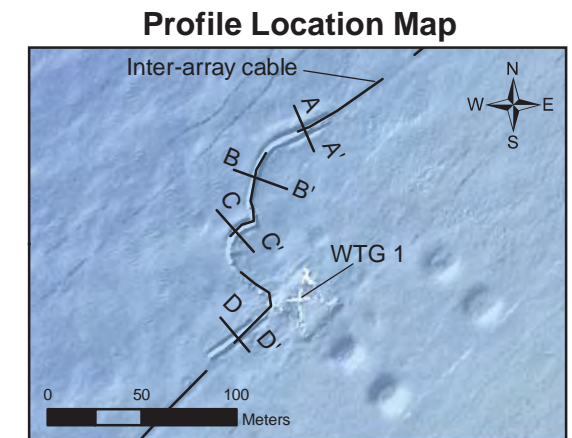
**EXAMPLE OF SEAFLOOR RECOVERY
WIND TURBINE GENERATOR NO. 1**
Seafloor Monitoring Study
Block Island Wind Farm and Transmission Project
Offshore Rhode Island

Survey 1 was conducted before the cable and concrete mattresses were installed.

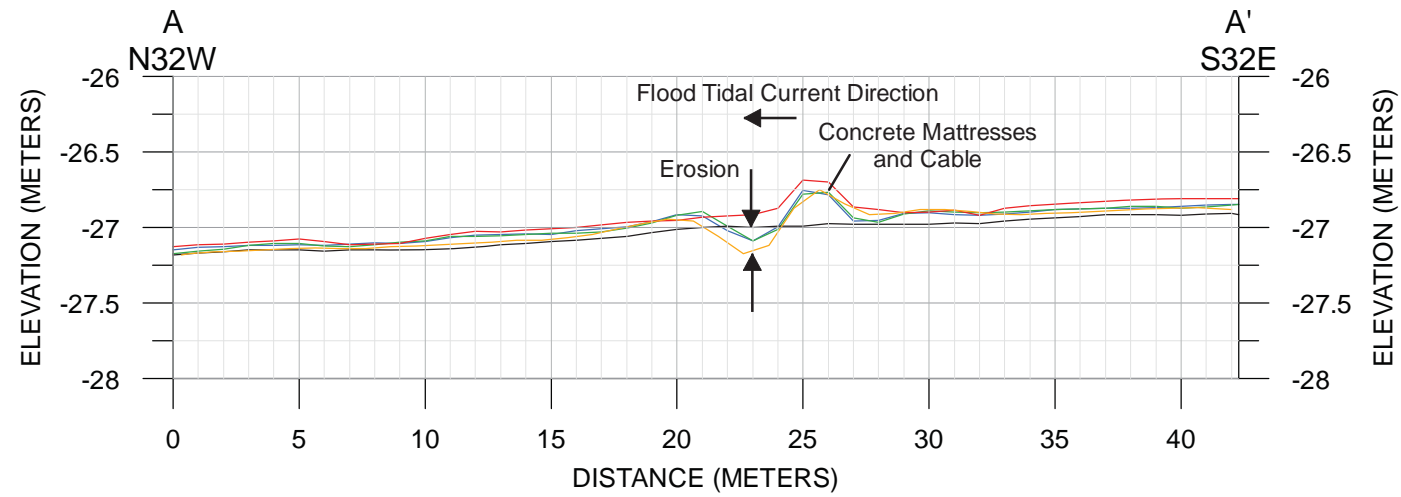
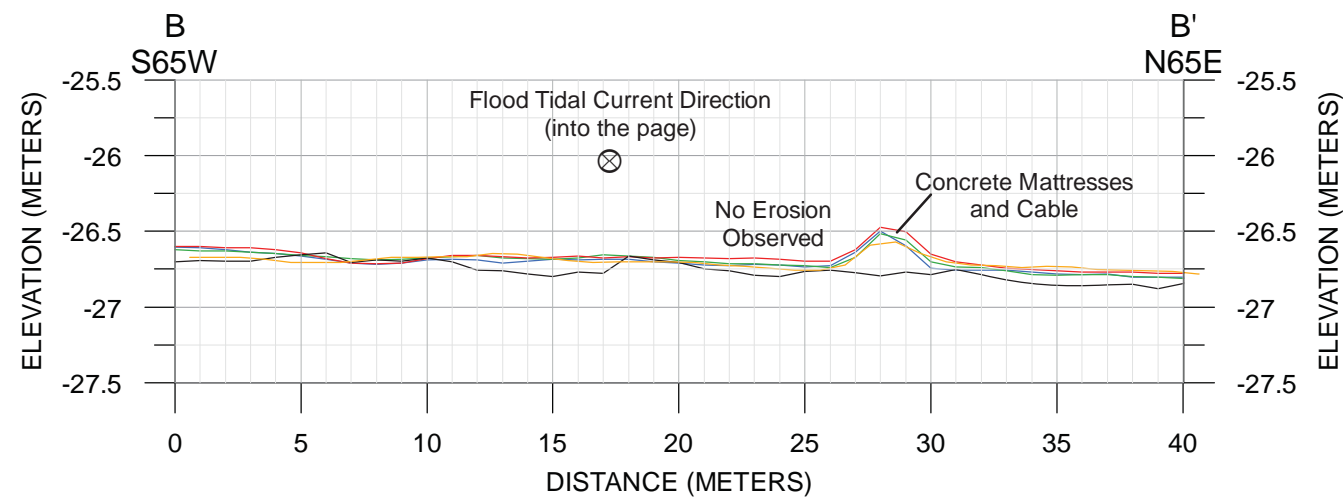
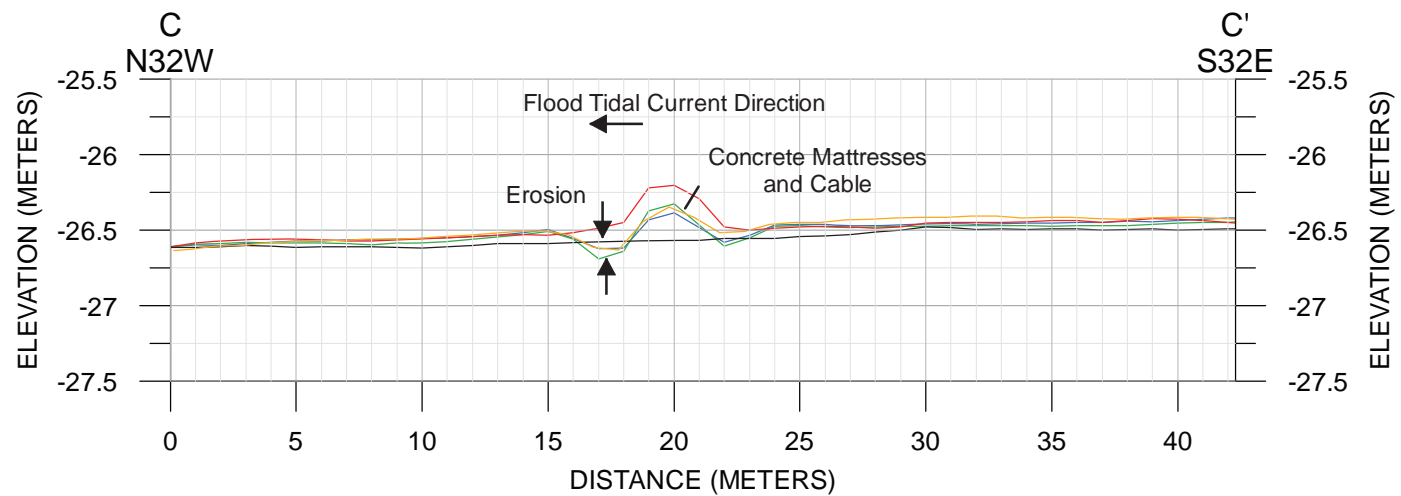
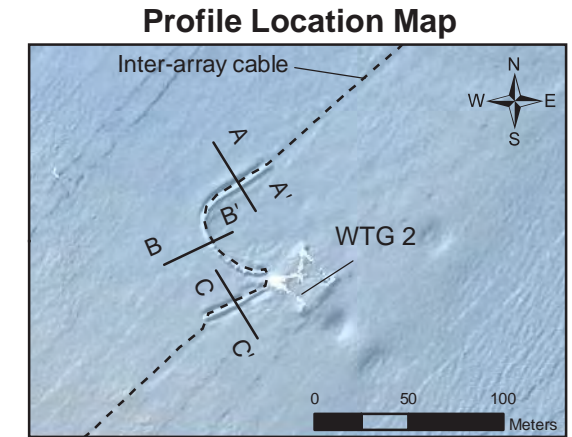
**EXAMPLE OF SEAFLOOR RECOVERY
WIND TURBINE GENERATOR NO. 2**
Seafloor Monitoring Study
Block Island Wind Farm and Transmission Project
Offshore Rhode Island

Survey 1 was conducted before the cable and concrete mattresses were installed.

Principle tidal axis is aligned in the NNW-SSE direction. Cable segment in Profile B is nearly aligned with the principle tidal axis and shows the least amount of scour. Cable segments shown in Profiles A and D are oriented perpendicular to the principle tidal axis. Scour is most prevalent on the northern side of the cable/concrete mattresses which indicates the dominant tidal current flow at this location is likely to the NNW (flood tidal current direction).

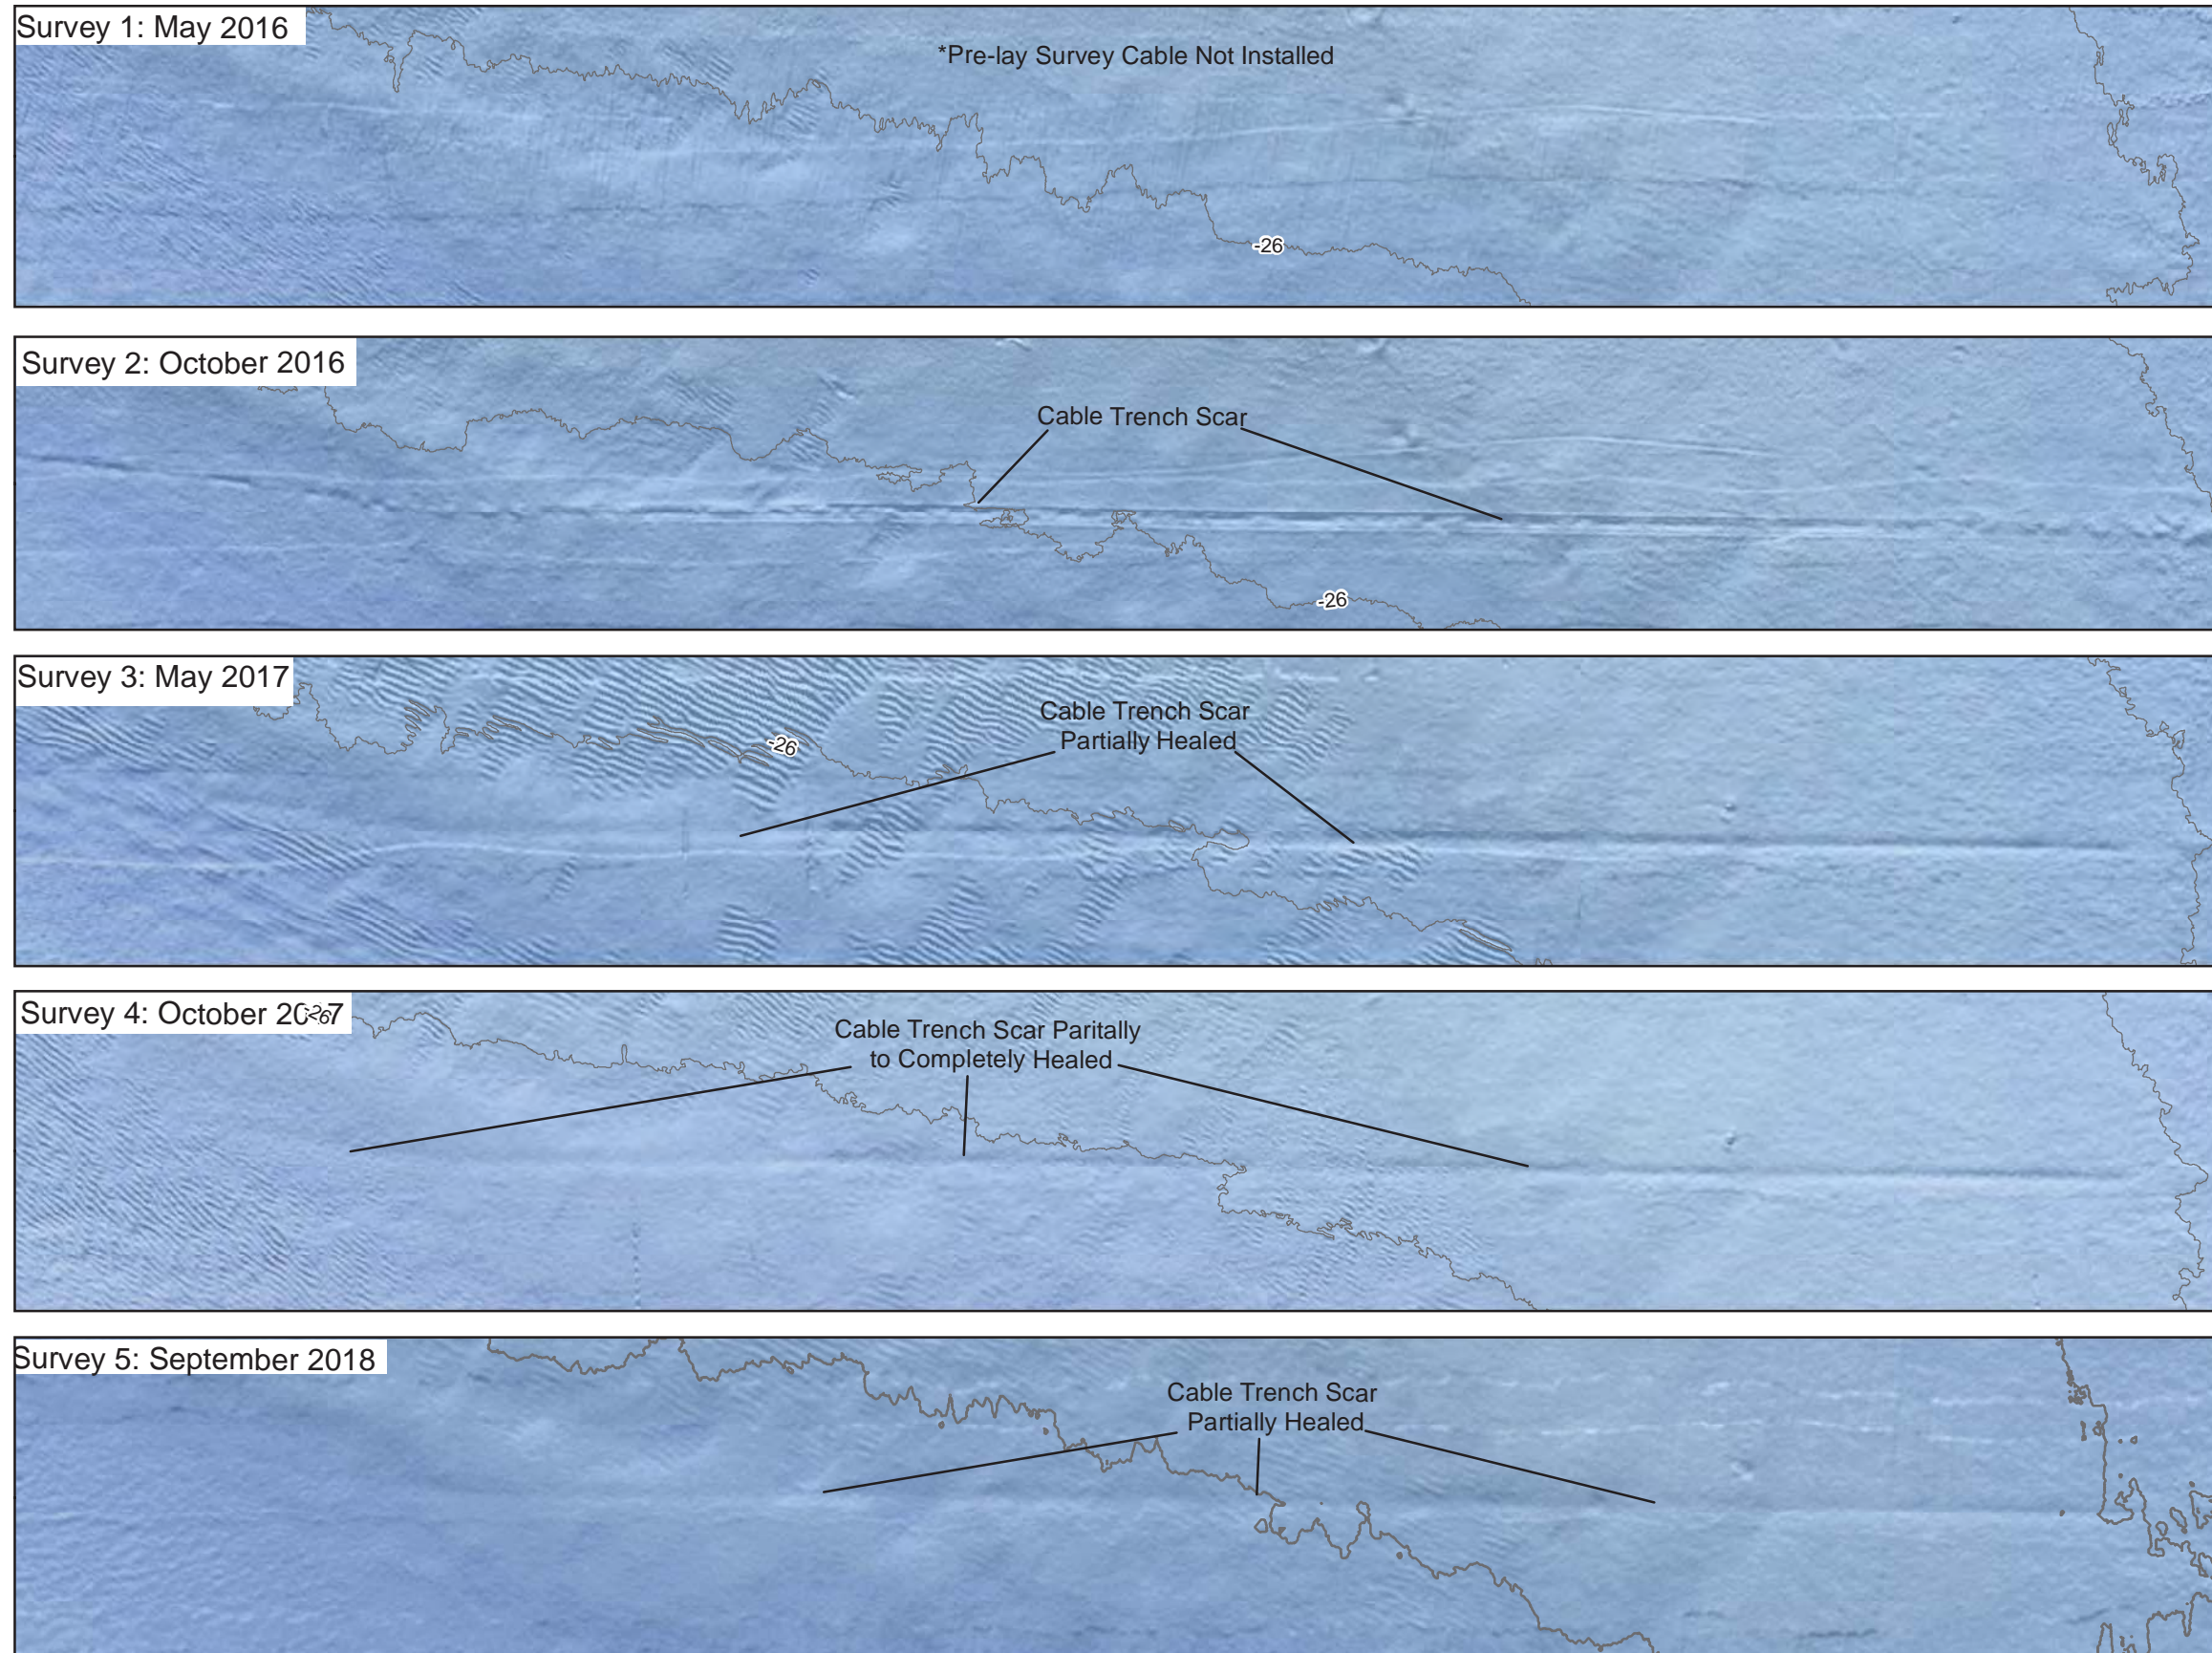
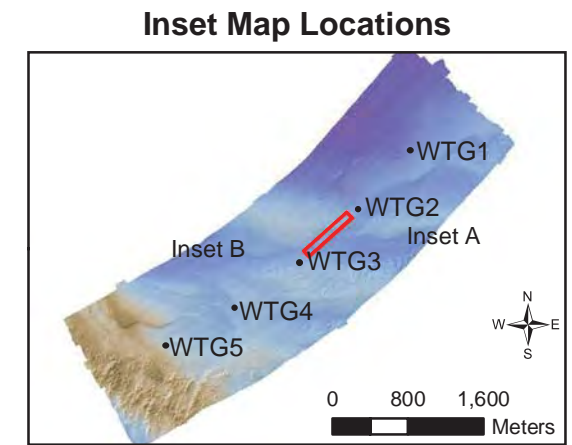
**INTER-ARRAY CABLE TRENCH
MAY 2016 THROUGH SEPTEMBER 2018 SURVEYS**
Seafloor Monitoring Study
Block Island Wind Farm and Transmission Project
Offshore Rhode Island

The comparison of the inter-array cable from the four surveys (May 2016 through October 2017), indicate that cable trench scar has partially healed. The inter-array cable was installed between June and July 2016, and Survey 2 (Oct. 2016) showed that the trench scar was up to approximately 10 cm in depth in this area. Survey 3 (May 2017) showed in this same area that portions of the cable trench had completely healed while other areas were up to 7 cm deep. Survey 4 (Oct. 2017) showed that most of the cable trench in this extent had healed, with a few areas up to approximately 5 cm in depth.
