Seafloor Disturbance and Recovery Monitoring at the Block Island Wind Farm, Rhode Island – Summary Report

March 2020

Prepared under BOEM Award
Contract No. M15PC00002
Task Order No. M17PD00015
By
HDR
9781 S Meridian Boulevard, Suite 400
Englewood, CO 80112

**US Department of the Interior
Bureau of Ocean Energy Management
Office of Renewable Energy Programs**

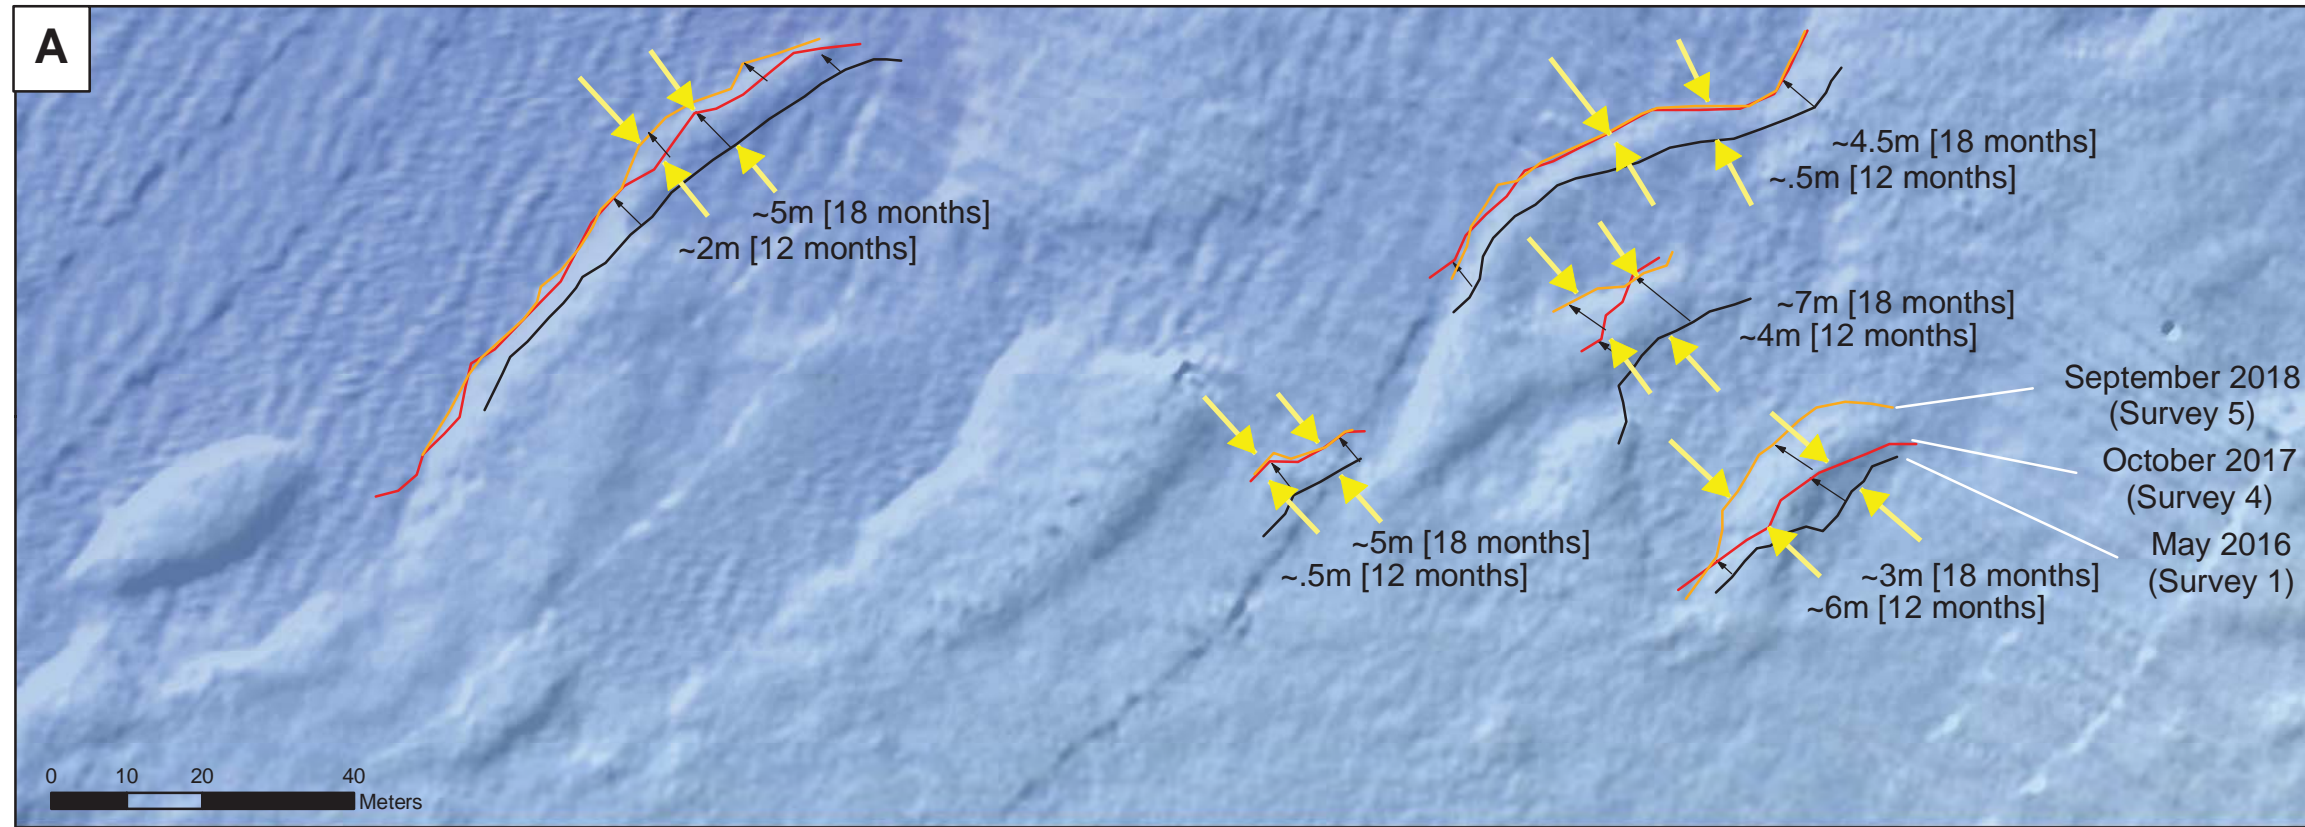
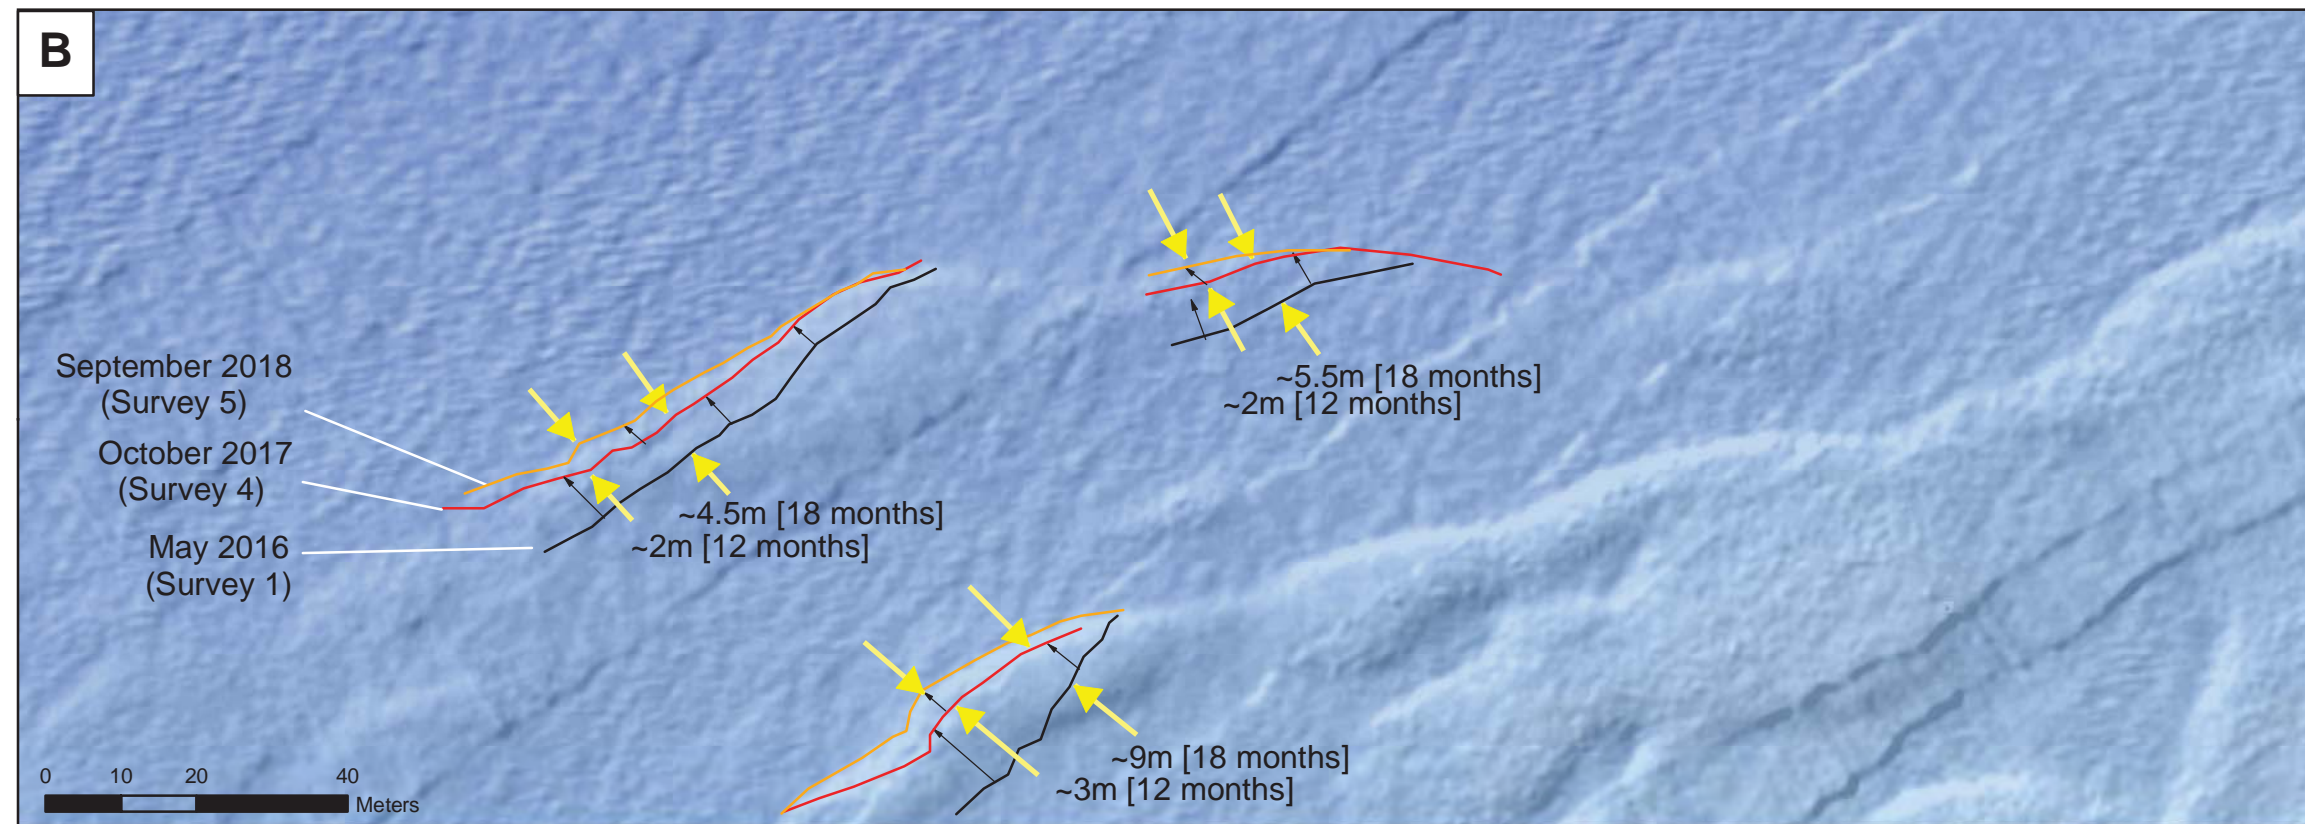
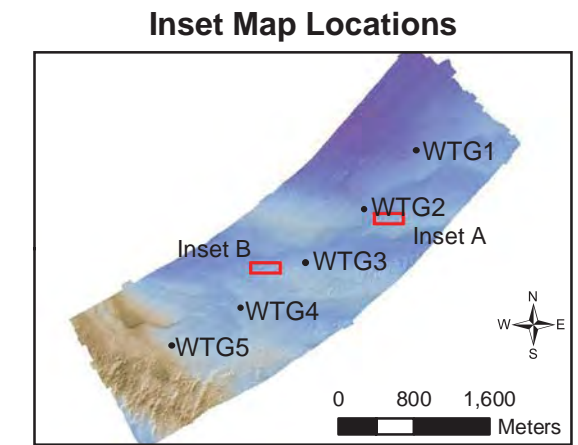
**BEDFORM CHANGES REVEALED BY
OCTOBER 2017 AND SEPTEMBER 2018 SURVEYS**
Seafloor Monitoring Study
Block Island Wind Farm and Transmission Project
Offshore Rhode Island

The comparison of bedform features from the two surveys (October 2017 and September 2018) conducted over one year apart, indicate that the bedforms have shifted approximately 2 to 6 meters to the northwest compared to the previous comparison of 3 to 9 meters from May 2016 and October 2017. The orange, red, and black lines represent the interpreted features from the September 2018, October 2017, and May 2016 surveys, respectively.

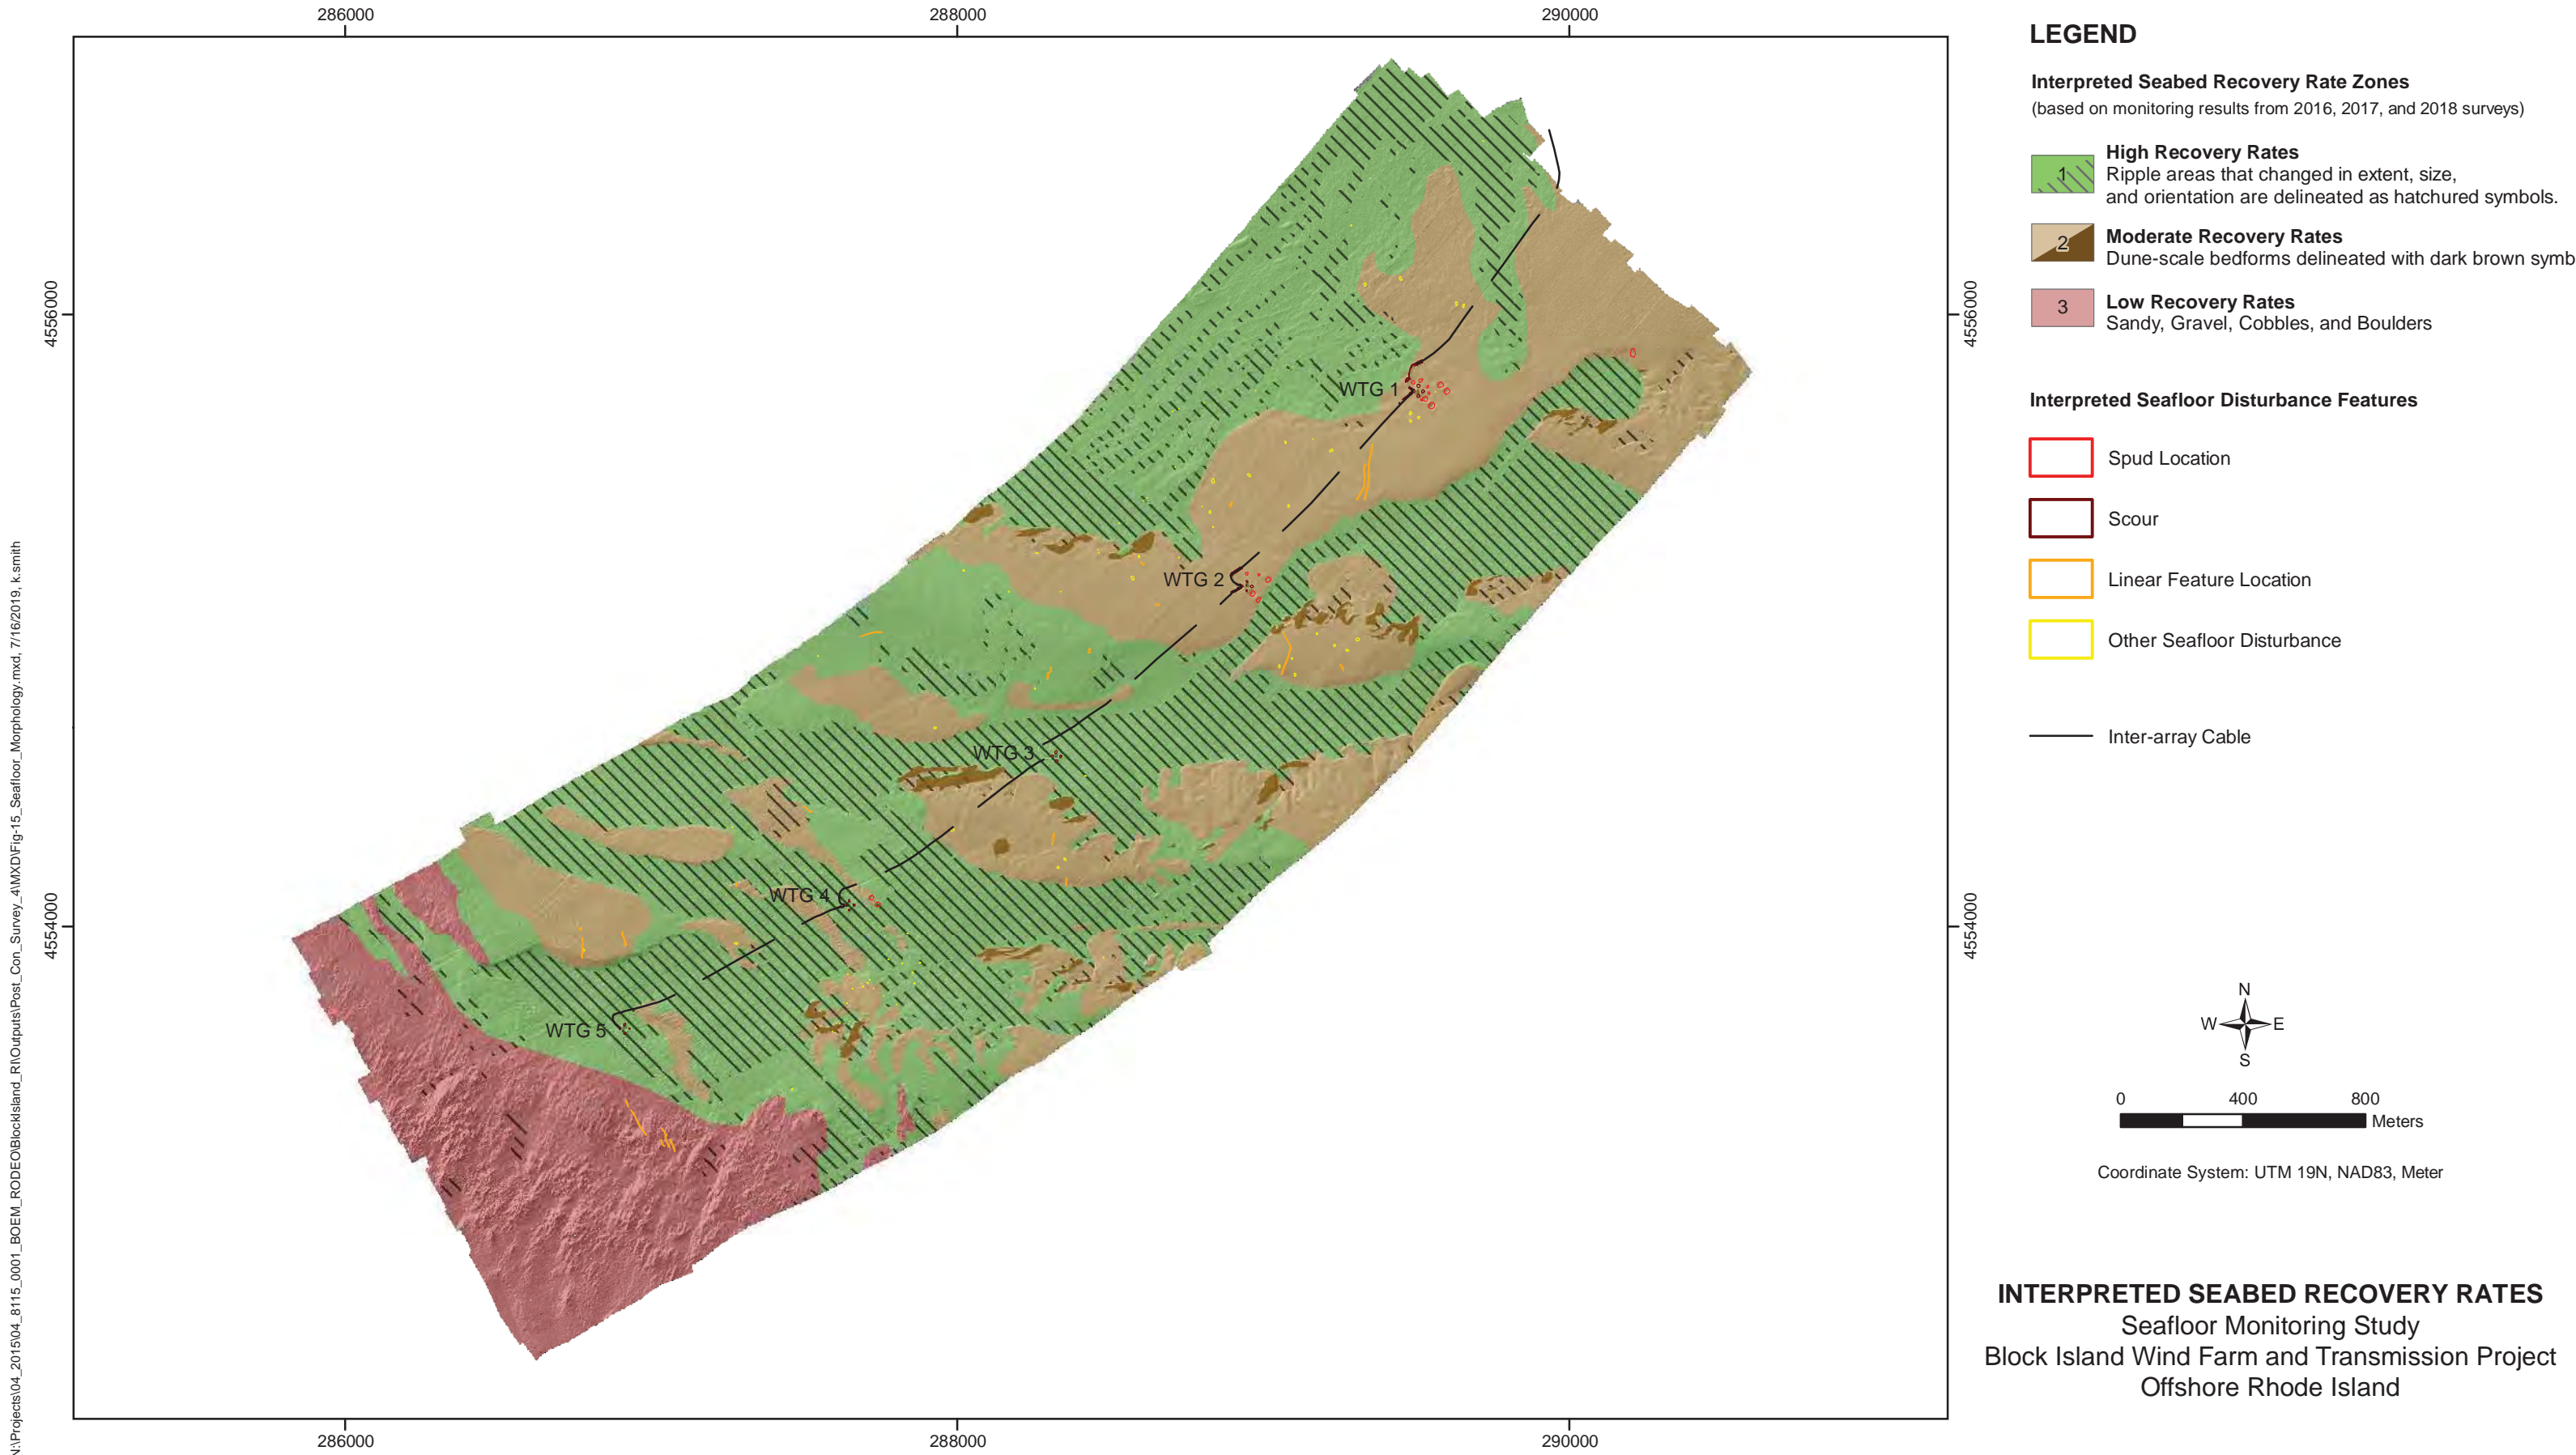
We categorize the survey area into zones based on bedform morphology and changes inferred from data collected during Surveys 1 through 5. Our observations of the survey data indicate that bedforms shift at the site at varying rates and extents of bedform zones (e.g. ripple fields) appear to change over time. We have also inferred the sediment type (e.g. grain size) based on information provided in DW project reports, Fugro's MBES backscatter data collected during Survey 5 (Figure 16), and benthic study grab sampling conducted at WTG 1, WTG 3, and WTG 5 by University of Rhode Island and Fugro during the RODEO program. Correlation between the backscatter data with previously acquired Side Scan Sonar data and grain size data from others, allowed interpretive boundaries to be established and updated for this report (based on the September 2018 survey data). Areas which displayed a high intensity on the backscatter indicate a harder return and suggested coarse material. Conversely, areas which experienced a lower intensity, suggested a finer grained material (e.g. fine sand).

We have evaluated recovery rates for the for various zones using the MBES data and interpretation from the Surveys 1 through 5. Recovery rates are variable across the site and related to seabed sediment type and morphology. The contrast between recovery rates can be abrupt over short distances as observed at WTG 4 in Figures 6b and 6c. In Figure 6b, two of the L.B Brave Tern spud depression are completed recovered and two are still present. The horizontal distance between the

spud depressions that completely recovered and the two still present is only approximately 150 meters which suggests the sediment type is a primary factor in sediment reworking and seafloor recovery. The seafloor recovery zones shown in Figure 15 are described in the following section and summarized in Table 3.4.

We interpreted seafloor recovery rate zones based on seafloor characteristics and morphology inferred from the MBES, side scan sonar, and sediment grain size data (Figure 15).

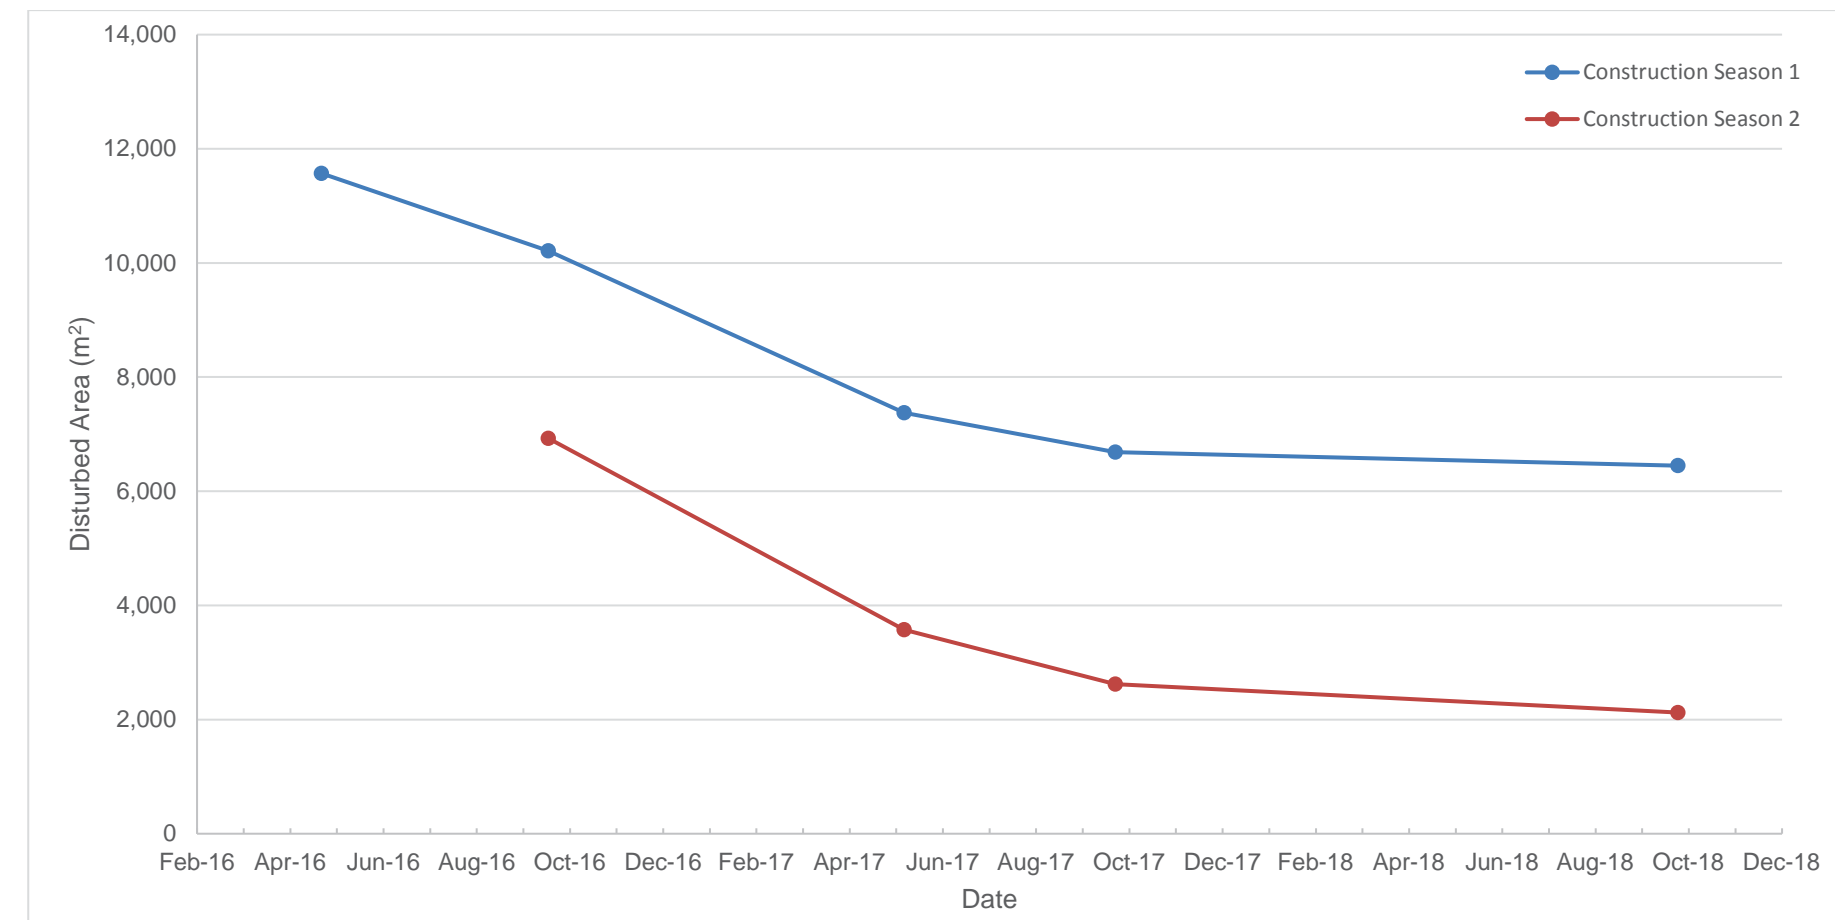
Inset graph (left) presents a summary of the disturbed seafloor area interpreted from each survey.

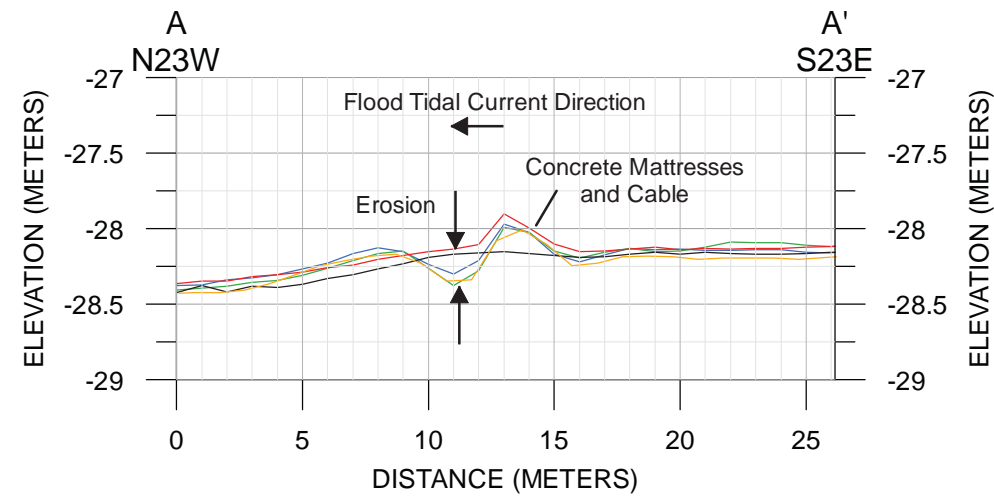
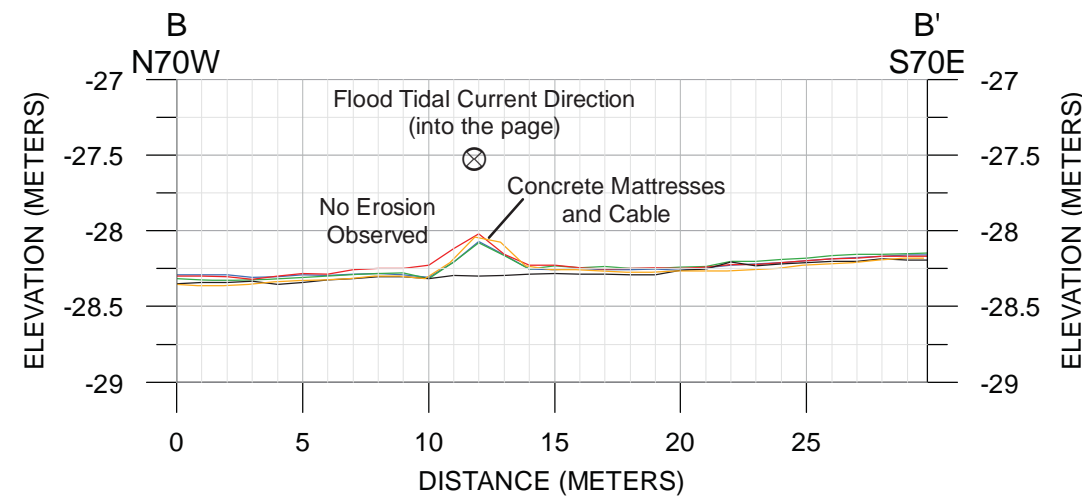
**EXAMPLE OF SEAFLOOR RECOVERY
WIND TURBINE GENERATOR NO. 1**
Seafloor Monitoring Study
Block Island Wind Farm and Transmission Project
Offshore Rhode Island

Survey 1 was conducted before the cable and concrete mattresses were installed.

Principle tidal axis is aligned in the NNW-SSE direction. Cable segment in Profile B is nearly aligned with the principle tidal axis and shows the least amount of scour. Cable segments shown in Profiles A, C, and D are oriented perpendicular to the principle tidal axis. Scour is most prevalent on the northern side of the cable/concrete mattresses which indicates the dominant tidal current flow at this location is likely to the NNW (flood tidal current direction).

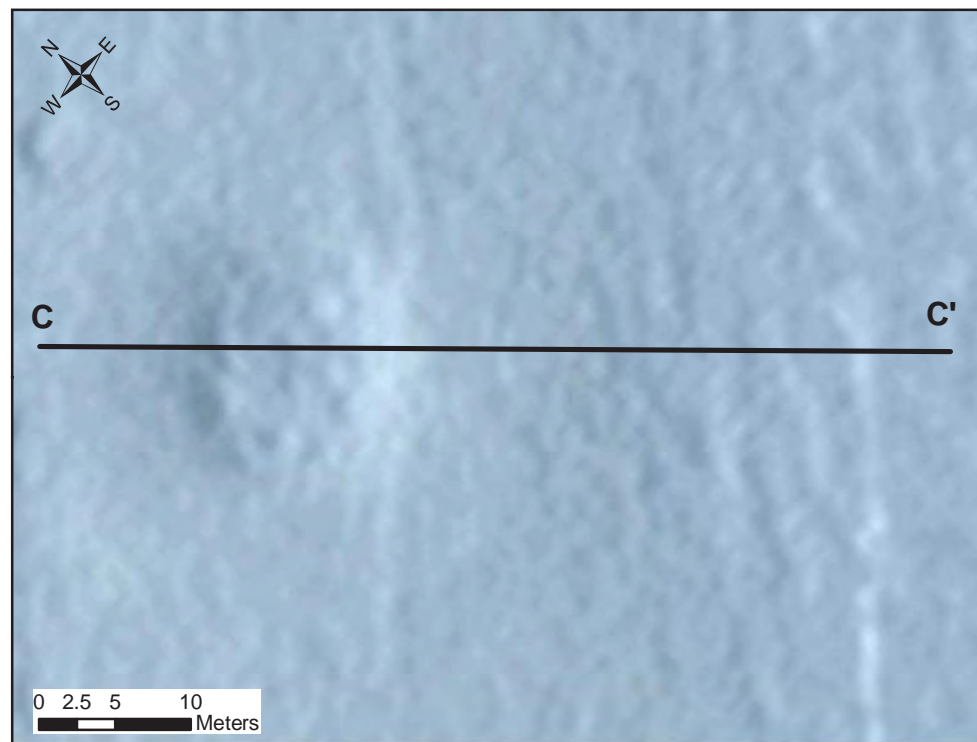
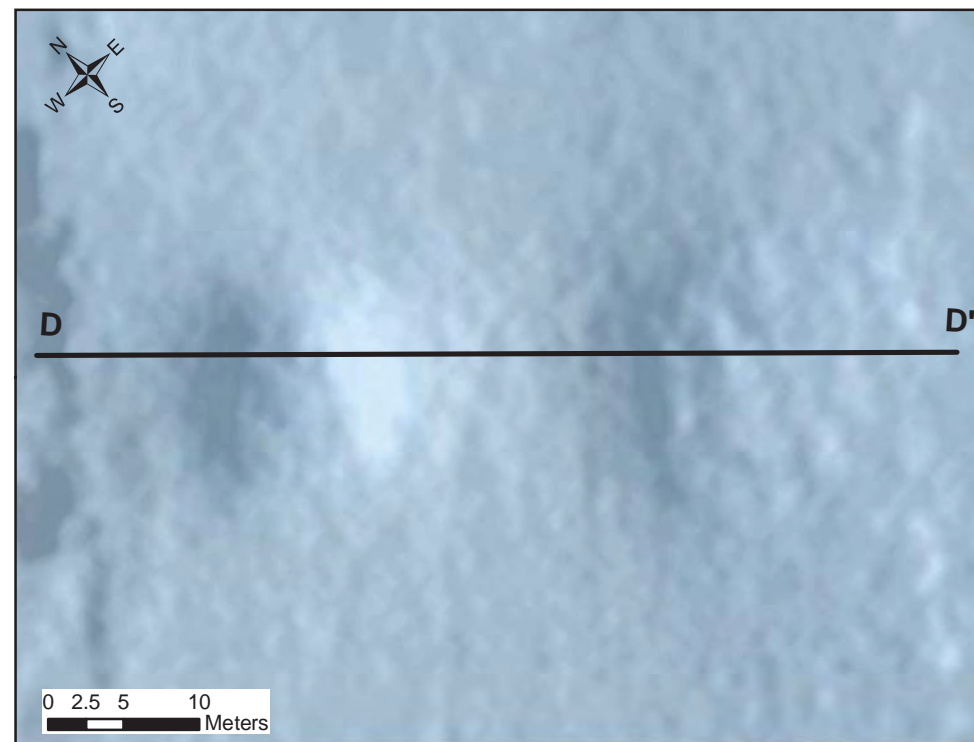
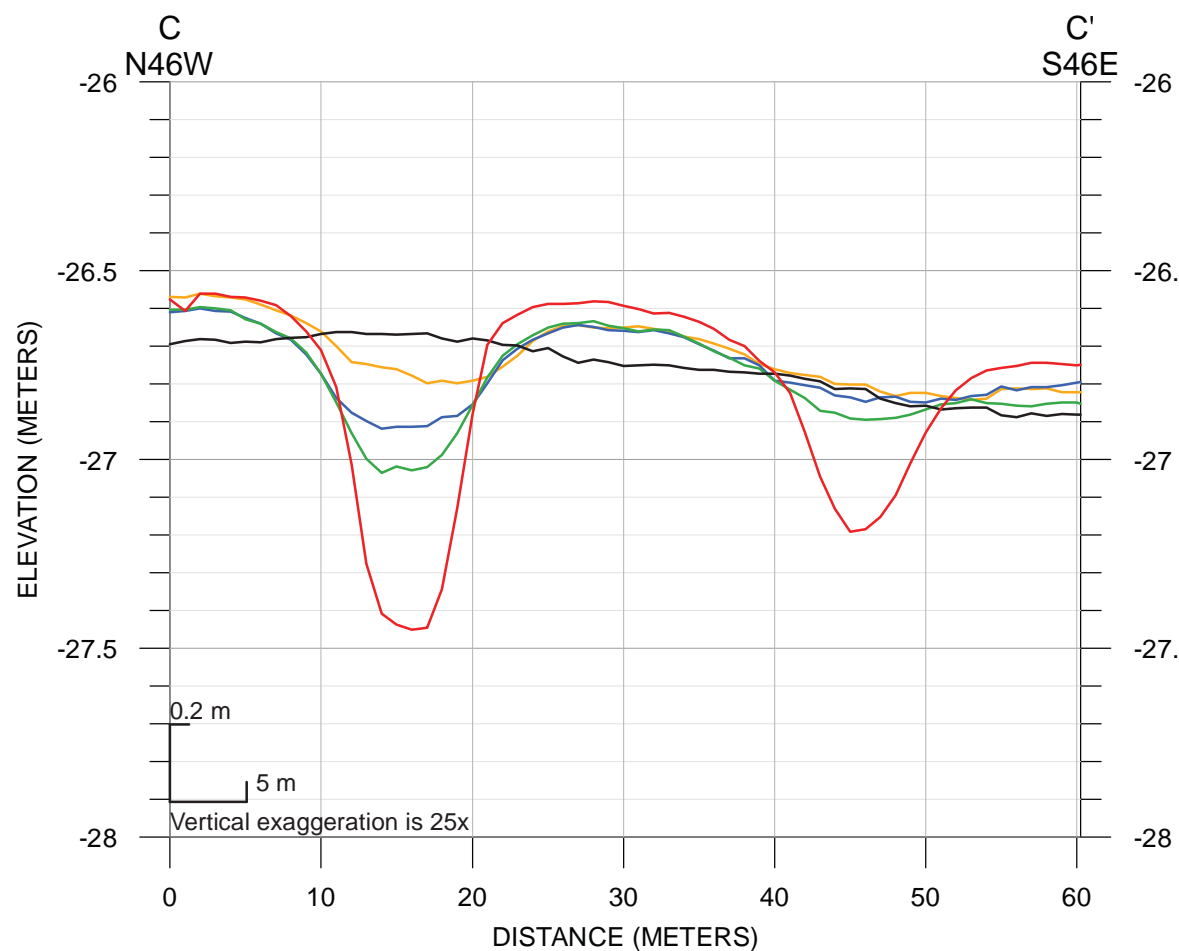
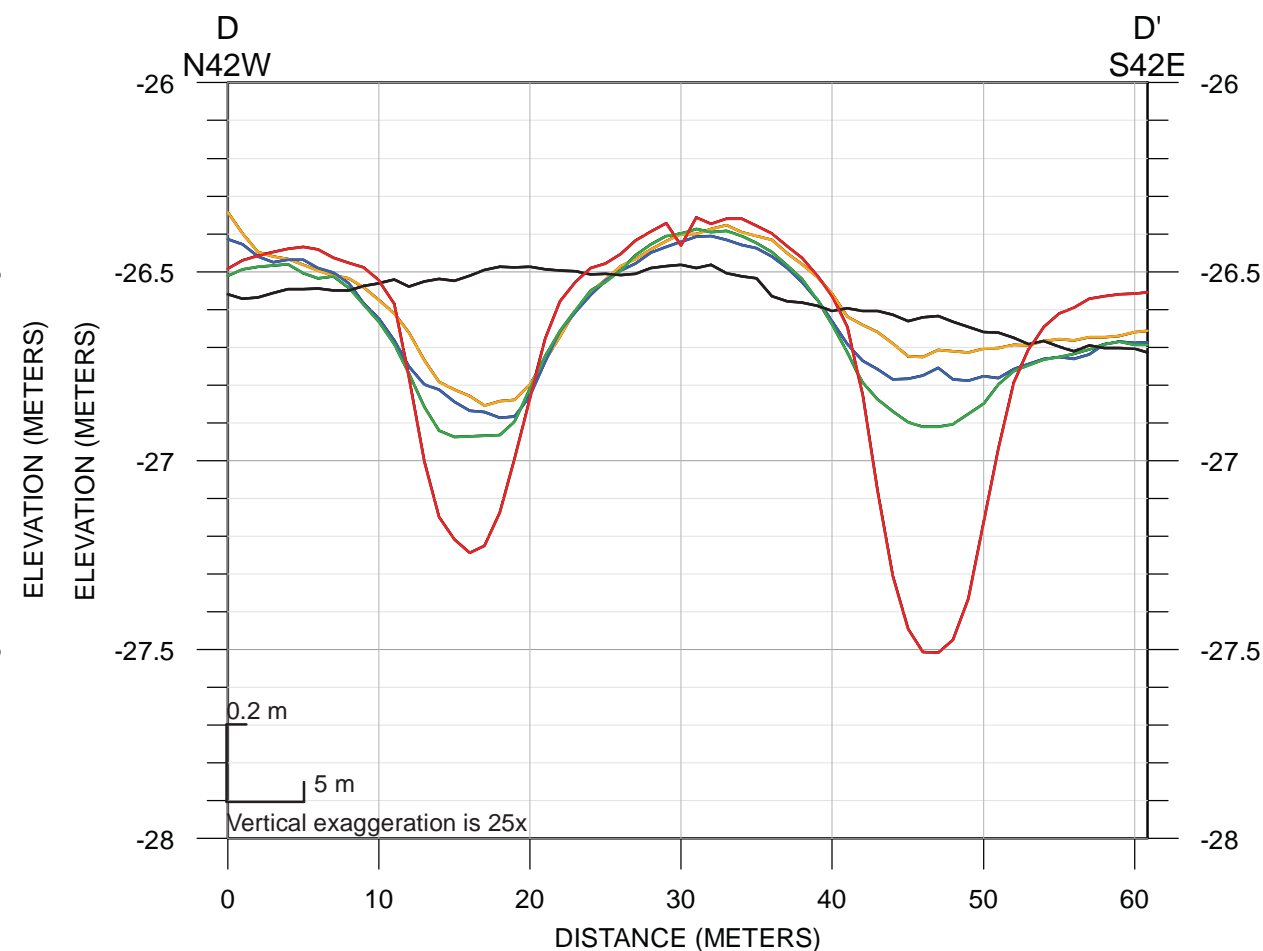
**EXAMPLE OF SEAFLOOR RECOVERY
WIND TURBINE GENERATOR NO. 2**
Seafloor Monitoring Study
Block Island Wind Farm and Transmission Project
Offshore Rhode Island

The depressions shown in this figure were created by the L/B Brave Tern vessel while installing the wind turbine during Construction Season 2 that occurred in between Surveys 1 and 2. Bathymetry data shown in the plan views are from Survey 5.

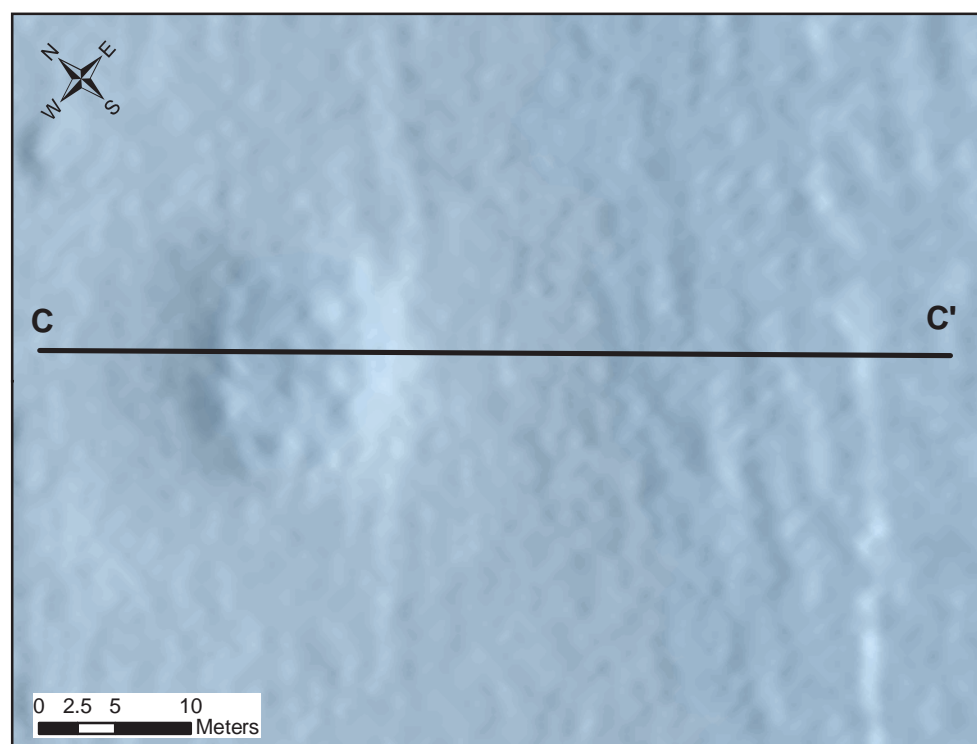
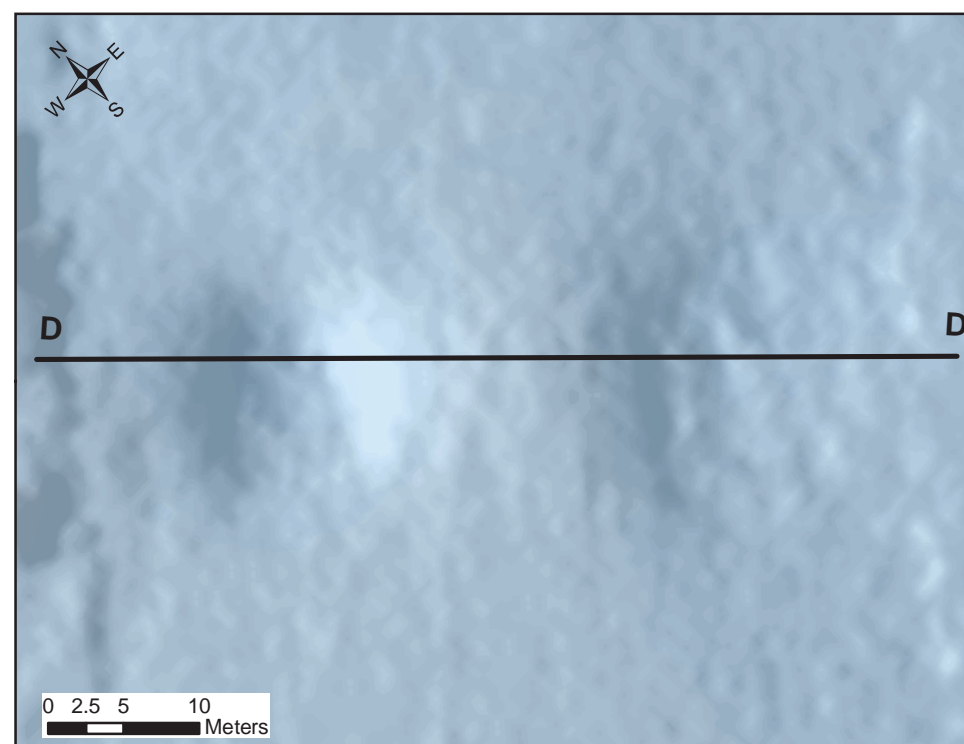
The depressions shown in this figure were created by the L/B Brave Tern vessel while installing the wind turbine during Construction Season 2 that occurred in between Surveys 1 and 2. Bathymetry data shown in the plan views are from Survey 5.

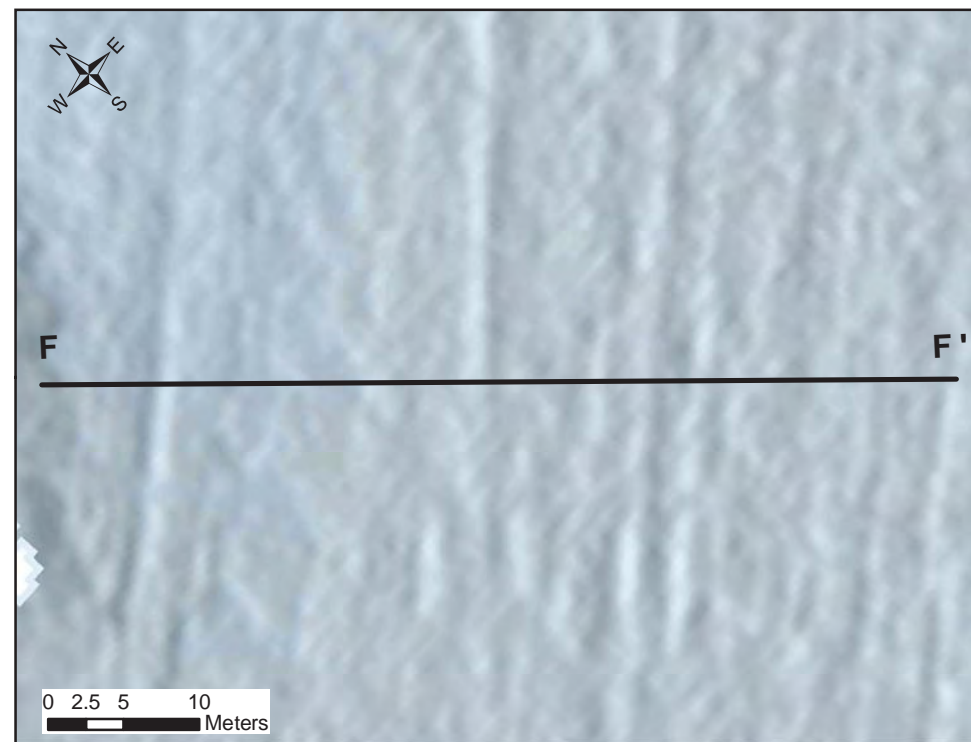
The depressions shown in this figure were created by the L/B Brave Tern vessel while installing the wind turbine during Construction Season 2 that occurred in between Surveys 1 and 2. Bathymetry data shown in the plan views are from Survey 5.

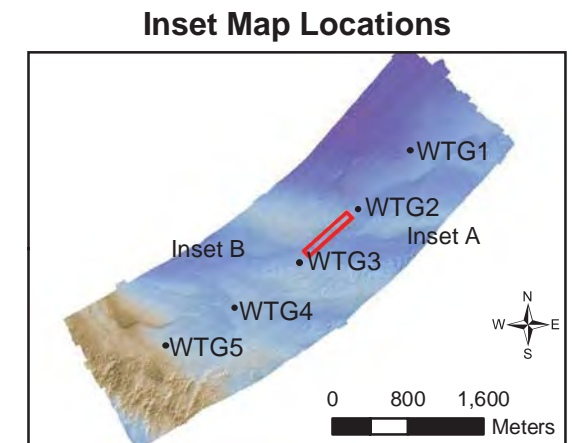
The comparison of the inter-array cable from the four surveys (May 2016 through October 2017), indicate that cable trench scar has partially healed. The inter-array cable was installed between June and July 2016, and Survey 2 (Oct. 2016) showed that the trench scar was up to approximately 10 cm in depth in this area. Survey 3 (May 2017) showed in this same area that portions of the cable trench had completely healed while other areas were up to 7 cm deep. Survey 4 (Oct. 2017) showed that most of the cable trench in this extent had healed, with a few areas up to approximately 5 cm in depth.

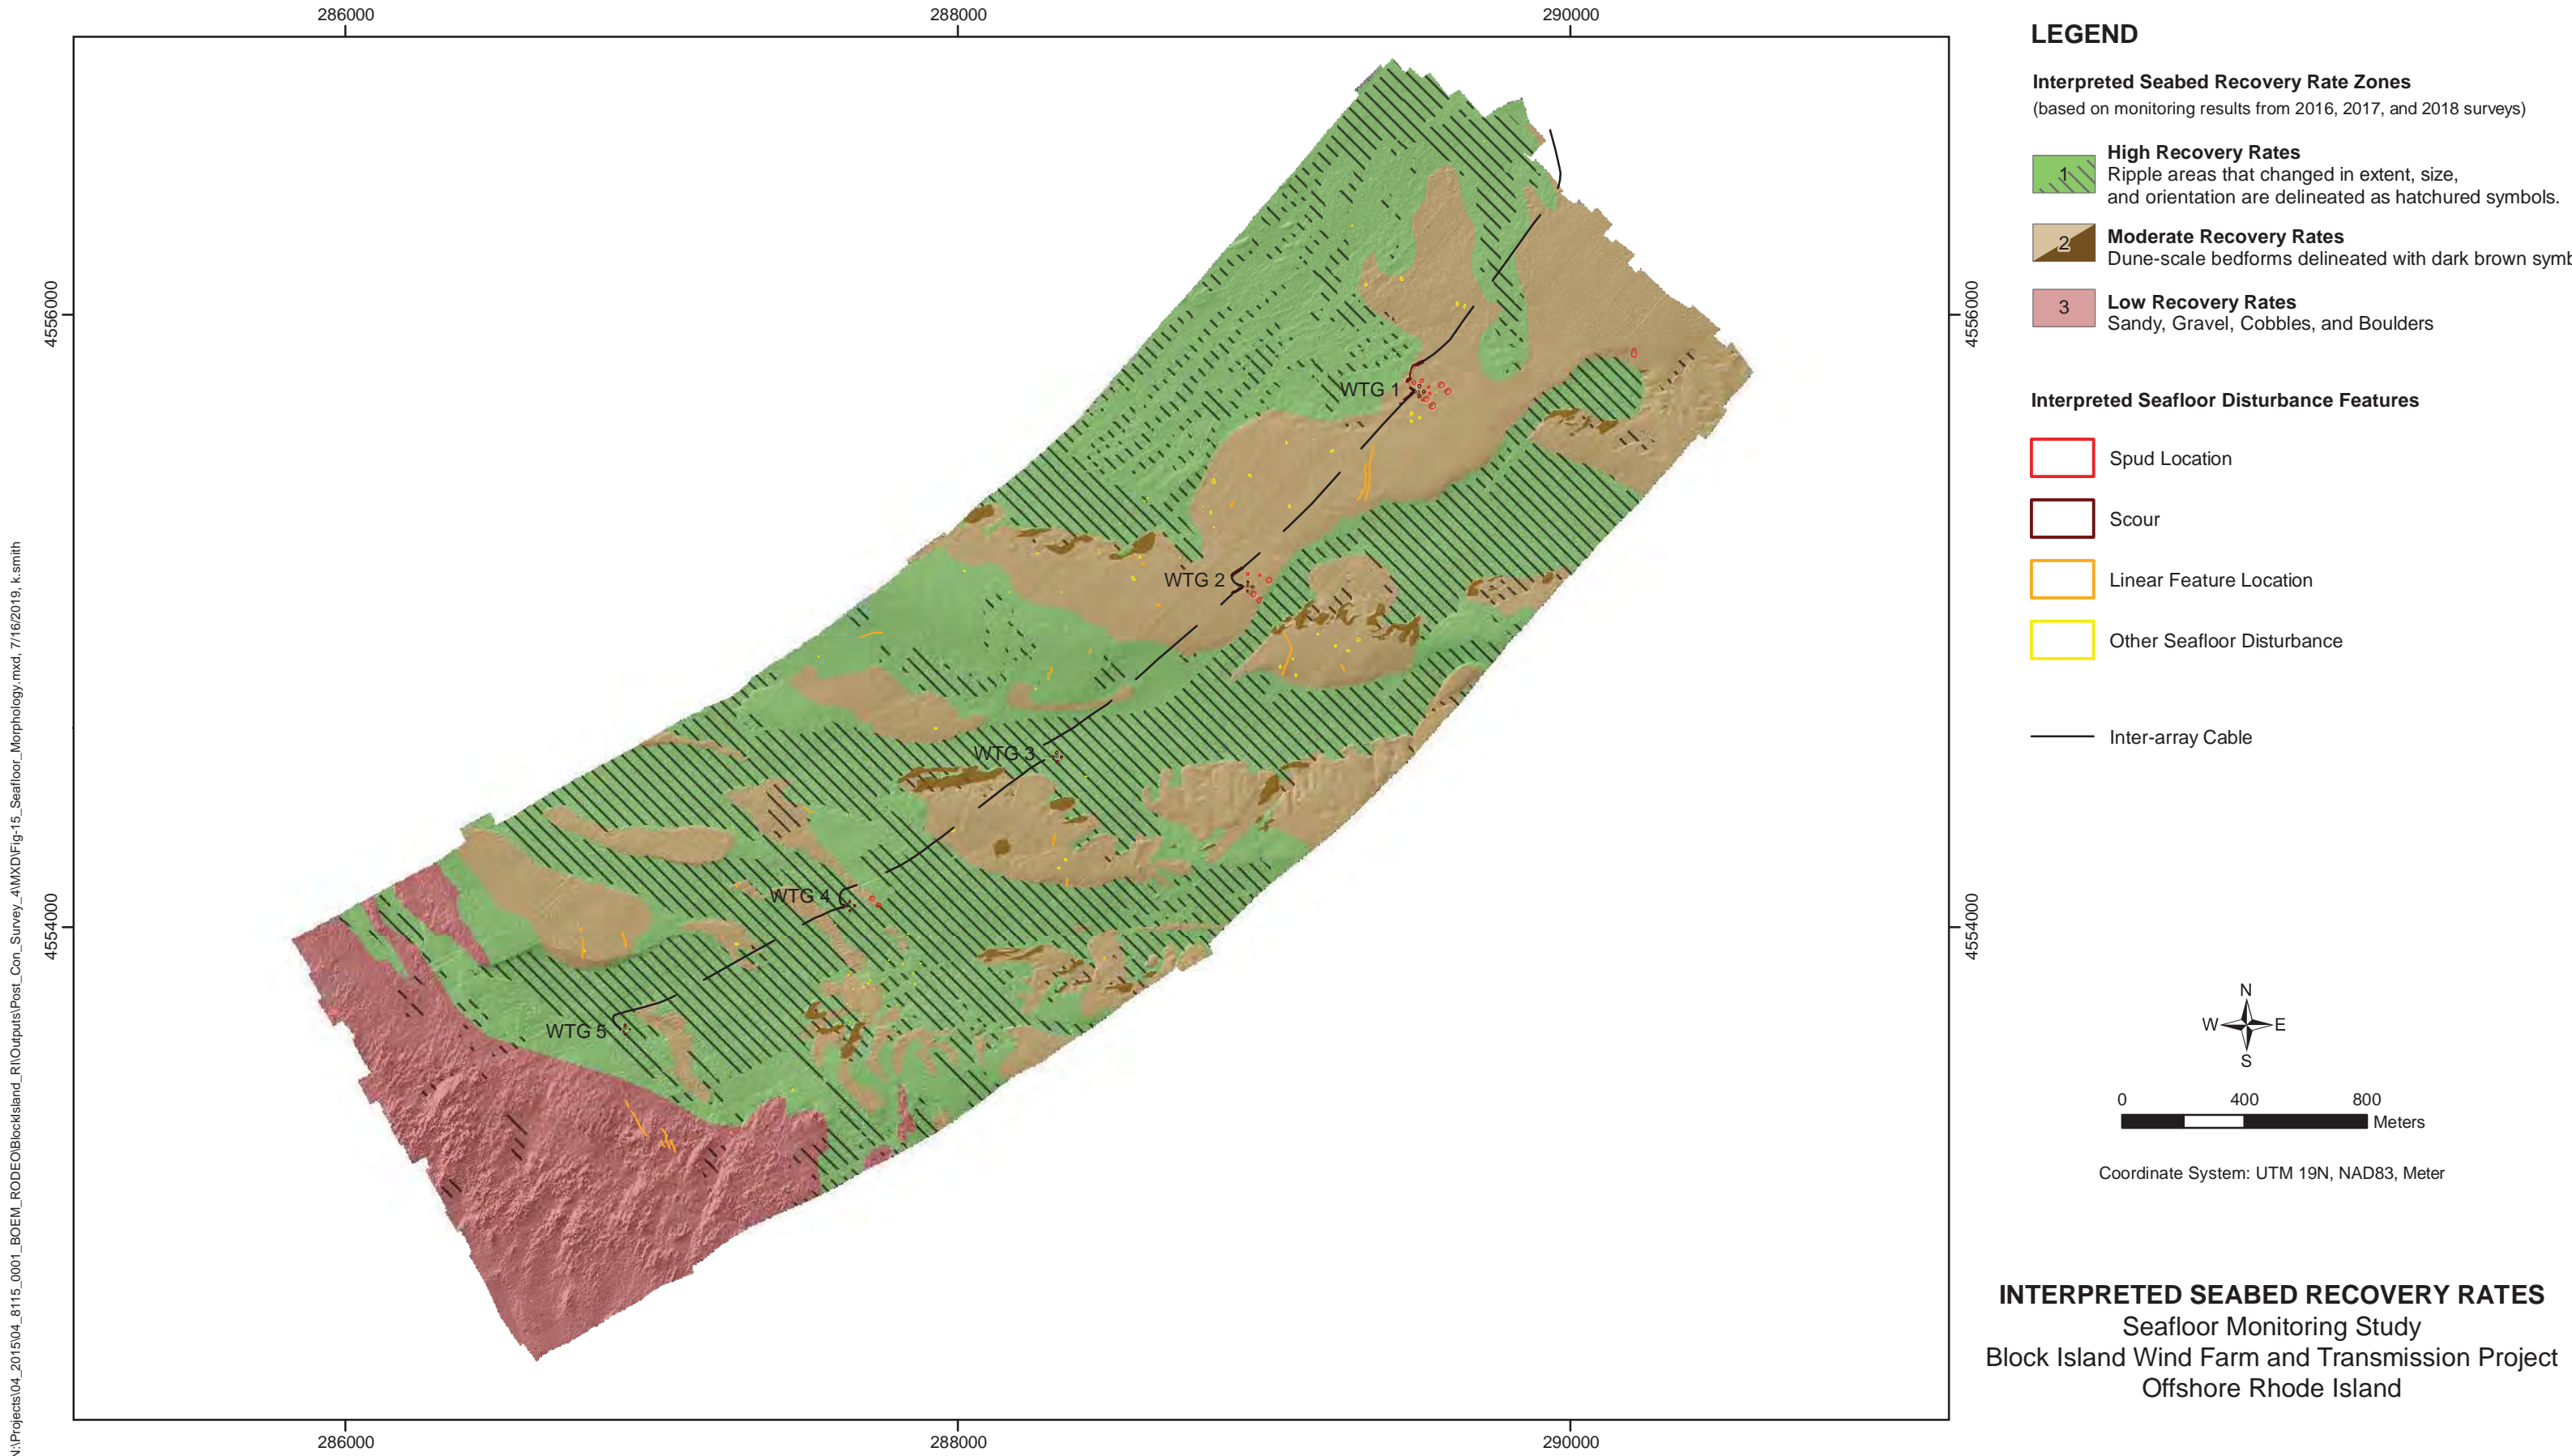
Several large ripple fields were observed to either change in spatial extent or size and in orientation between some surveys (Figure 15). Orientation of ripple crestlines in Surveys 1 and 3 were primarily east-west oriented, while in Survey 2 they were primarily northeast-southwest oriented. Observations of ripple crestlines in Survey 4 revealed that their orientation had approximately remained the same (east-west). It was also noted that the ripples in Survey 4 had grown in spatial extent and in height as compared to previous surveys. Ripples observed in Survey 4 were up to 20 cm tall, compared to approximately 10 cm tall in Surveys 1 and 3 and only about 5 cm tall in Survey 2. Although a seasonal change could still be at work, which was postulated in Survey Report 3, the lack of change in orientation and growth of spatial extent and size of the ripples observed in Survey 4 could be due to the occurrence of large storm events that were present in the area shortly before the Survey 4 data was acquired (e.g. Hurricane Jose at the end of September 2017). Ripple crestlines retain an east-west orientation in Survey 5 except for in the area around WTG 1 where the orientation is northeast-southwest and the area around WTG 4 where there appears to be a combination of the two orientations present. Ripples in Survey 5 had reduced in height to approximately 10 cm tall since Survey 4 where they were observed to be up to 20cm tall.

We categorize the survey area into zones based on bedform morphology and changes inferred from data collected during Surveys 1 through 5. Our observations of the survey data indicate that bedforms shift at the site at varying rates and extents of bedform zones (e.g. ripple fields) appear to change over time. We have also inferred the sediment type (e.g. grain size) based on information provided in DW project reports, Fugro's MBES backscatter data collected during Survey 5 (Figure 16), and benthic study grab sampling conducted at WTG 1, WTG 3, and WTG 5 by University of Rhode Island and Fugro during the RODEO program. Correlation between the backscatter data with previously acquired Side Scan Sonar data and grain size data from others, allowed interpretive boundaries to be established and updated for this report (based on the September 2018 survey data). Areas which displayed a high intensity on the backscatter indicate a harder return and suggested coarse material. Conversely, areas which experienced a lower intensity, suggested a finer grained material (e.g. fine sand).

spud depressions that completely recovered and the two still present is only approximately 150 meters which suggests the sediment type is a primary factor in sediment reworking and seafloor recovery. The seafloor recovery zones shown in Figure 15 are described in the following section and summarized in Table 3.4.

Zone 2 – Moderate Seafloor Recovery Rate. This zone is characterized by sand accumulation areas that appear to be migrating over coarser sediments. The side scan sonar reflectivity is generally low and MBES backscatter intensity values are typically between -27 and -30 db. Sediment type is inferred to be predominantly fine to medium-grained sand with low amount of fine-grained sediment (particle size less than 0.075mm). The sand accumulation bodies are approximately 0.5 to 1m tall and fall within a dune scale size. Figure 14 presents examples of these sand accumulation features and interpreted to be moving at rates of approximately 1 to 3m per year in a northwesterly direction.

We interpreted seafloor recovery rate zones based on seafloor characteristics and morphology inferred from the MBES, side scan sonar, and sediment grain size data (Figure 15).
