Seafloor Disturbance and Recovery Monitoring at the Block Island Wind Farm, Rhode Island – Summary Report

March 2020

Prepared under BOEM Award
Contract No. M15PC00002
Task Order No. M17PD00015
By
HDR
9781 S Meridian Boulevard, Suite 400
Englewood, CO 80112

**US Department of the Interior
Bureau of Ocean Energy Management
Office of Renewable Energy Programs**

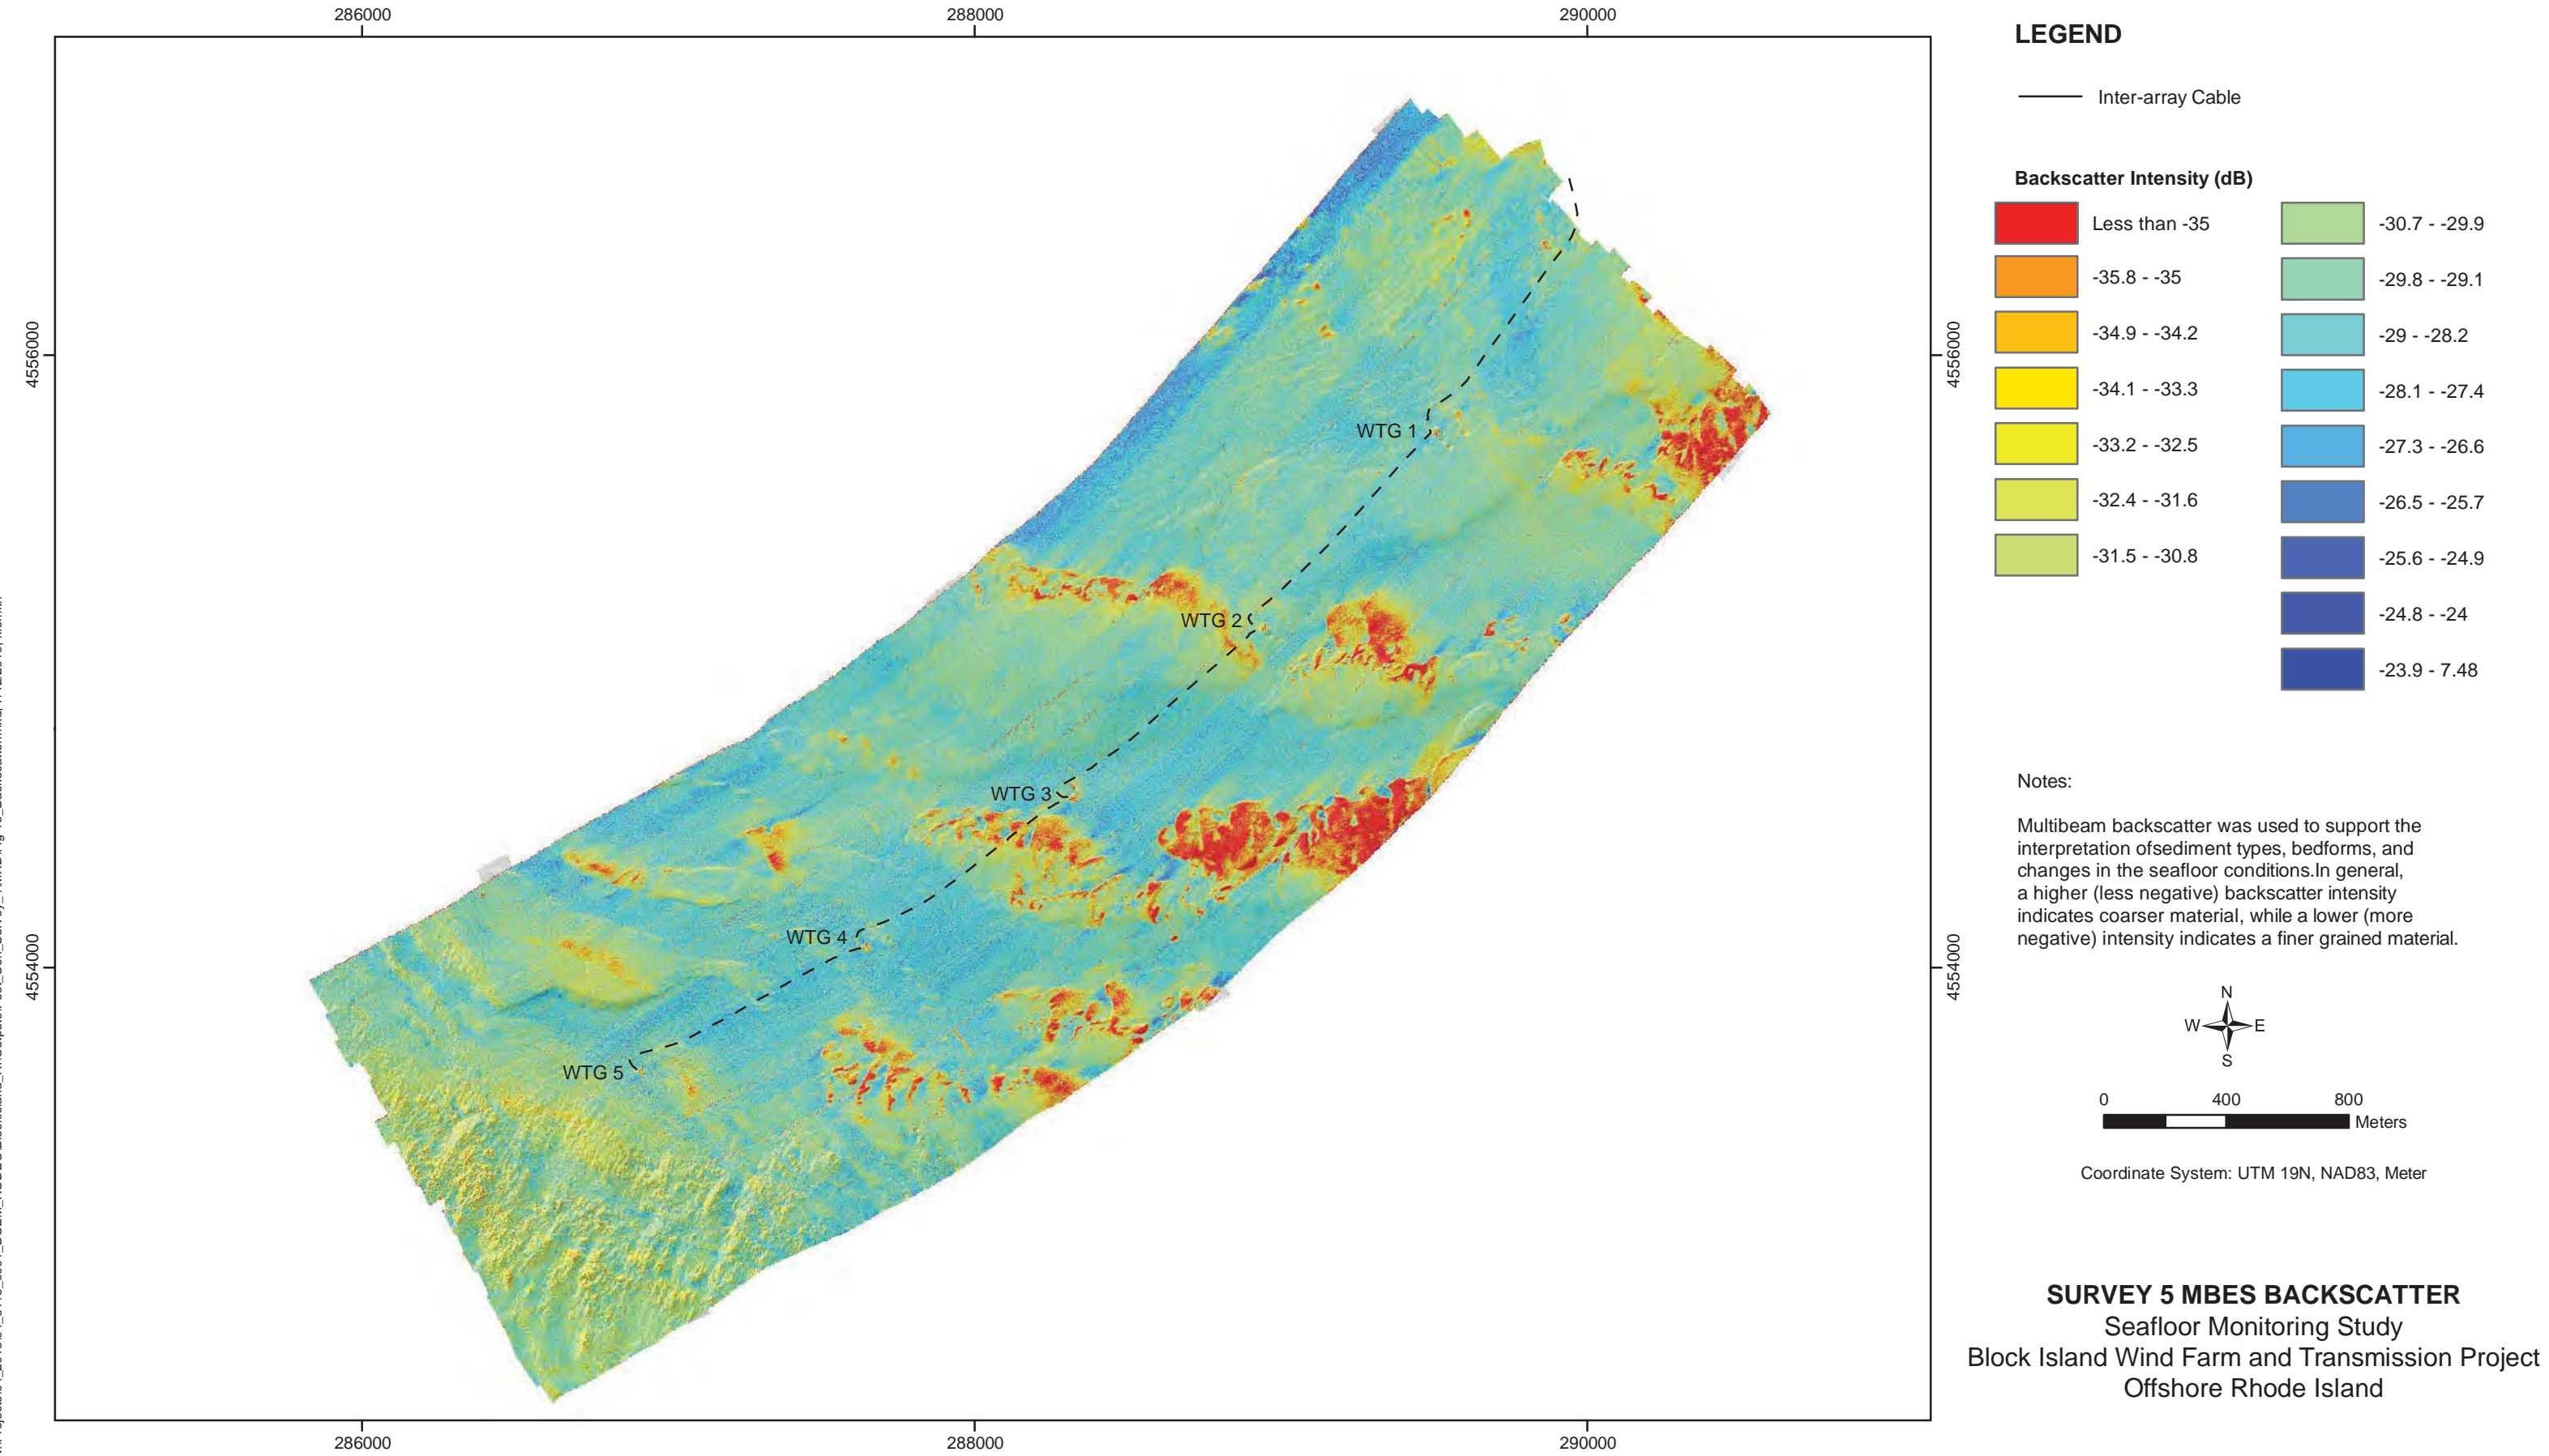
Multibeam backscatter data are used to evaluate seafloor conditions and habitat type. Backscatter data are related to sediment grain size and seafloor roughness and provide qualitative and quantitative information on the composition of the seafloor.

Multibeam backscatter data were collected using the R2Sonic 2024 Multibeam Echosounder. Multibeam backscatter data have been processed from Surveys 3, 4, and 5 and have been used to support the interpretation of sediment types, bedforms, and changes in the seafloor conditions. Limited grain size data (e.g. grab samples collected during RODEO's Benthic Monitoring Program near WTGs 1, 3, and 5) and limited seafloor sediment type information from Deepwater Wind reports were available and incorporated in the evaluation of the backscatter data. Figure 16 and Chart 9 present backscatter data collected during Survey 5.
