SPB01 Seaside Park Beach

Seaside Park Borough, Ocean County, New Jersey

Atlantic Shores Offshore Wind Project Outer Continental Shelf - New Jersey Key Observation Point: SPB01 - Seaside Park Beach Attachment E: Photosimulations: Page 4 of 159

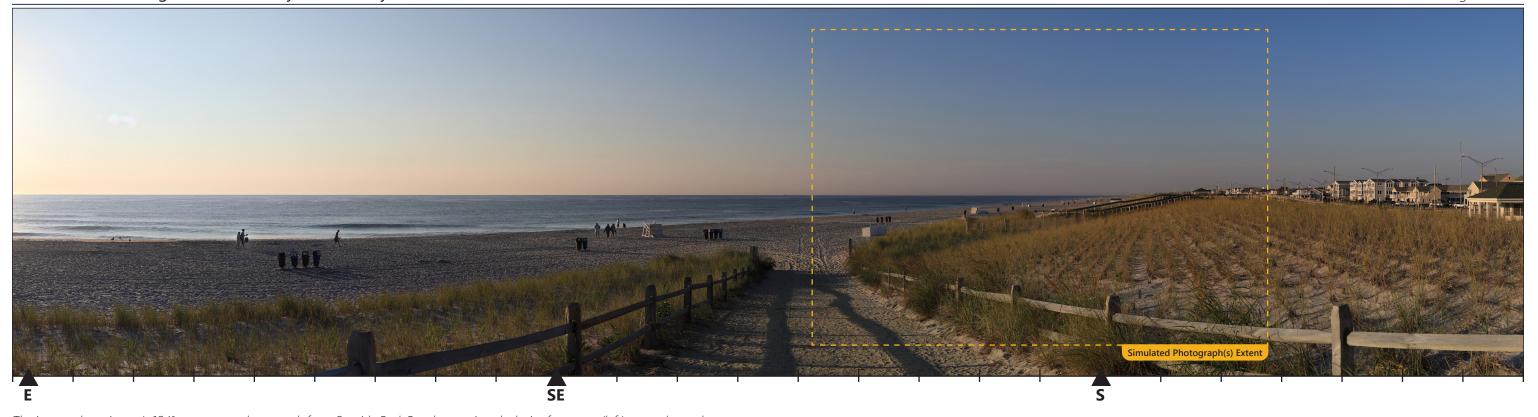
The image above is a +/- 124° panorama photograph from Seaside Park Beach, panning clockwise from east (left) to south-southwest (right). The yellow rectangle within the photo represents the extent of the photosimulation photo(s).

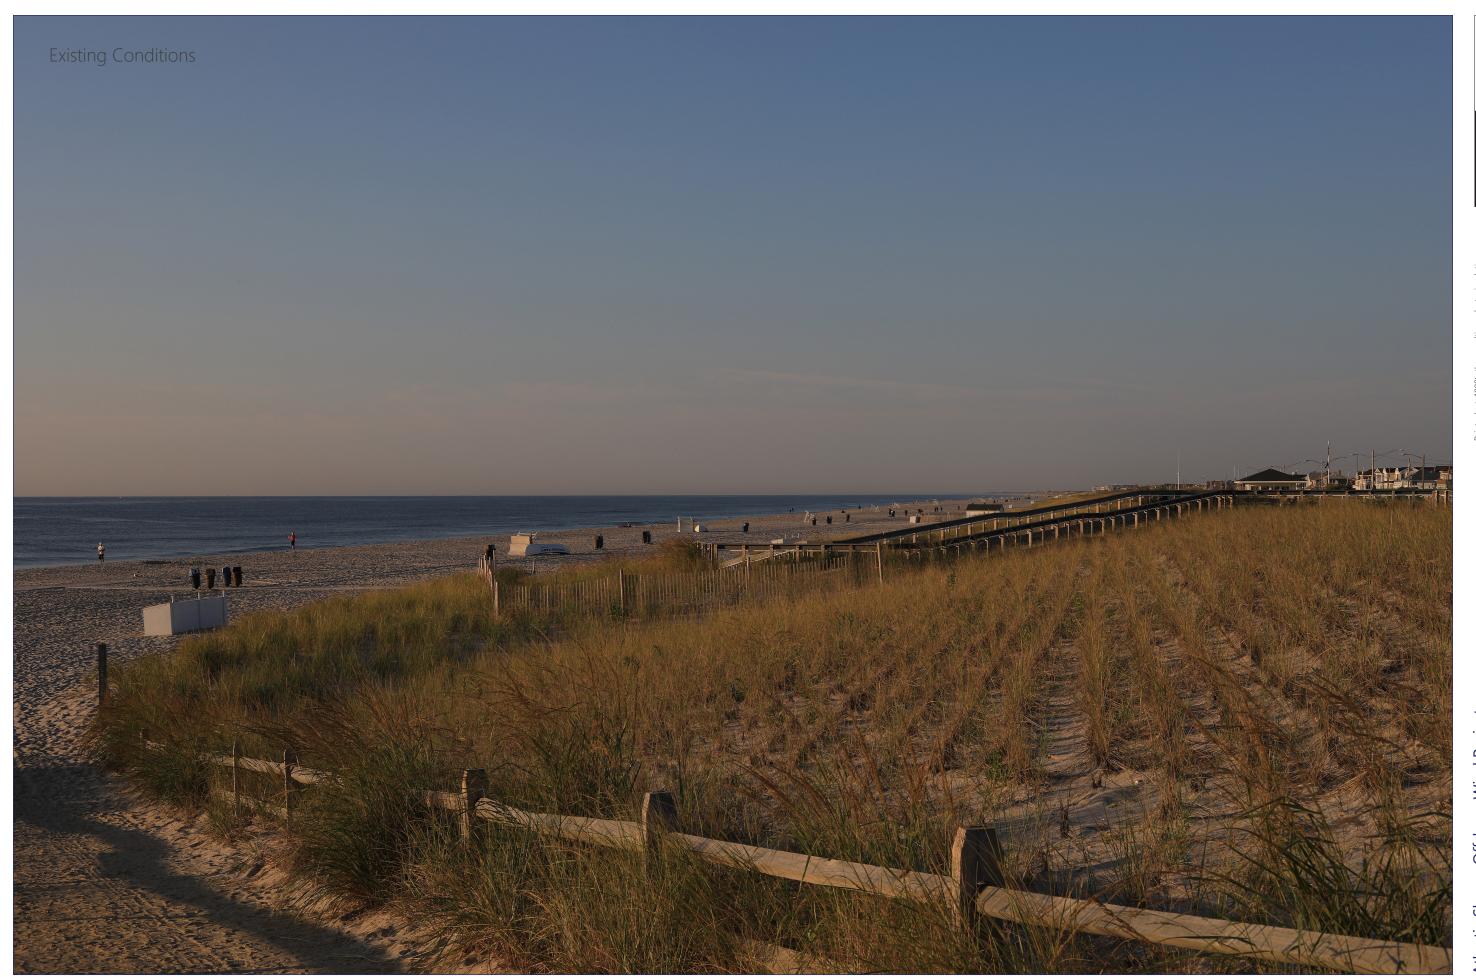
With the proposed Project in place, the southern view is not dominated by the introduction of the WTGs, as the WTG rotor tips are nearly indiscernible along the horizon. 172 degrees of relatively unobstructed ocean horizon is available at this location, and 188 degrees of horizon is obstructed by landward views. While the Project occupies approximately 21 degrees (primarily over ocean horizon), a portion of the Project is viewed over obstructed horizon (e.g., landforms). Project visibility is further limited by distance (38.96-miles from the nearest Project WTG) and the side lighting provided by the setting sun. The rating panel members reaction to the impact resulting from the Project WTGs was consistent with their original rating of the existing conditions, with the VIA scores ranging from 11.3 to 13.7 (average score = 12.3). These scores indicate an average reduction of 0.3 points in comparison to the existing view, with individual rating panel members indicating reductions that ranged from 0.3 to 0.7. Panel members indicated that the presence of the WTGs would be minimally noticeable to most beach visitors since the viewer's attention is focused on the foreground dunes, middle ground beach, and rolling ocean surf. The movement of the rotor blades could attract viewer's attention; however, the tips are so obscure on the horizon that it is unlikely that the casual observer would notice them. In addition, the visibility of the WTGs is likely to be reduced under more hazy or foggy sky conditions. With the Project in place, the viewpoint remains partially retained and impacts would be negligible.
